Case Study:

Formation Of New Bell Mouths Over ScottishPower's Electrical Network

Case Study: Low Voltage Cable Fault Located At Road Gully Pot/Concrete

Case Study: Drainage Manhole Constructed Around HV Cable

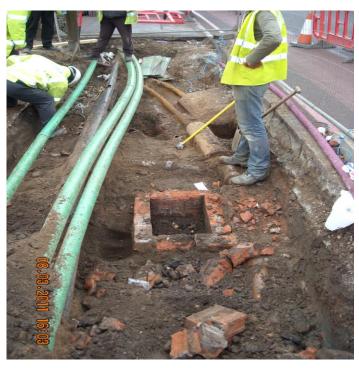
The majority of construction sites require new bell mouth openings; on this occasion the main excavations took place without undertaking trial holes to determine the line and depth of all utilities at the locus. ScottishPower cables are installed at a recommended depth for all different ground surface types, taking into consideration the voltage of the cable, removing ground cover on a footpath to form a carriageway bell mouth reduces the level of cover required.

Prior to the main bell mouth construction taking place, contact with ScottishPower should take place to determine if the existing electrical cables require to be deepened and spare electrical ducting installed, preferably at the planning stage of the project. (Encasing the ScottishPower electrical network with a concrete raft is not an option when forming bell mouths)

No concrete to be installed close to or around the ScottishPower electrical network at anytime.

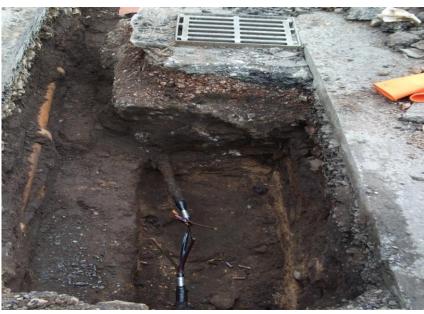
The above image demonstrates a low voltage cable fault on ScottishPower's underground electrical network.

In this scenario the cable has went into a fault situation of its own accord, however it should be highlighted that on occasions gully pots and the large amount of concrete required to keep the road gully pot in place can contribute to the cable being damaged. Placing concrete on or around the underground electrical network is not recommended.

No Concrete To Be Placed On Or Around The ScottishPower Underground Network

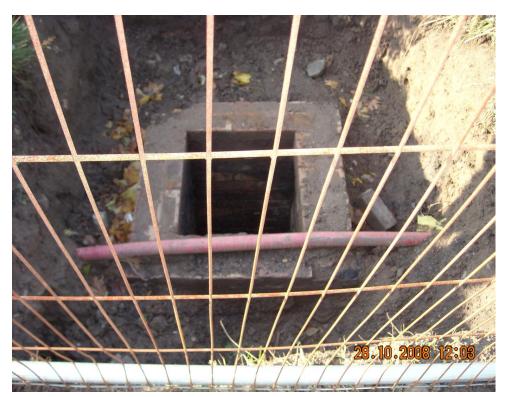
The above image highlights a situation where a ScottishPower high voltage cable was found to be constructed into a drainage manhole.

When installing new services such as gas, water, drainage or telecom - check on the correct separation with your supervisor. Never build existing cables into a manhole, telecom chamber walls or encase them in concrete. The consequences of encasing cables in underground chambers could lead to serious injuries for unsuspecting operatives at a later date. To rectify this situation a cable deviation took place. Cable record enquiries are to be directed to ScottishPower Data Management section.

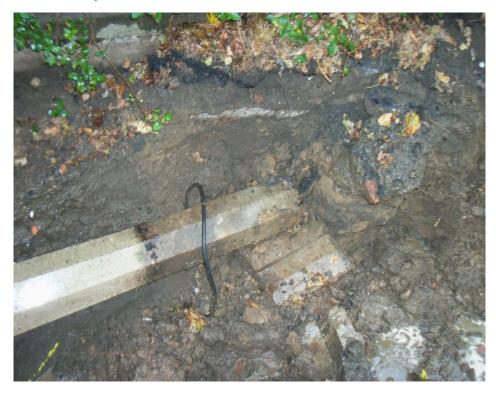
The above image highlights a situation which may well have lead to more serious consequences. The operative's task was to CONTACT excavate to remove an existing link box (underground electrical In an emergency, or if there is any network switching point) and replace with new link box apparatus. During excavations the concrete lamp post snapped below ground at approximately 400mm depth, and crashed to the ground. Fortunately on this occasion no injuries were sustained to the operatives, when excavating in close proximity to concrete lamp posts a risk assessment regarding the stability of the lamp post should be implemented and repeated checks should be carried out as excavations progress to ensure the

Implement A Risk Assessment When Excavating In The **Vicinity Of Street Furniture**

safety of operatives and the general public.
