Assessment of overhead line  
performance during severe storms

Prepared for:  
Scottish Power Energy Networks

# Assessment of Overhead Line Performance during severe storms

Report No:  
82880

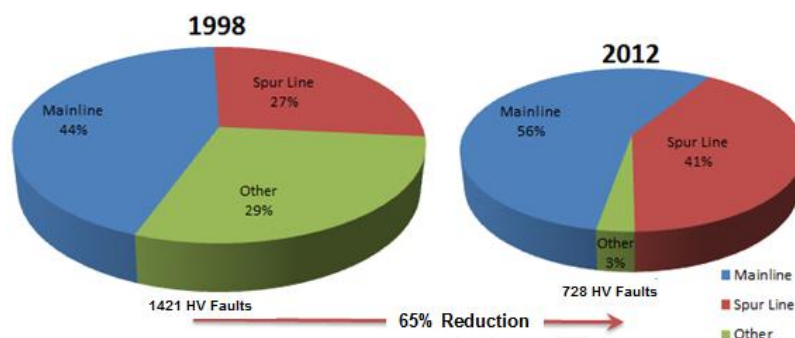
### Figure 9 – Overhead Line types

The storm event of the 26<sup>th</sup> Dec 1998 (Figure 9) had 44% mainline faults and 27% spur lines. The storm event of 2012 in comparison with 1998 experienced a 31% reduction in HV (Damage) faults, these were categorised as 56% mainline and 41% spur lines. The main line and spur line figures are not comparable due to the large number of overhead lines categorised as 'Other' in 1998. What it does display, is that the reporting of the circuits line type has drastically improved with only 3% reported as 'Other' in 2012.

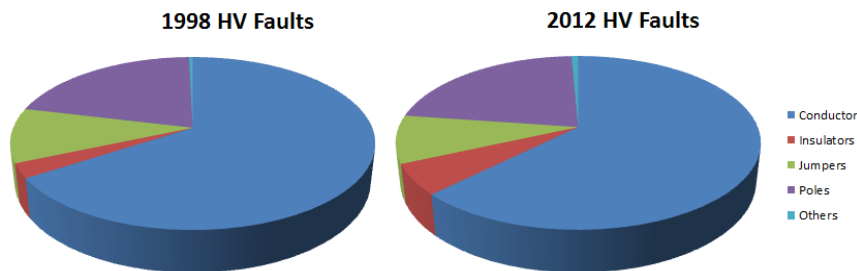
Figure 12 – Fault distributions

HV network faults are categorised as ‘Conductor’, ‘Insulators’, ‘Jumpers’, ‘Poles’, and ‘Others’. Figure 12 illustrates the fault distributions from each storm event, and shows a proportional increase in Insulator faults.

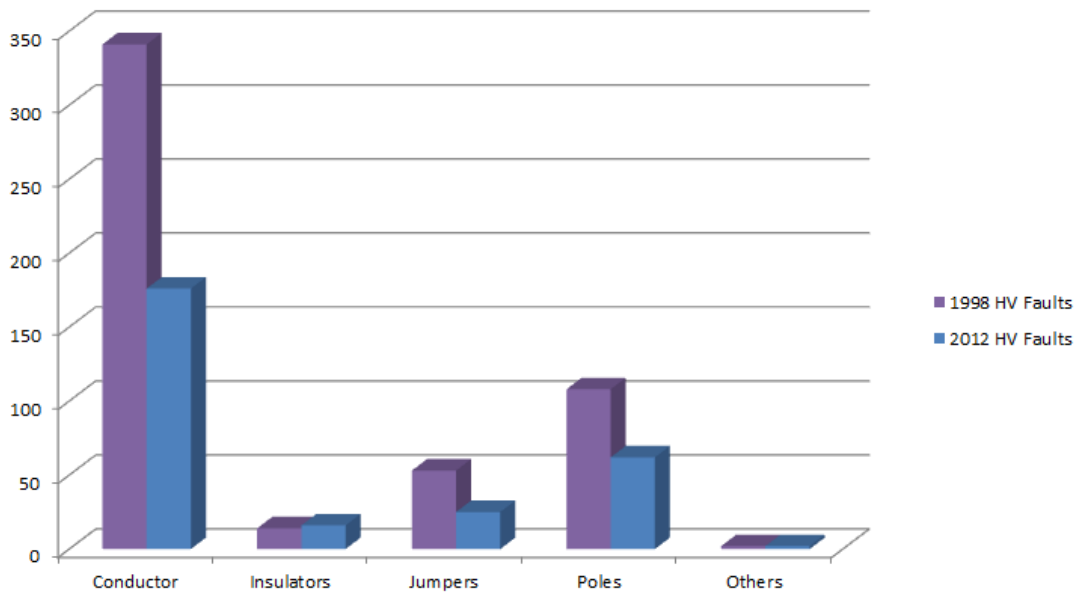
**Figure 13 – Fault Categories**

Figure 13 shows that for the 2012 storm event compared to the storm event of 1998 there was a 48% reduction in Conductor faults; **14% increase in Insulator faults**; 53% reduction in Jumper faults and a 43% reduction in Pole faults.

**During the 2012 storm event 61% of the HV damage faults were attributed to trees and 39% to other factors, mainly windborne debris.**

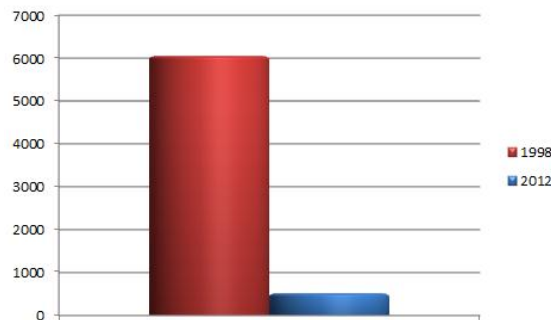
**Figure 14 – LV Faults**

The LV network suffered from 6,051 LV faults during the 1998 storm event whilst in 2012 it suffered from 518. **This is a reduction in LV faults of 92%.**

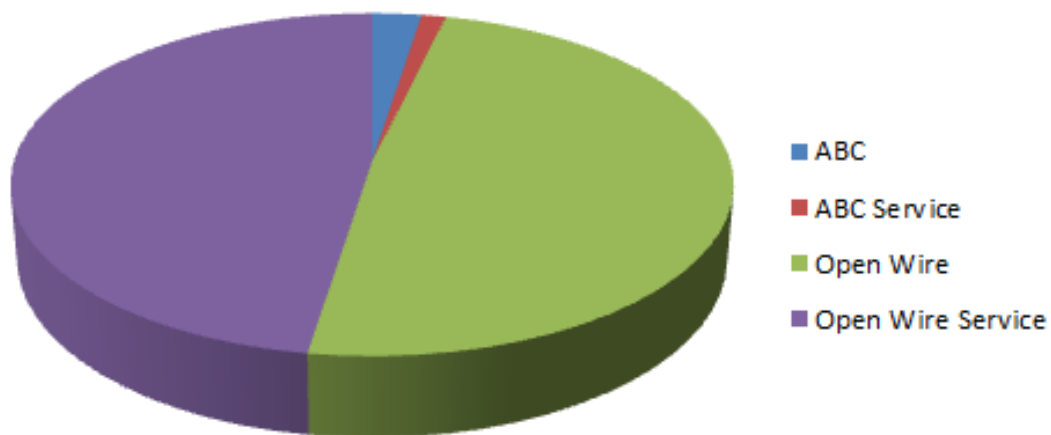
Figure 15 – LV faults per construction

The total proportion of ABC faults is 3% (2% ABC Main, 1% ABC Service), which would indicate that ABC has an increased resilience during storm damage over open wire construction. The major component in the LV fault figures is conductor damage (Figure 12), therefore as the population of ABC increases within SPEN's Scottish LV network the LV fault levels should further reduce during storm events.

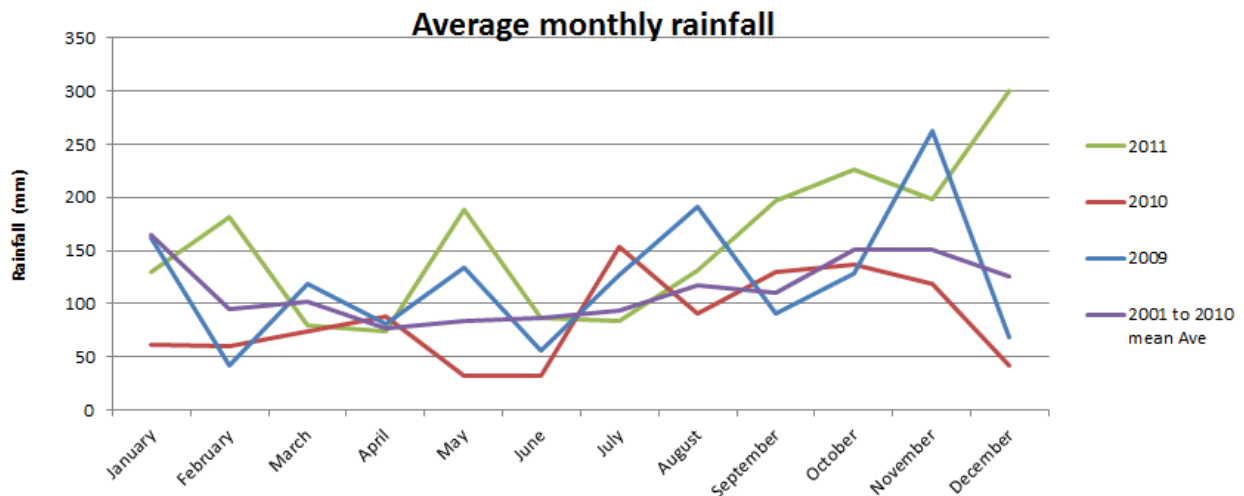
Figure 19 – Monthly Rainfall

Figure 19 illustrates the monthly rainfall figures for 2009 to 2011 plus the mean average from 2001 to 2010. The 2011 graph shows above average rainfall figures for most of the year, the December figures show a massive increase above average. It would be safe to assume that the significant increase in rainfall had contributed to some tree foundation instability, contributing to some of the healthy tree failures.

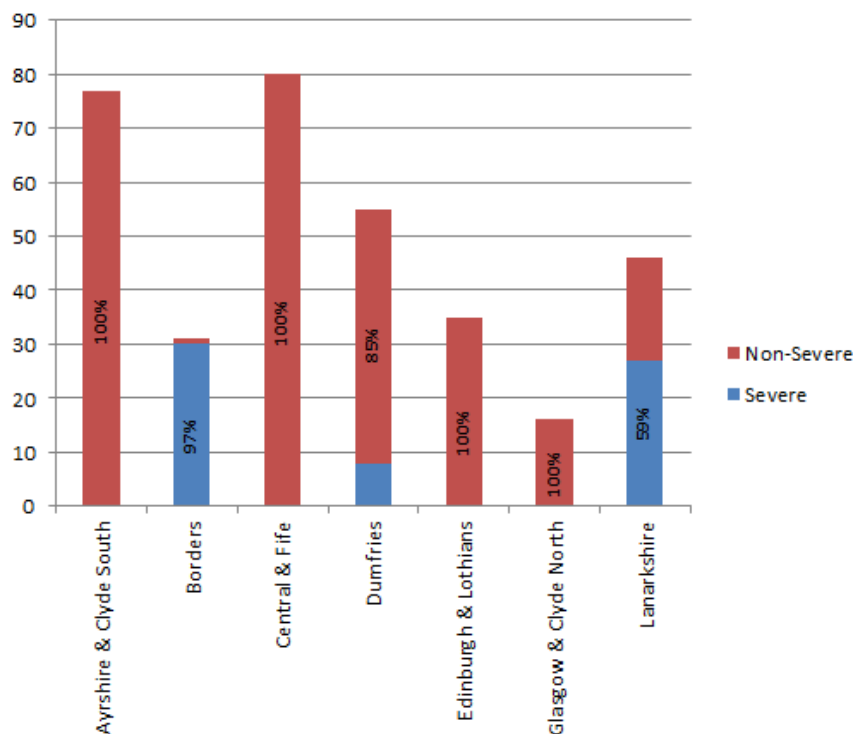
Figure 22 – Weather zone faults

97% of the HV faults in the Borders region occurred within a severe weather area; 59% of Lanarkshire region's HV faults occurred within a severe weather area and the Dumfries region had 15% of their HV faults occur within a severe weather area.

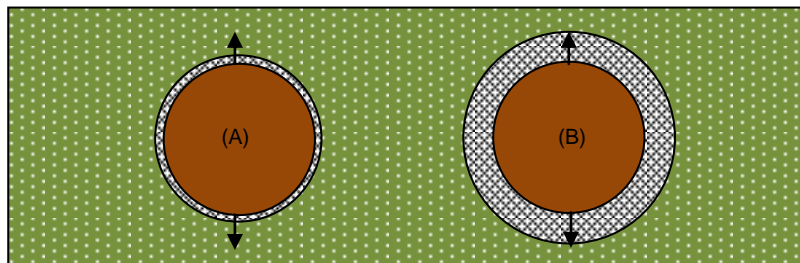
Figure 23 – Augered pole holes

As LV poles do not have any pole baulks installed, LV poles can be installed with the excavator or pole auger methods. Installing poles with the auger method minimises the amount of ground that needs excavating, however augered holes are usually so tight to the pole that no reinstating can be carried out (Figure 23A) or so large that too much reinstatement is required (Figure 23B). In other words no reinstatement material can be packed down the sides of a tightly augered hole and too much ground is removed on large augered holes. Both of these scenarios result in leaning poles.

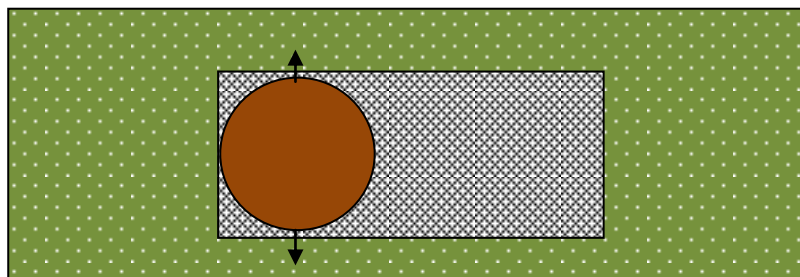
Figure 24 – Excavator pole hole

Poles installed with an excavator are usually easier to obtain a tight hole as it can be reinstated through the corners (Figure 24). Both of these pole installation methods are valid, however the quality of the pole's foundation is directly attributable to the quality of the installation. Therefore auditing of pole installations or holding contractors to account for leaning poles for at least 2 years will increase the quality of pole installations.

**There is no evidence of pole failures due to poor foundations during the storm event of 2012; however these failures can go undetected, as leaning poles do not always threaten the security of the supply.**

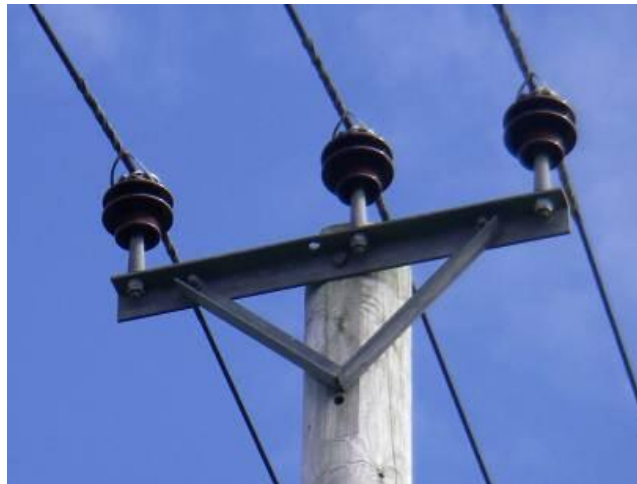
Figure 27 - BLX

There is anecdotal evidence that during fault conditions BLX has been reconducted with bare conductor due to insufficient stocks and knowledge of the construction. The use of bare conductor on BLX crossarms subsequently resulted in clashing problems.
