This document details the **Approved** procedure for removal of the insulated voltage test sockets and the associated wires from the ABB Nitran LV Take-Off Chamber (LV fuse cabinet) applicable to OPSAF-16-215 SOP 215-ABB-TYPE IP2X LV fuse cabinets.

There is a known failure mode associated with insulated voltage test sockets fitted to the transformer incoming side of LV Take-Off chambers manufactured between 1991 and 1998 by ABB Power T&D. The voltage test sockets are not fused hence there is potential for disruptive failure when the voltage test socket insulated body fractures during use. To prevent a flashover occurring at the transformer busbar connected LV voltage test sockets, OPSAF-14-054 required that the insulated voltage test sockets fed from the top contacts (incoming side) of the transformer disconnector were not to be used for **Live** testing. SWG-17-111 was introduced to retrospectively install blanking caps to prevent further use.

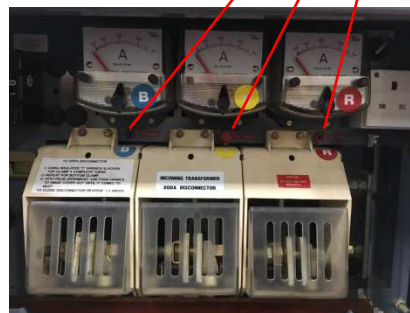
Figure 2: Test Sockets

Subsequently the ageing of the sockets has now presented a different failure mode whereby mechanical vibrations are sufficient for the degraded voltage test sockets insulated body to fracture, causing the unfused voltage test socket to dislodge from the panel fixing and for the exposed conductive end of the voltage test socket to make contact and short to adjacent earthed metalwork or live busbars (refer Figure 6: Test socket wire). As the failure is due to aged degradation, this failure mode is applicable to voltage test sockets that may visibly appear to be in good condition. It is noted that even the vibrations during the opening and closing of the LV TOC door are sufficient to trigger this failure mode as experienced at Pollockshaws Road substation on the August 31<sup>st</sup> 2018. OPSAF-16-215 was updated to reflect this different failure mode requiring full **Live** working personal protective equipment to be worn when accessing the LV TOC.

3. Identify and firmly hold the L1 test socket wire prior to breaking off the test socket end from the instrument panel. Lift the test socket end of the wire (complete with test socket, see Figure 6: Test Socket Wire) clear from contact with conductive parts.

4. Using **Approved** diagonal cutting nippers (SAP Commodity Code: 30982456), cut the wire as close to the top end of the ring crimp on the L1 busbars as possible (care shall be taken not to drop the wire markers). The ring crimp on the busbar shall not be removed or tampered with.

5. Remove the wire (complete with the test socket) from the LV TOC and dispose of the wire and socket.
6. Repeat steps 3 to 5 for L2 and L3.

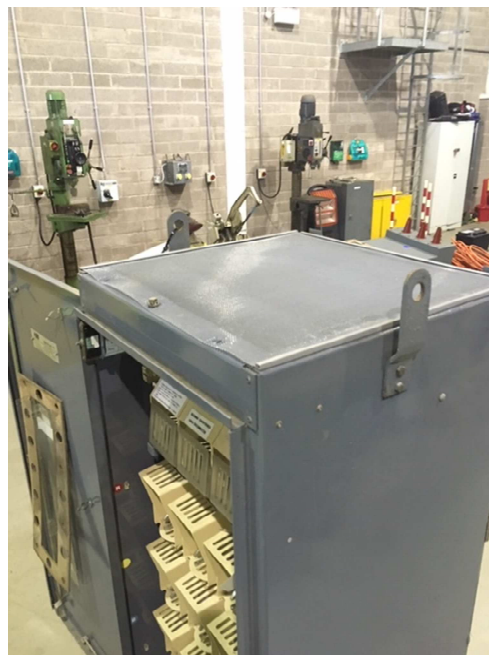
Figure 5: LV Take-Off Chamber with Wire Mesh (Lid removed)

1. Open the LV TOC lid. There is a wire mesh guard under the lid (refer Figure 5 below). If there are signs of excess rust on the wire mesh and if working **Live** under the **Limited Work Certificate**, then stop any further operation, cancel the **Limited Work Certificate** and arrange a **HV Isolation** with an emergency **LV** outage (refer section 10.1.2) to perform the modification works on the **Apparatus** not **Live**. The works shall be carried out under a new **Limited Work Certificate**. Otherwise, remove the wire mesh temporarily.
