1. SCOPE

This document details the application of SOP 264 (Applicable to Ferguson Pailin BVRP and AEI BVRP Circuit Breakers operating at voltages 6.6 and 11kV) issued by the Energy Networks Association.

EQUIPMENT TYPE	Ferguson Pailin BVRP and AEI BVRP (SP17 Form A mechanism only) 11kV CBs
ORIGINATING COMPANY	ScottishPower
DATE	12/10/00
NUMBER INSTALLED IN ENERGY NETWORKS NORTH	519
NUMBER INSTALLED IN ENERGY NETWORKS SOUTH	0
REASON	OCB slow closed whilst in service.
STATUS IN INITIATING COMPANY	Risk of slow closing. Do not charge springs with the OCB in the service position until a full functional check has been carried out with the OCB isolated and withdrawn. The OCB to be spring charged, closed, spring charged again and then tripped, closed, and tripped. The OCB may be returned to normal service if this process is completed without problems. Otherwise, maintenance must be carried out on the switch.
SPEN APPLICATION	<p>Applying a charge to the CB closing springs is prohibited with the CB in the service position unless the following functional check is carried out immediately prior to operation and with the CB withdrawn.</p> <p>Starting with the CB in the open position:</p> <ol st

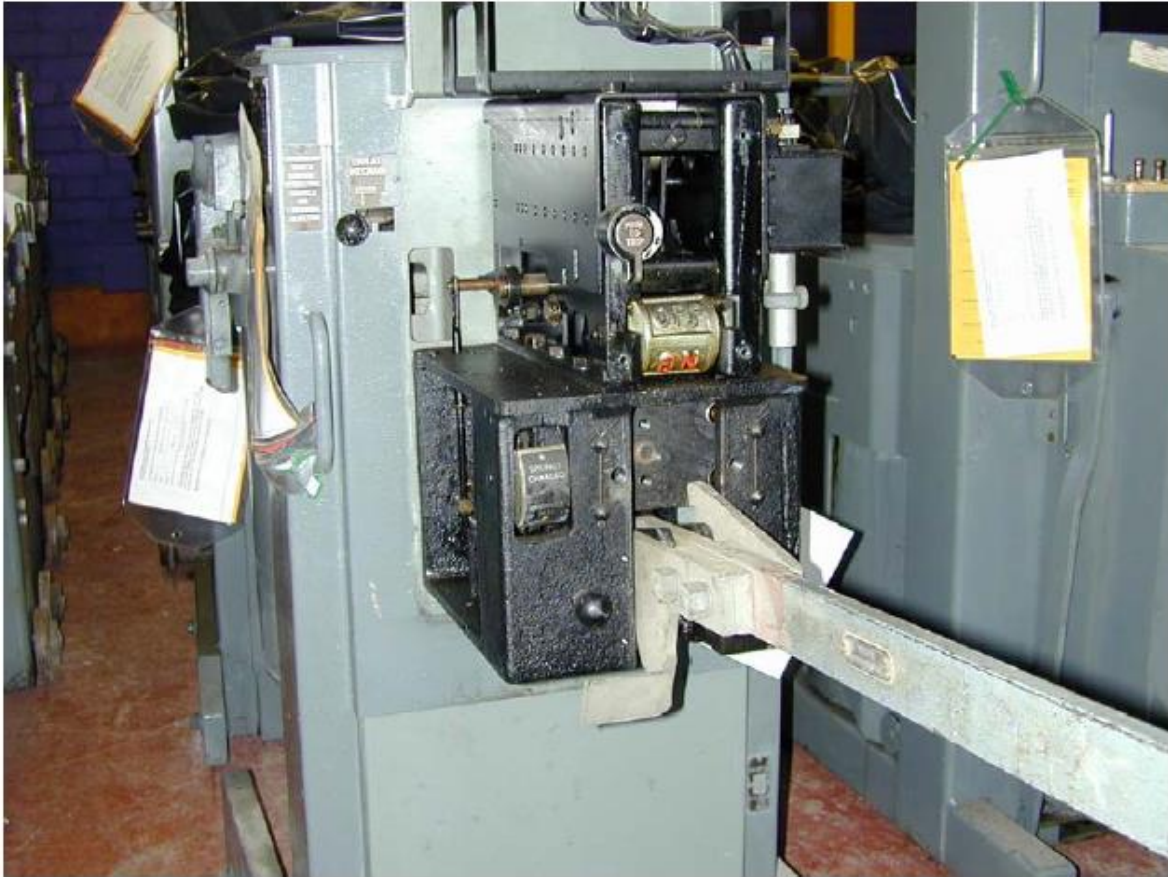
ADDITIONAL INFORMATION	<p>Only original BVRP17 units with SP17 (original form) mechanisms form part of the affected range, BVRP17 units with SP17 Form B units are not affected. See Appendix A for information</p> <p>Unit types affected include:</p> <ul style="list-style-type: none">• AEI/Metro Vicks BVRP3 11kV Oil Circuit Breakers• AEI/Metro Vicks BVRP17 11kV Oil Circuit Breakers

Image A: Ferguson-Pailin BVP 17 11kV OCB with SP17 Mechanism

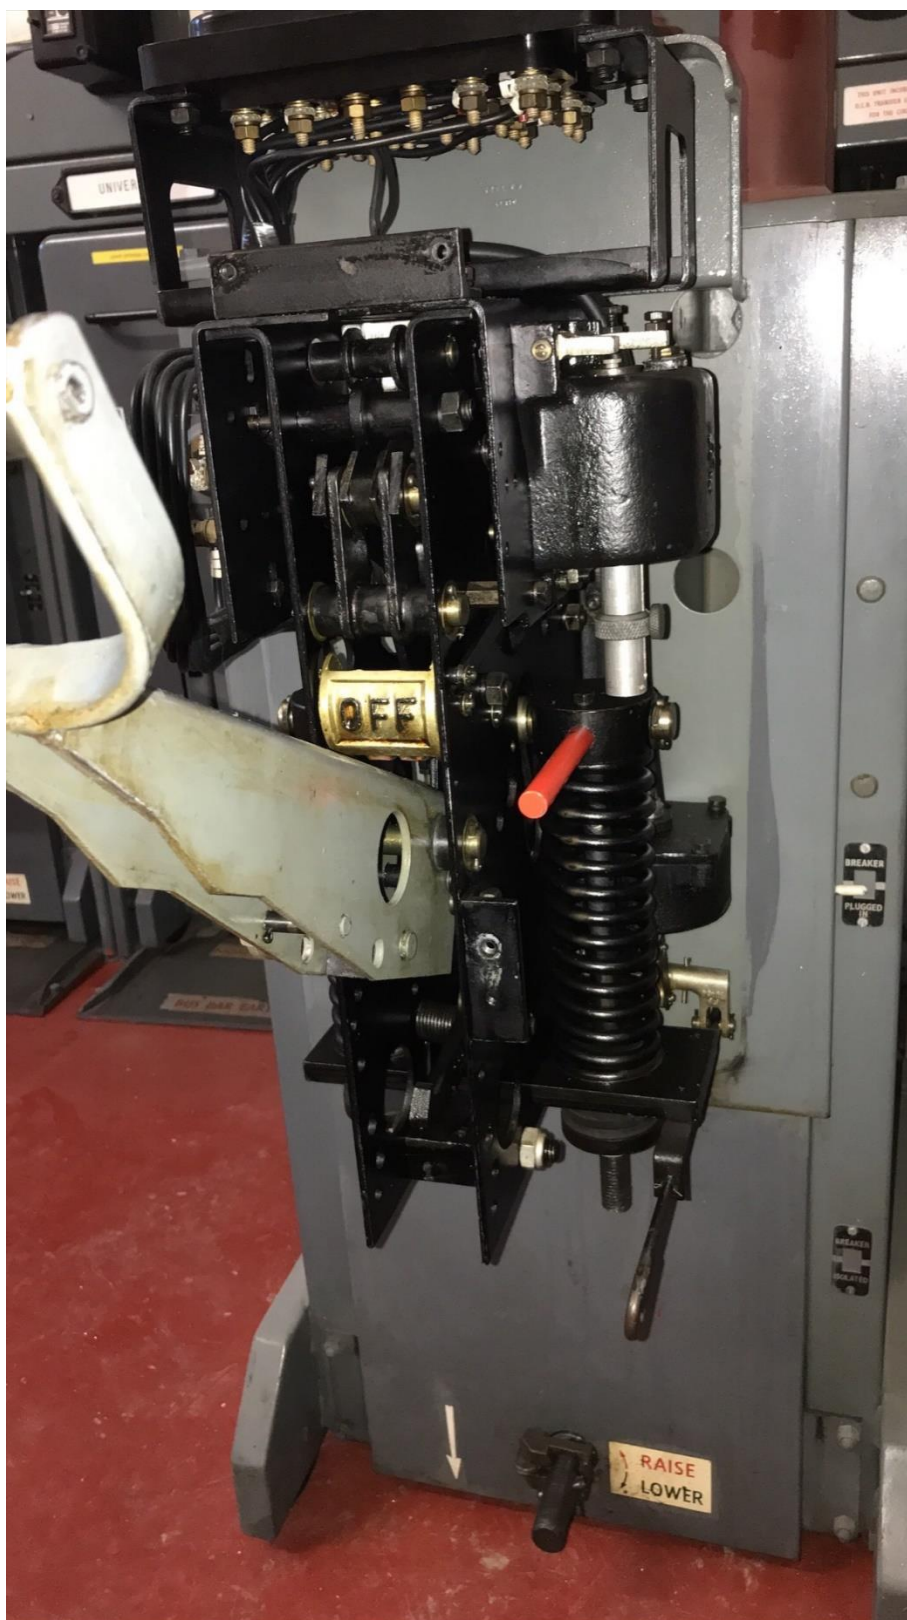
Image B: Ferguson-Pailin BVRP 17 11kV OCB with SP17 form B mechanism
SOP does not apply to this model
