1. SCOPE

This document details the application of SOP 2001/0278/00 (Applicable to GEC Alstom Type OX36 Circuit Breakers at system voltage 33kV) issued by the Energy Networks Association.

EQUIPMENT TYPE:	GEC Alstom – OX36 – Circuit Breaker
ORIGINATING COMPANY	24seven Utility Services Ltd
DATE:	4 th August 2001
NUMBER INSTALLED SPEN NORTH:	17
NUMBER INSTALLED SPEN SOUTH:	212
AFFECTED RANGE:	All GEC OX36, 33kV Circuit Breakers
NUMBER AFFECTED SPEN NORTH:	17
NUMBER AFFECTED SPEN SOUTH:	212
REASON:	During routine switching a circuit breaker remained closed on one phase after the circuit breaker was opened. Investigation by Alstom. Circuit breaker mechanism drives centre phase directly, outer phase contacts are driven by lever and extended drive rods. The left hand phase drive lever was noted to have become detached from its contact drive shaft.
STATUS IN ORIGINATING ORGANISATION:	The operating mechanism shall be inspected before and after operation of the circuit breaker to ensure that the drive linkages are correctly attached.
SPEN APPLICATION:	The operating mechanism shall be inspected before and after operation of the circuit breaker to ensure that the drive linkages are correctly

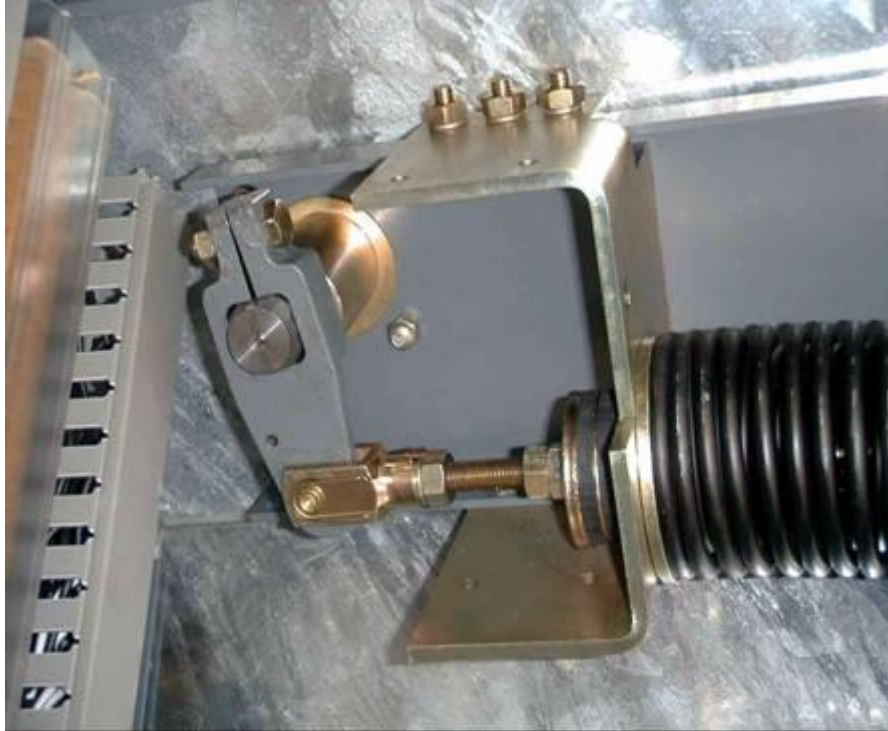
Linkage correctly attached

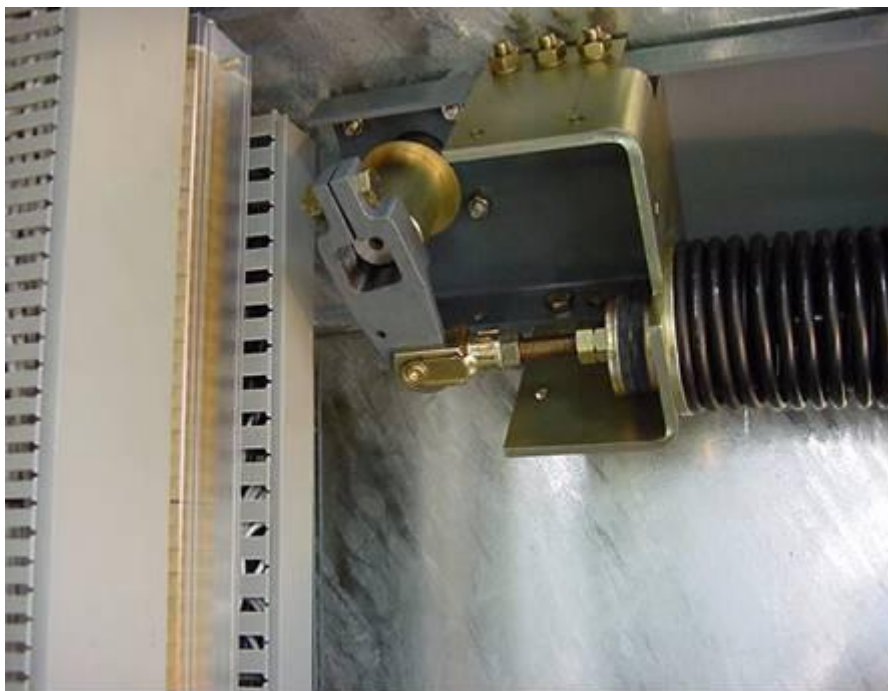
Linkage not correctly attached

ADDITIONAL INFORMATION:	None
UPDATE:	Update May 2012. SOP278 to be applied in SAP and System Diagram. If the drive linkage is found to be correctly attached during the next inspection SOP278 can be lifted permanently.
REMEDIAL ACTION:	None
