This document details the application of SOP 334 (Applicable to Power Isolators Type DSB 132kV disconnector with Type PT motor powered mechanism) issued by the Energy Networks Association.

SWITCHGEAR TYPE:	Power Isolators Type DSB 132kV double-break (RCP) disconnecter with Type PT motor powered mechanism.
ORIGINATING DNO	United Utilities
DATE:	17 May 2006
NUMBER INSTALLED IN ENERGY NETWORKS NORTH:	33
NUMBER INSTALLED IN ENERGY NETWORKS SOUTH:	51
REASON:	Grid Transformer 132kV disconnecter closed of its own accord. Transformer 33kV circuit-breaker was open at the time, so no load transfer occurred and disconnecter was undamaged. (See Additional Information below)
STATUS IN INITIATING DNO:	“There must be no live operation of the above switch type. There must be no access to the isolator control cabinet of the above switches. In addition, the following access restriction will apply:- Access to substation compounds containing the above switchgear is limited to essential operational activities only when the switchgear is live” (6 units affected in initiating DNO)
SPEN APPLICATION:	SOP will NOT be applied in Energy Networks at this time. (See Additional Information below)

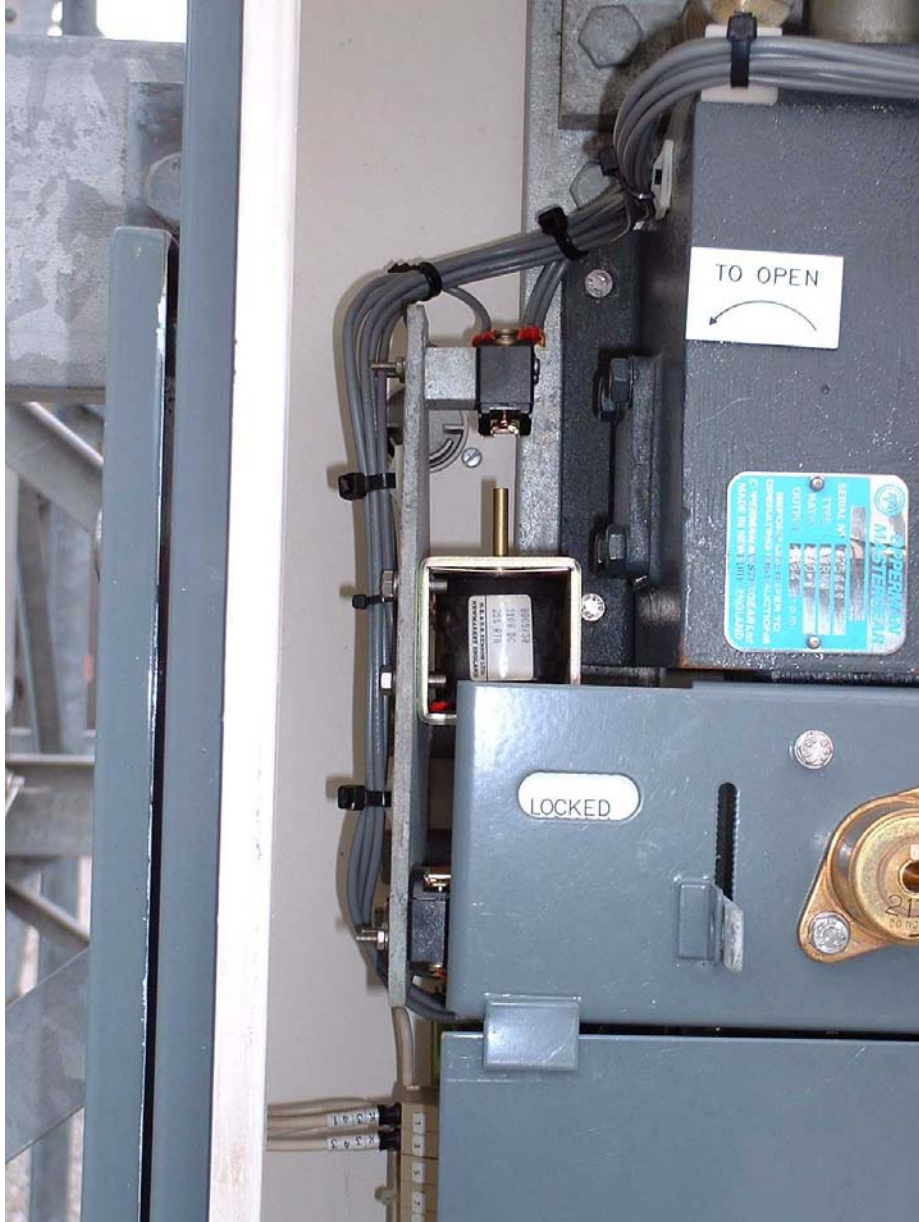
Photograph 1 shows the PT mechanism mag-bolt and “upper limit switch” in the normal position (disconnecter fully open or fully closed and not under operation). Under healthy conditions, the mag-bolt would be electrically operated when a valid open or close command is given. The normally open upper limit switch is closed by the mag-bolt when the mag-bolt is fully raised. Photograph 2 shows the mag-bolt plunger, limit switch operating plate and “bottom limit switches” in the normal position. The mag-bolt plunger, which is permanently attached to the operating plate, keeps lower limit switches open. When disconnecter is operated the mag-bolt lifts which allows the lower limit switches to close.

In the incident in question, a piece of the plastic moulding had broken off the side of the normally closed lower limit switch. This piece of plastic had then become wedged between the lower limit switch and the mag-bolt operating plunger. The lower limit switch was thus released to its normally closed position. The mag-bolt plunger was in a higher position than normal due to being wedged on top of the piece of plastic broken from the lower limit switch. The effect being that the mag-bolt was sufficiently raised to close the normally open upper limit switch.
