This document details the application of SOP 402 (Applicable to Lucy Switchgear LV Boards pre-1970) issued by the Energy Networks Association.

7. SOP DETAILS

EQUIPMENT TYPE	Lucy Switchgear LV Boards pre-1970
ORIGINATING COMPANY	Northern Powergrid
DATE	15 June 2016
NUMBER INSTALLED IN ENERGY NETWORKS NORTH	Unknown
NUMBER INSTALLED IN ENERGY NETWORKS SOUTH	Unknown
REASON	A flashover occurred on an LV fuseboard whilst the operator was withdrawing a fuse carrier at a Distribution substation.
STATUS IN INITIATING COMPANY	<p>This restriction applies to the pre-1970s Lucy LV board (see photos included). The Lucy LV board can be identified by the following common and distinctive features.</p> <ul style="list-style-type: none">• Large porcelain fuses with flat blade contacts.• The fuses/contacts have no facility to hinge or vertically align the fuse when inserting the fuse.• The MDI panel is at the top of the LV board as shown in the photograph.• The LV board has distinctive bolted transformer links equipped with a shielded handle. <p>If in doubt as the LV board type, operatives should assume this Operational Restriction applies. For any access to a substation containing a pre-1970s Lucy

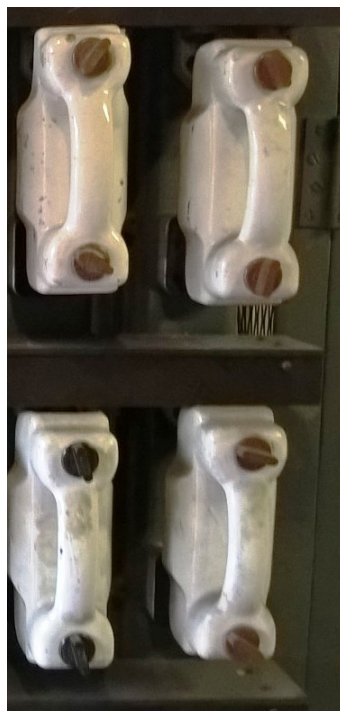
The NPG Panel of Inquiry concluded that the fuse carrier moved downwards whilst the middle phase fuse carrier was being withdrawn from the LV board – the upper jaws moved forward and made contact with the earthed steel upright of the fuseway making a circuit between the live busbar jaw and the earthed steelwork. The NPG recommendation is for the fitting of an insulated “ledge” to take up some of the space between the feeder side of the fuse carriers and the insulation shield for the busbar below. The “ledge” is a 25mm cellular layer of polycarbonate (Marlon ST Longlife clear) with a layer of solid 6mm polycarbonate (Marlon FS clear) above it and secured with tie-wraps to the upper surface.

Before Remediation with gap below Fuse Carrier

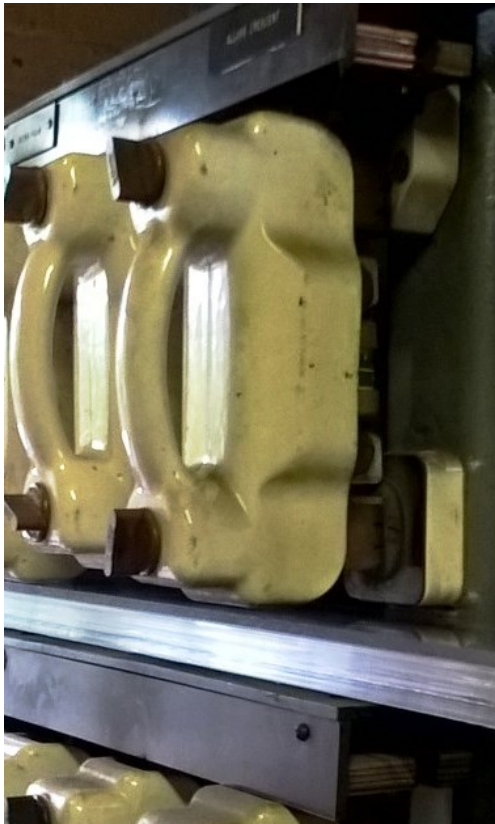
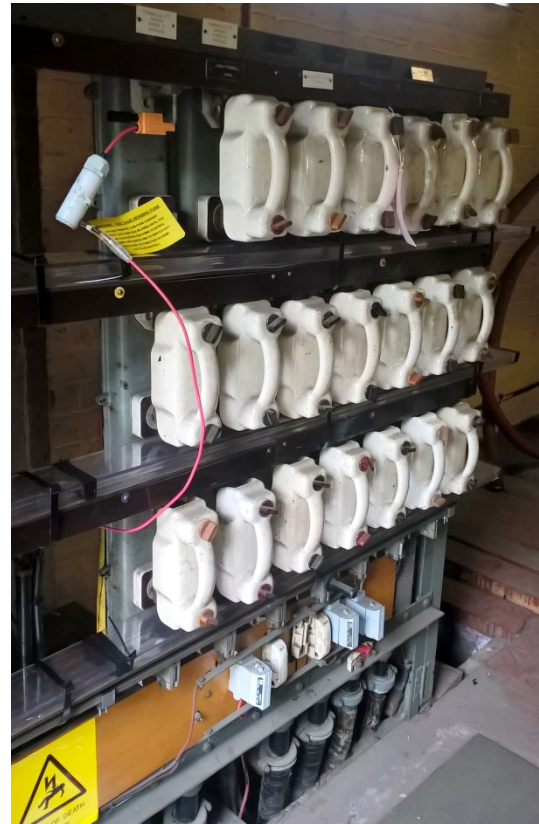
After Remediation with gap taken up by the Insulated Ledge
