This document details the application of SOP 442, applicable to Lucy AcuLok LV cabinets, issued by the Energy Networks Association.

EQUIPMENT TYPE	Lucy AcuLok LV Cabinets
ORIGINATING COMPANY	SP Energy Networks
DATE	29/01/25
NUMBER INSTALLED IN ENERGY NETWORKS NORTH	885
NUMBER INSTALLED IN ENERGY NETWORKS SOUTH	279
REASON	<p>This SOP has been raised following the disruptive failure of a Lucy AcuLok LV cabinet at Rail Freight Depot substation. The LV cabinet was found to be smoking, with significant heat identified as originating from the L3 transformer disconnecter.</p> <p>Following investigation at Lucy's Thame factory it was noted that both the L2 and L3 disconnectors showed signs of poor electrical contact leading to arc damage of the main contacts and melting of the plastic components associated with the disconnecter.</p> <p>This SOP also covers the known type-defect of pre-serial no. LVT0002225 AcuLok transformer disconnectors. The early design leaf spring mechanisms have the potential to deform causing operation to become stiff or to seize.</p>

9.1 AcuLok TMFC Inspection LIP 10-055 Issue 2

9.2 AcuLok Disconnecter Operation LIP 10-047 Issue 2

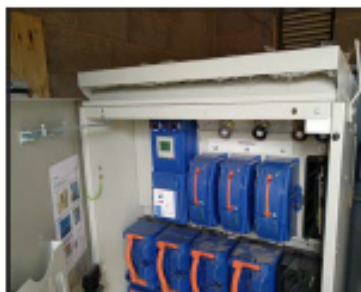
With the cabinet door closed, check for deposits of white/beige powder around the vents at the top of the cabinet both at the front and rear of the roof panel. If the commonly present cobwebs are laden with a white deposits this is a sign that overheating has/is taking place. These white deposits are the flame retardant added to the plastics during the moulding process and there are no concerns under COSHH regarding handling.

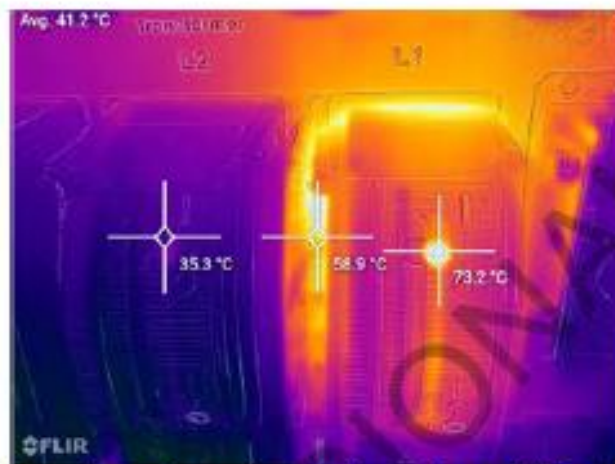
Next conduct a thermal investigation of the three disconnecter bodies paying particular attention to any unexplained discrepancies between phases. Any disconnecter that is running significantly hotter than any other phases also suggest potential overheating within that Disconnecter phase (see picture below).

If the readings show a variance of 10°C between phases or any phase is 20°C above ambient temperature, do not attempt to switch the disconnecter. All further activity should be suspended and Lucy Electric Energy Services contacted for immediate intervention. This may require a disconnecter replacement which will necessitate a HV shutdown.

If either signs of white deposits are observed or any phases show a significant temperature difference, **do not attempt to operate any of the disconnectors**.

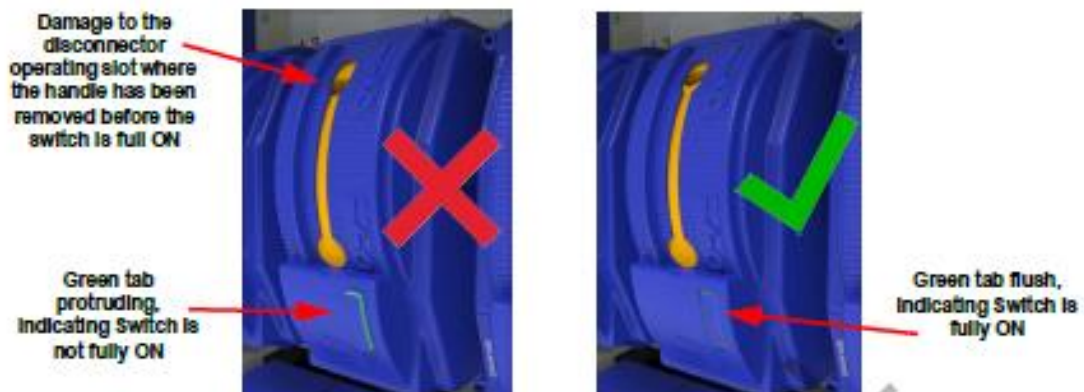
Next, visually check the position of the cassette tabs which should be flush with the front face of the blue disconnecter housing indicating that the disconnecter contacts correctly engaged and the switch is fully in "ON".

If the green tabs are protruding, and there are no signs of overheating, insert the operating handle and attempt to operate the handle upwards until the contacts are fully engaged and the tabs fully flush with the blue cover. If this is not possible contact Lucy Electric Energy Service to arrange a site visit.

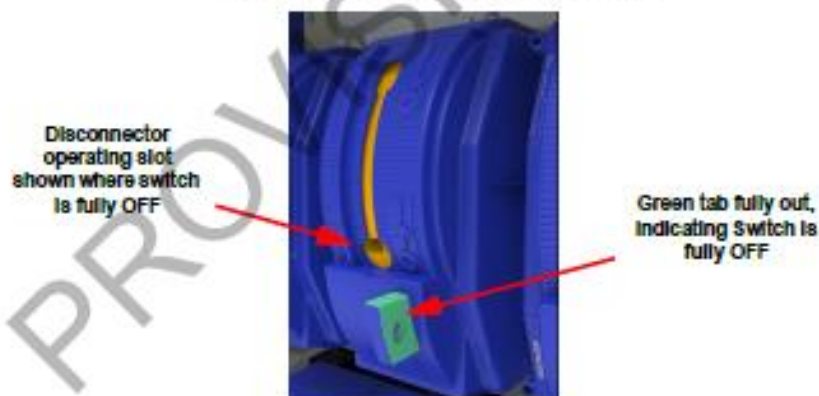
Disconnector Shown In OFF Position

Note: The green tab should either be protruding 29 – 31 mm when the disconnector is fully OPEN or flush with the blue cassette body when the disconnector is fully CLOSED.

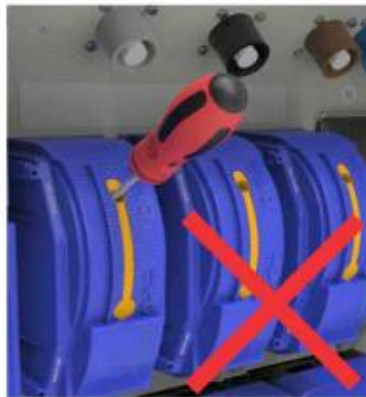
Observation 1

Never use a screwdriver or other improvised tool.

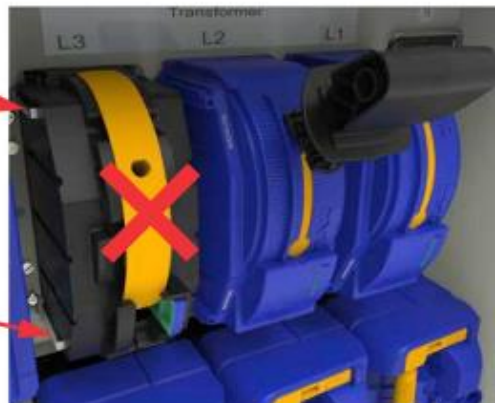
Observation 2

Always operate the disconnecter with the blue cover in place as failure to do so will expose the live test contacts.

Exposed Tx
potential test stalk

Exposed cable
potential test stalk

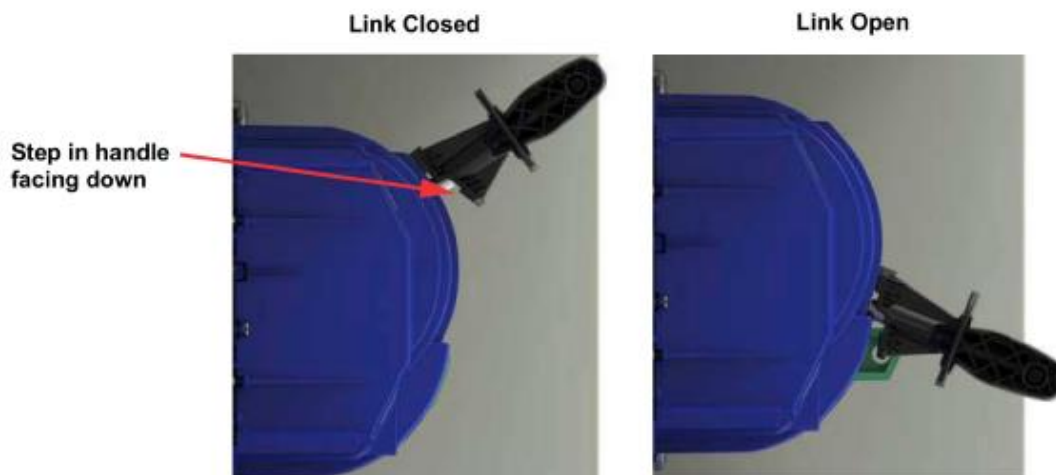
Observation 3

Always ensure handle is fully home and in the correct orientation.
The step in the black handle must face downwards (see observation 4).

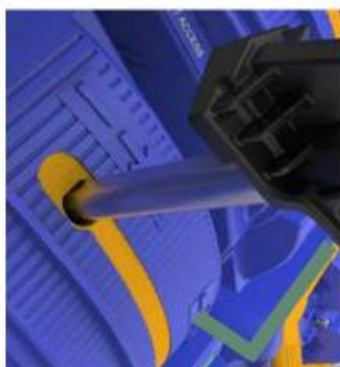
Observation 4

This view shows handle being correctly inserted
(flat side of shaft to flat in orange mounting).

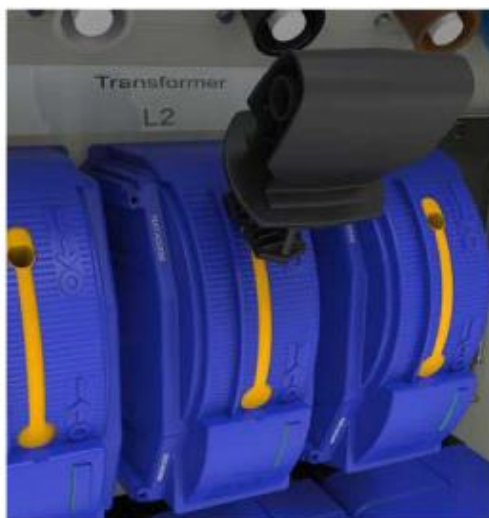
1. START position with contacts closed. Insert operating handle in correct orientation.

**Contact Closed:
Green Tab Flush**

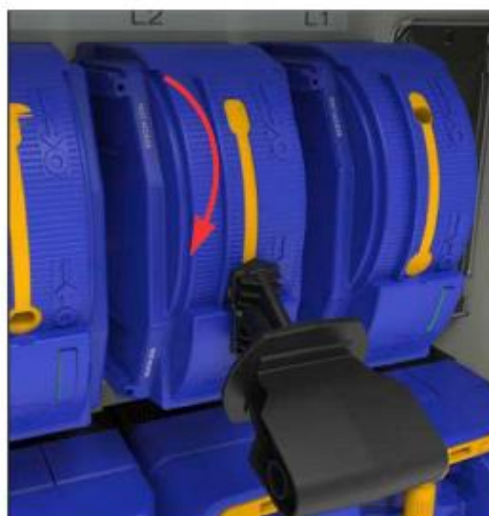
2. Move handle downwards with a firm gesture. Handle travels smoothly all the way to the bottom of the stroke.

**Contact Open:
Green Tab Out**
