Flexible Networks for a Low Carbon Future

Real Time Thermal Rating System

- Phase I Asset
Condition Assessment

Report No.: 14-2132

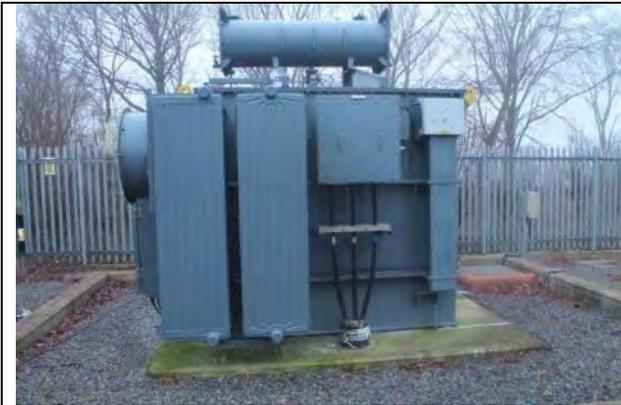
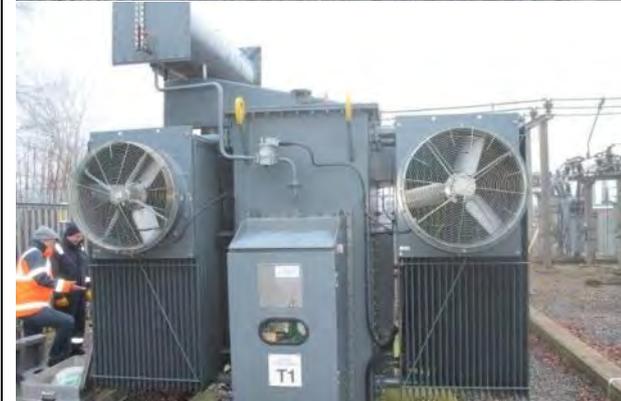
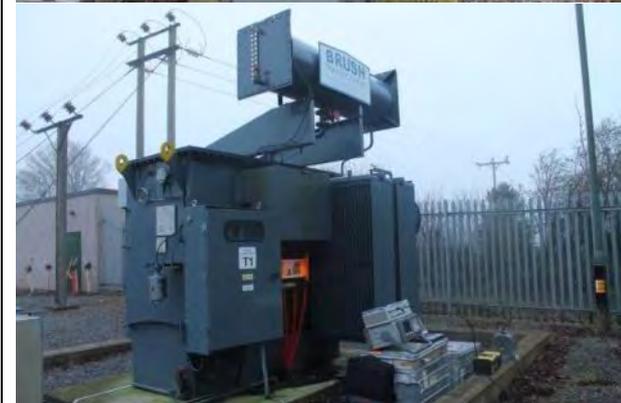
Overview pictures of transformer T1 at substation Whitchurch. Transformer installed in 2010.

No severe signs of damage, leakage and deterioration.

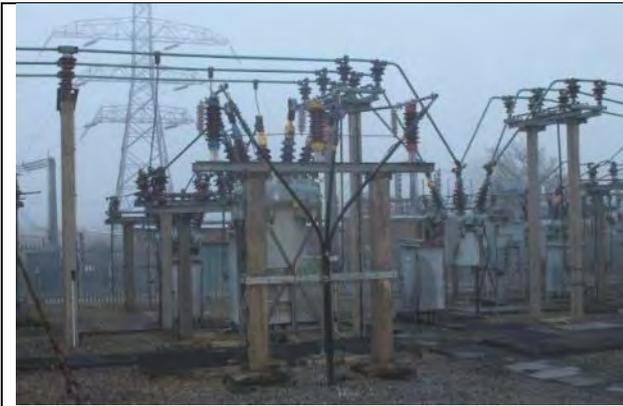
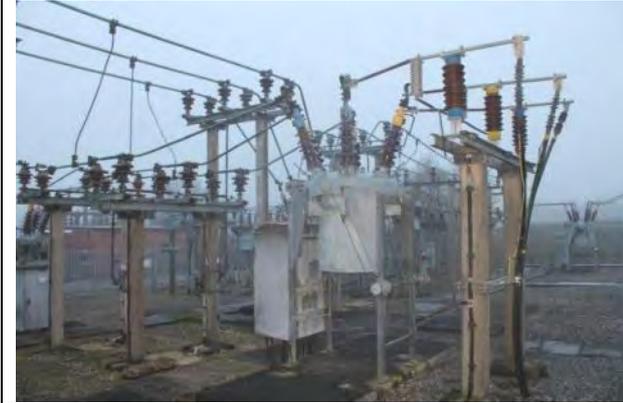
Terminations of 33 kV feeding cables. New cables have been installed in 2010. Other components in the bay are older, but show no severe signs for deterioration or damage.

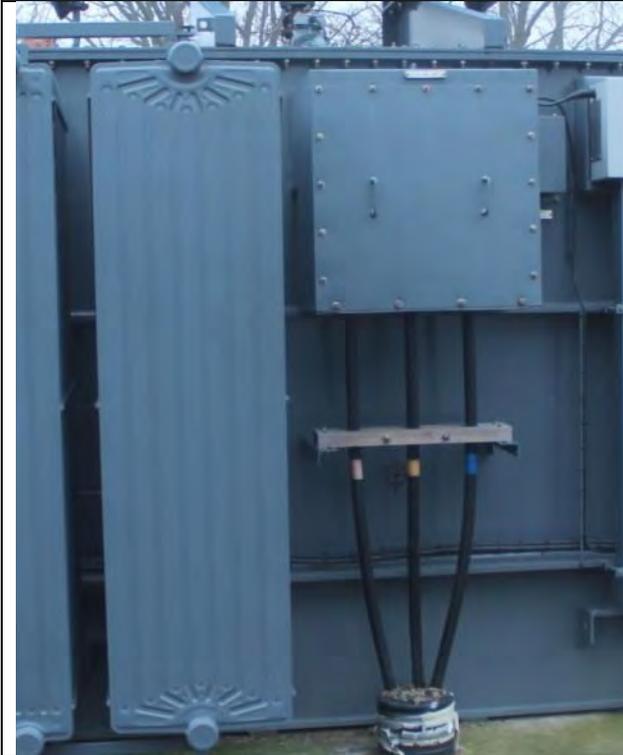
33 kV cable termination box.

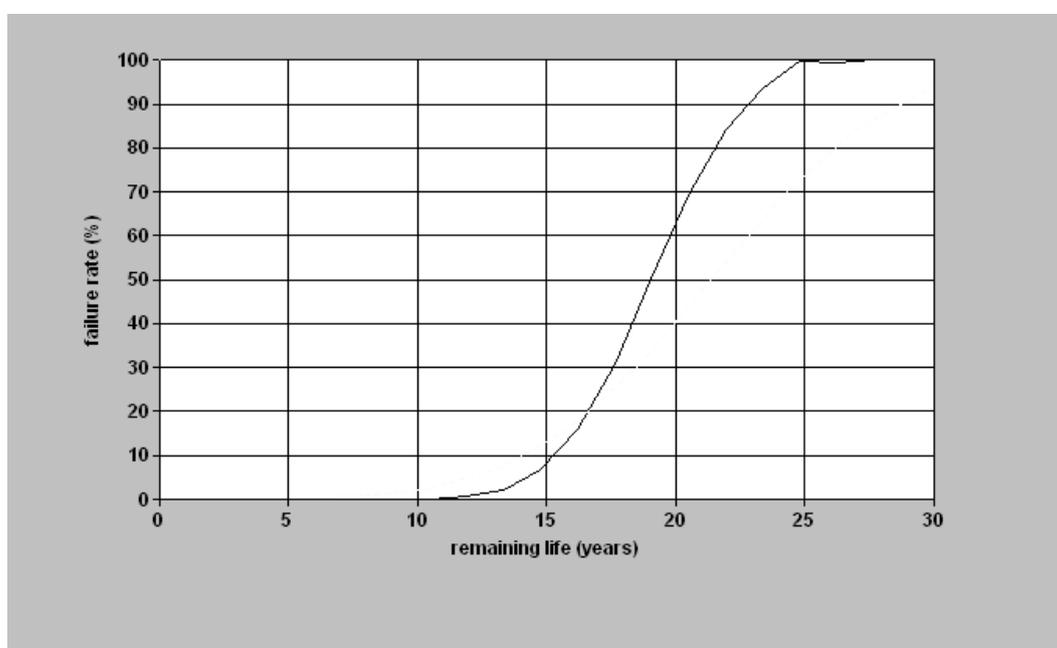
Figure 3.2 Assessed failure rate of transformer Whitchurch T1 (unrealistic)

In figure 3.2, the assessment of the remaining life of this transformer is given. From this figure it can be seen that the expected remaining life is rather small. For a 5% failure rate, the remaining life is estimated at 14 years. This is because of taking a 2-furfural concentration of 0.1 mg/kg (worst case) after only 4 year of service. This concentration is very unlikely and is expected to be lower than the detection limit of 0.1 mg/kg. The model is only useful for young transformers if there is a measurable concentration of 2-furfural.

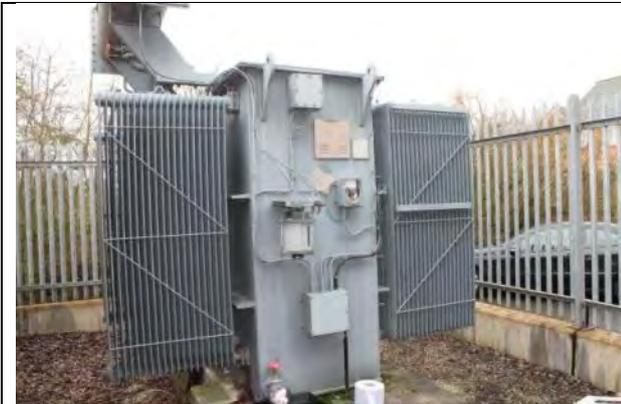
Overview pictures of transformer T1 at substation Liverpool Road.

No severe signs of damage and deterioration.
Some oil sweating at the oil expansion tank.

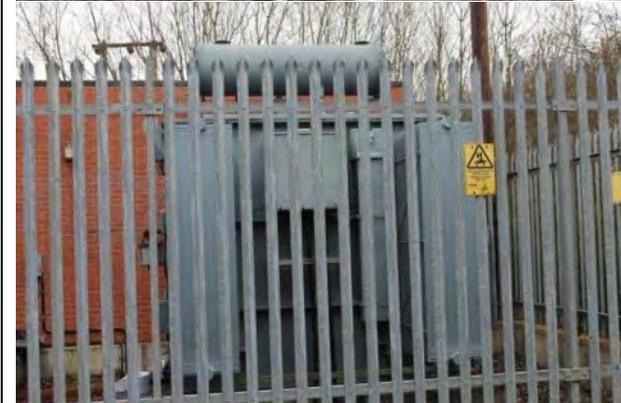
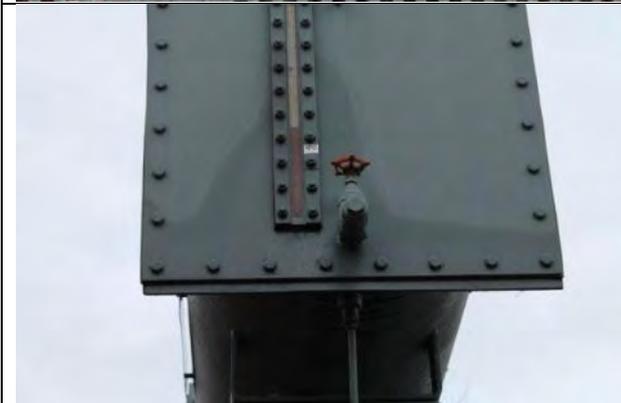
Some oil sweating at the expansion tank.

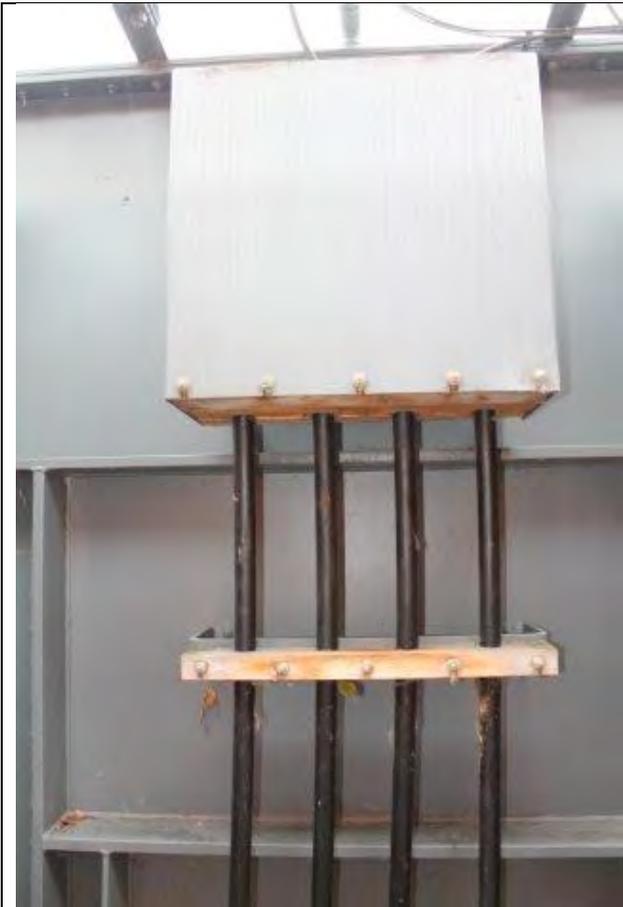
11 kV cable termination box, no signs for deterioration, ageing and leakage.

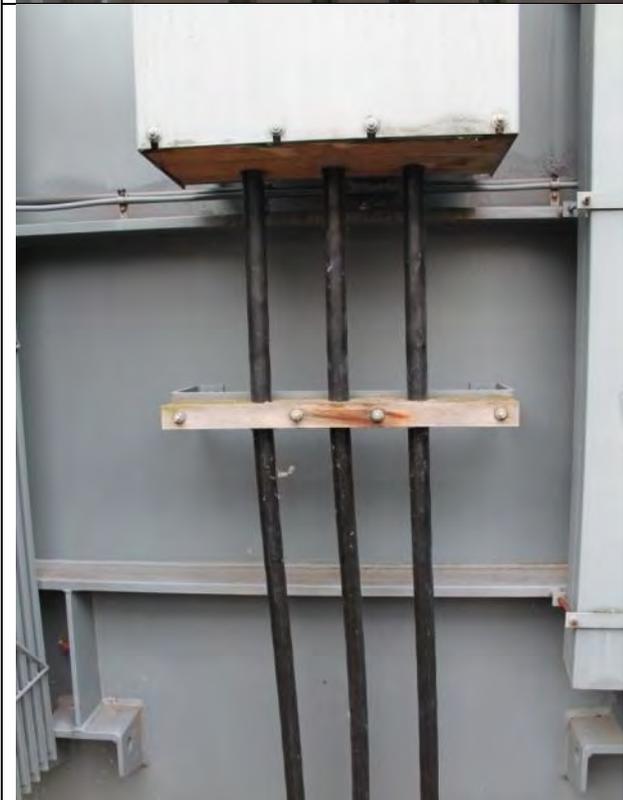
33 kV cable termination box, no signs for deterioration, ageing and leakage.

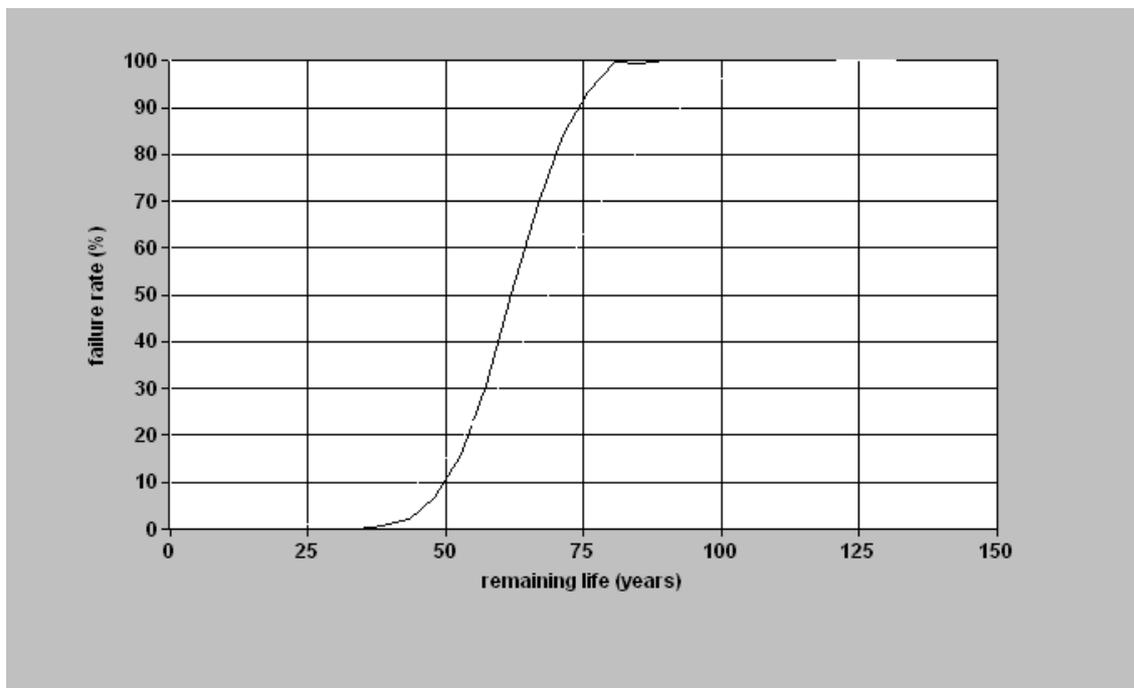
Figure 3.4 Assessed failure rate of transformer Liverpool Rd T1

In figure 3.4, the assessment of the remaining life of this transformer is given. From this figure it can be seen that the model predicts a rather high remaining life although the 2-furfural concentration is below the detection limit (compared to the results of the transformers Ruabon T1 and Whitchurch T1). For a 5% failure rate, the remaining life is estimated at 45 years.

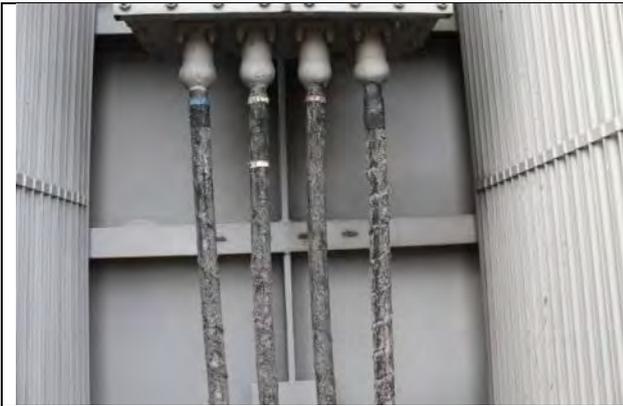
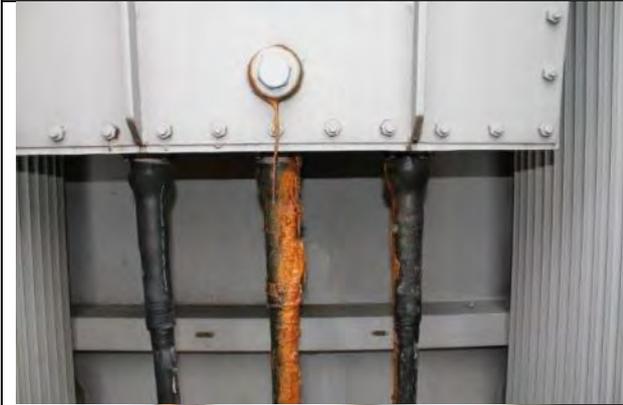
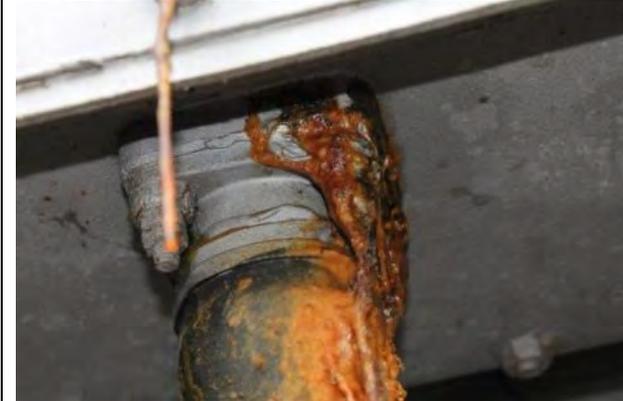
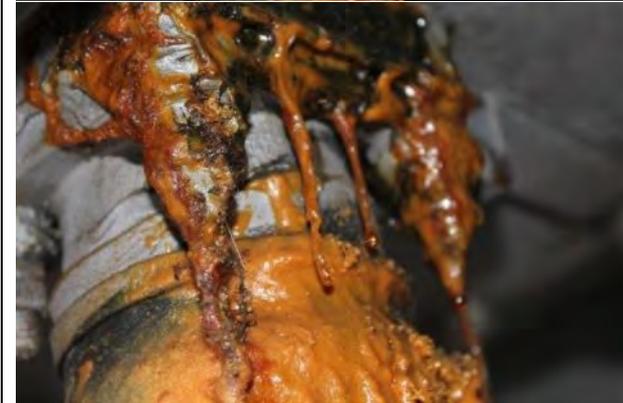
New 33 kV incoming cables installed in ±2000. Severe signs of leakage of mass at the termination box, middle phase. Right phase shows some mass leaking.

During the visual inspection, no severe signs of damage, deterioration and leakage have been observed. Some small rust spots have been observed. Severe leakage of mass from the 33 kV cable termination box has been observed.

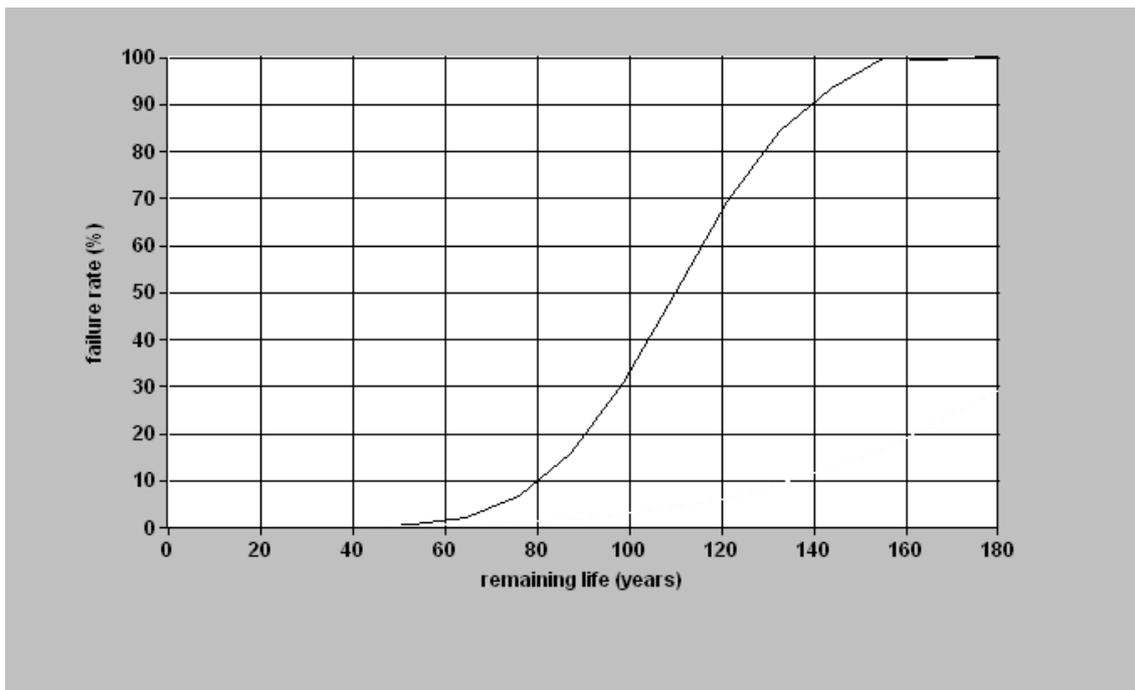
Figure 3.6 Assessed failure rate of transformer Yockings Gate T1

In figure 3.6, the assessment of the remaining life of this transformer is given. From this figure it can be seen that the expected remaining life is very high. For a 5% failure rate, the remaining life is estimated at 70 years.

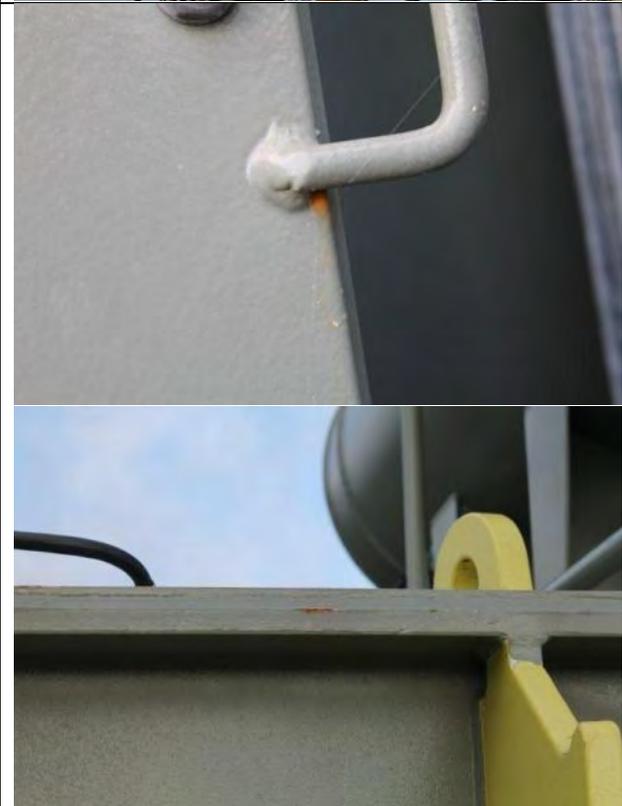
<p>Some small rust spots were observed.</p>

- define and implement actions to correct/mitigate the observed rust.
 - St. Andrews T2:
 - define and implement actions to correct/mitigate the observed rust;
 - define and implement actions to correct the observed hot-spot on a 33 kV-terminal.
 - Cupar T1, Cupar T2:
 - define and implement actions to correct/mitigate the observed rust.
 - Whitchurch:
 - define and implement actions to correct the observed hot-spots on 33 kV-disconnectors.
 - Yockings Gate T1:
 - define and implement actions to correct the observed mass-leakage from the 33 kV-cable box.
- 3) In addition to the normal maintenance regime, perform the following long-term actions (24-60 months):
- Cupar T1, Cupar T2 and Yockings Gate T1:
 - define and implement actions to correct/mitigate the observed sweating.

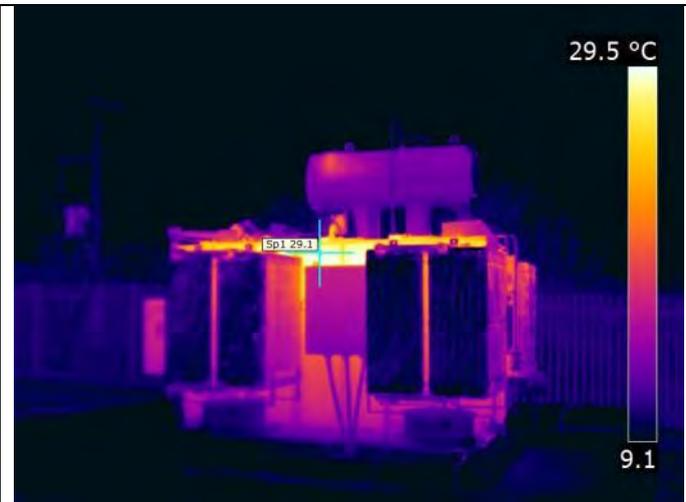
<p>29.5 °C</p> <p>Sp1 29.1</p> <p>9.1</p>	<p>Temperature difference between main tank and radiators is noticeable. Possibly, the difference is caused due to differences in emissivity of the surface:</p> <ul style="list-style-type: none"> • main tank: painted steel • radiators: galvanized steel. <p>However, it could not be unambiguously determined whether the observation was caused by another phenomenon, e.g. incorrect position of radiator valves.</p>

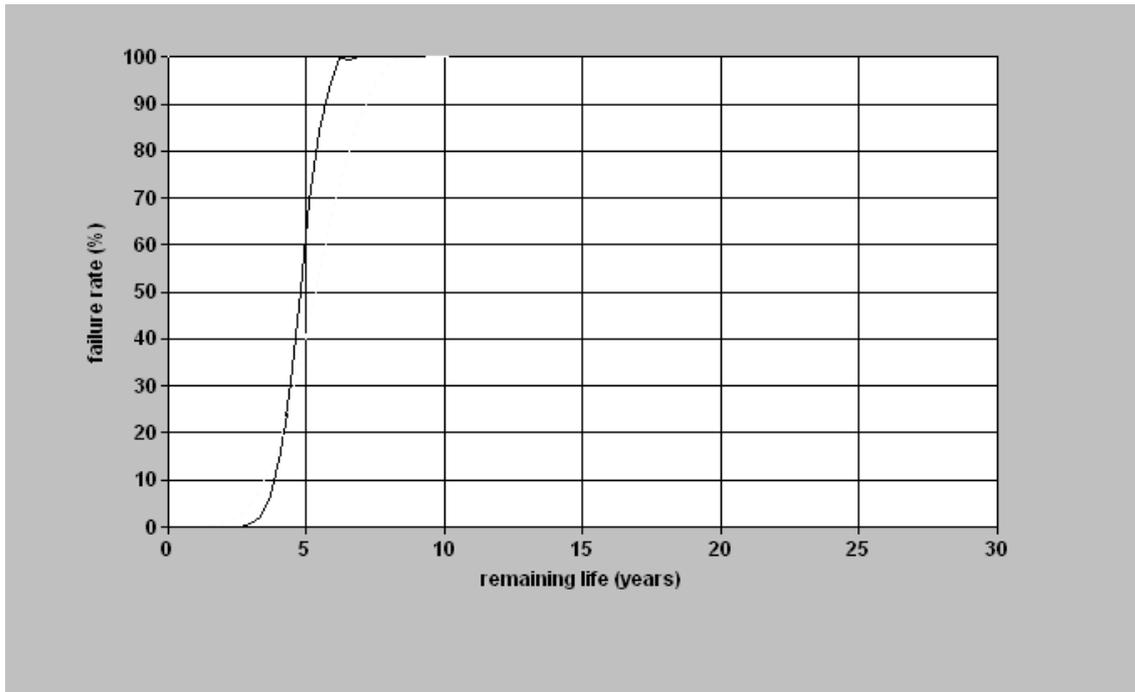
Figure 3.9 Assessed failure rate of transformer Ruabon T1 (unrealistic)

This concentration is very unlikely and is expected to be lower than the detection limit of 0.1 mg/kg. The model is only useful for young transformers if there is a measurable concentration of 2-furfural.

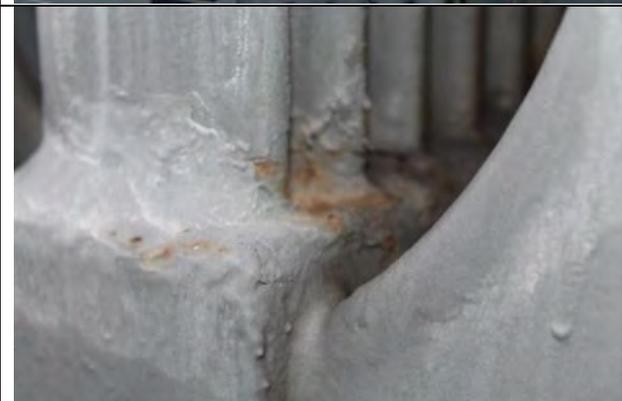
<p>Rust was found on several locations on the radiators.</p>

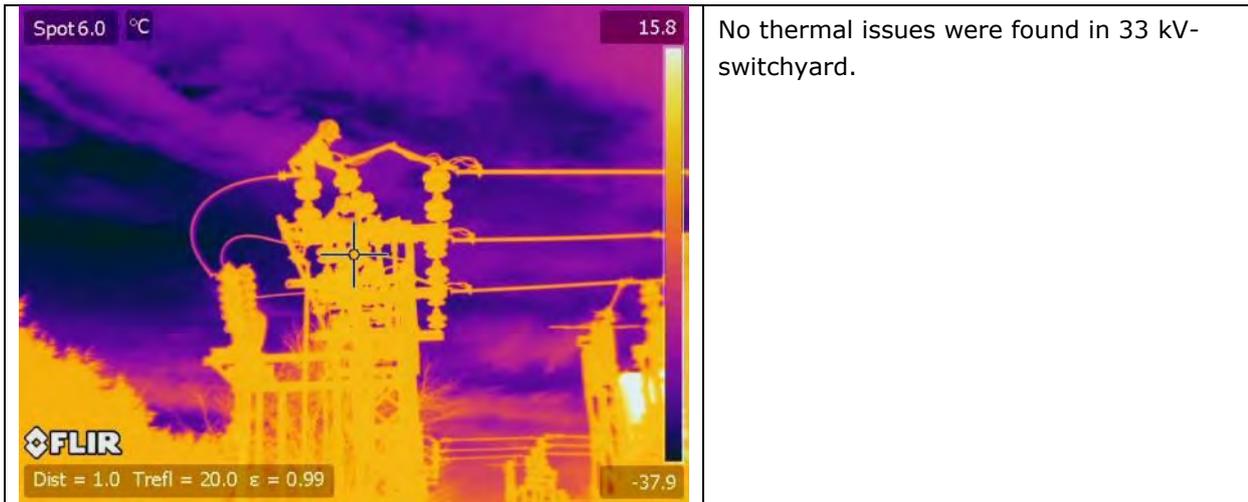
A minor hot spot was found on the terminal a 33 kV- transformer bushing. It is recommended to address this hot spot during the next scheduled maintenance/outage.

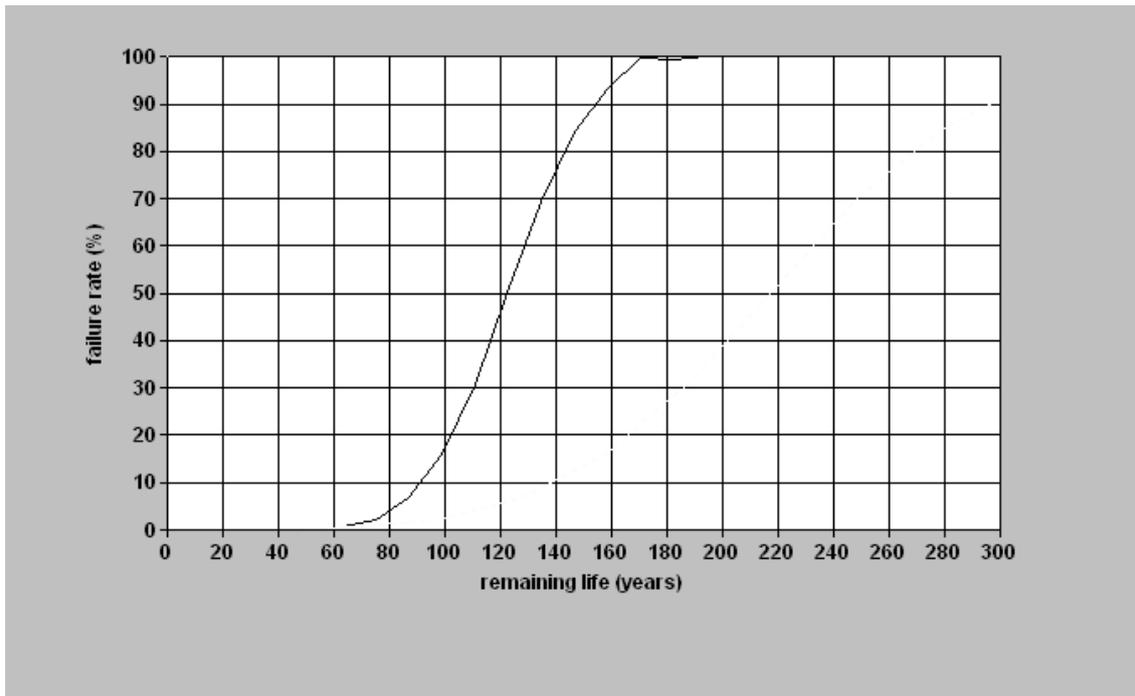
Figure 3.13 Assessed failure rate of transformer St. Andrews T2

In figure 3.13, the assessment of the remaining life of this transformer is given. From this figure it can be seen that the expected remaining life is very high. At 5% failure rate, the remaining life is 85 years.

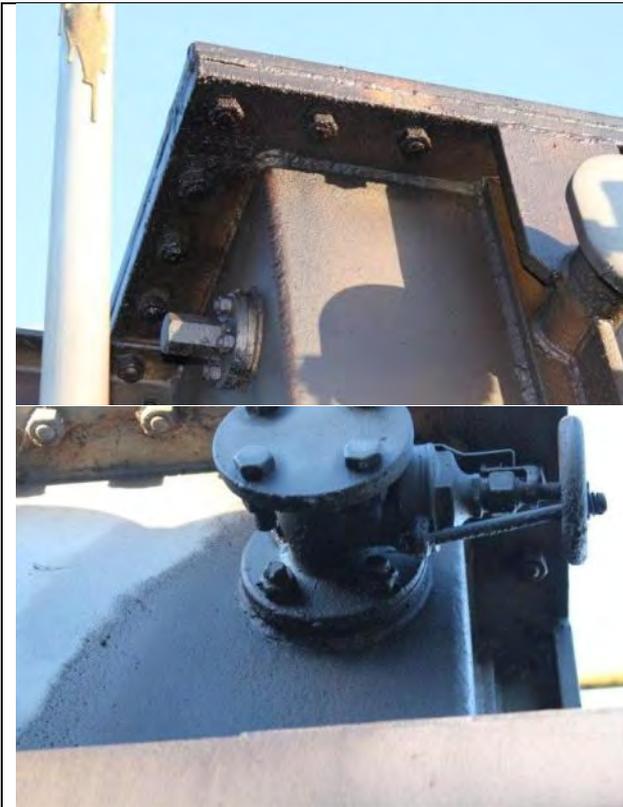
Oil sweating at one of the corner tops of the transformer housing and around one of the valves.

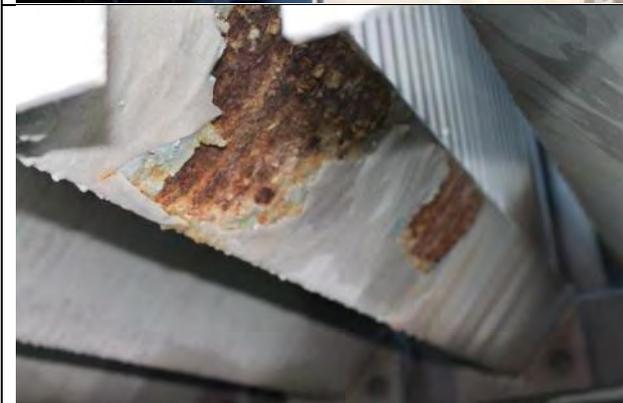
Rust was found on several locations on the radiators, in particular large spots at the bottom of the radiators.

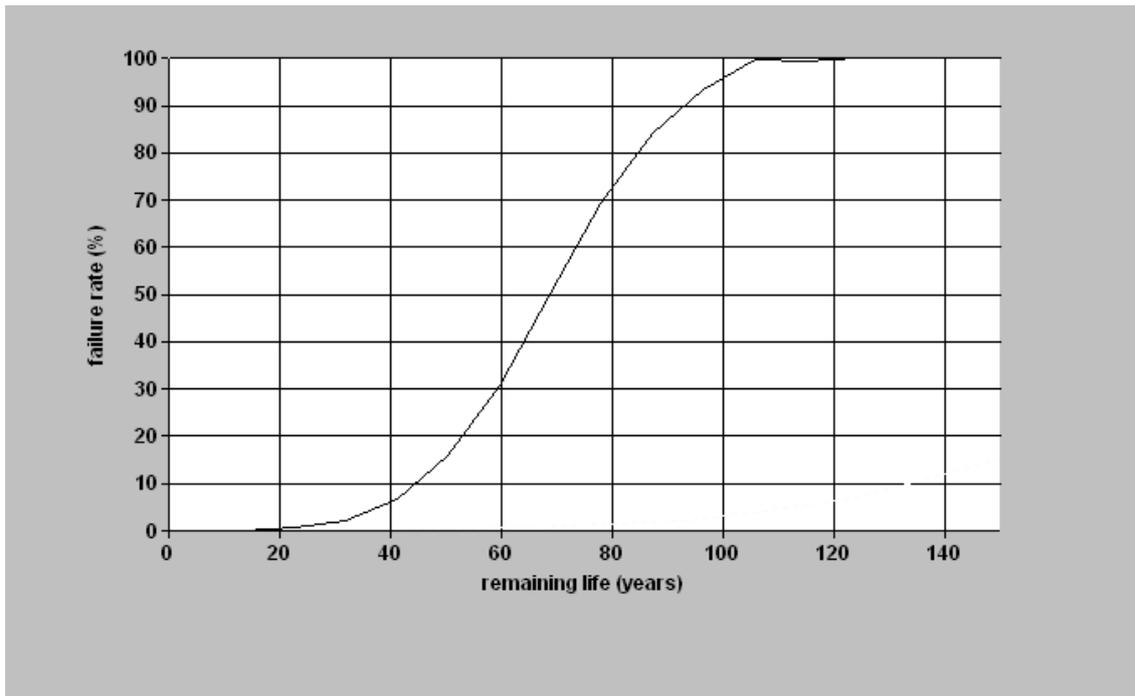
Figure 3.15 Assessed failure rate of transformer Cupar T1

In figure 3.15, the assessment of the remaining life of this transformer is given. From this figure it can be seen that the expected remaining life is very high. At a failure rate of 5% the remaining life is estimated to be 38 years.

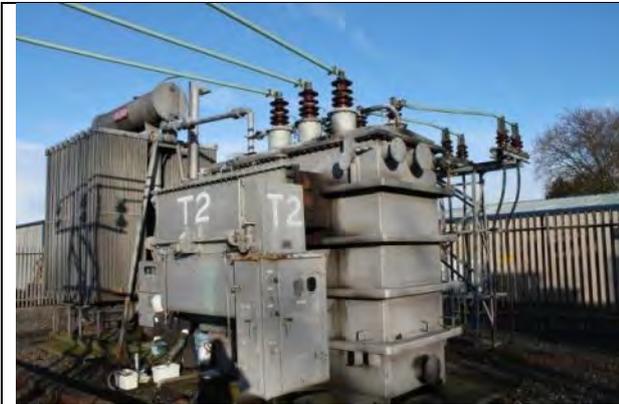
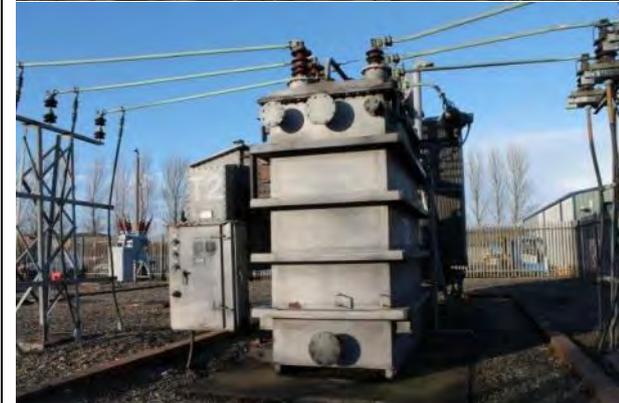
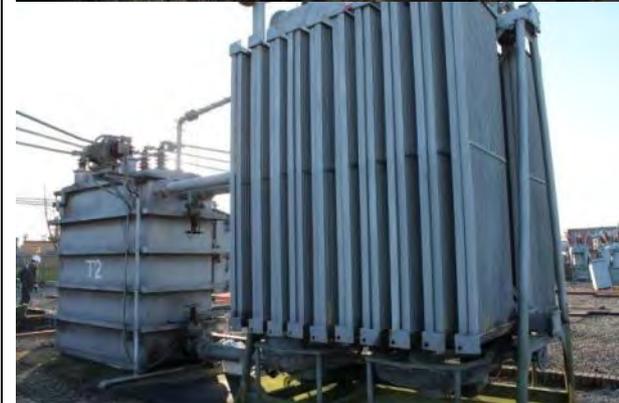
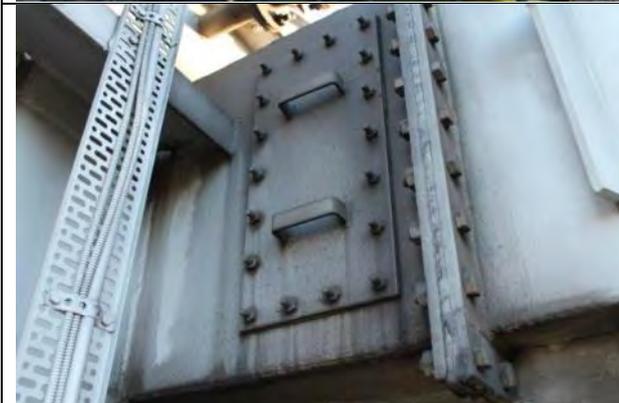
Overview pictures of transformer T2 at substation Cupar.

No severe signs of damage and deterioration. Oil leakage and sweating is observed at different spots.

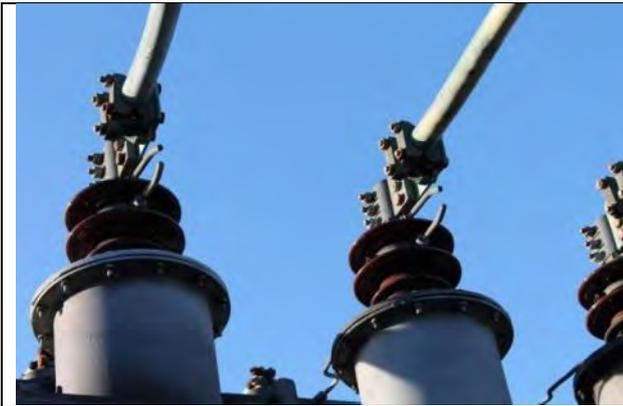
Picture of two 33 kV bushings.
No signs of damage or deterioration on the 33 kV and 11 kV bushings.

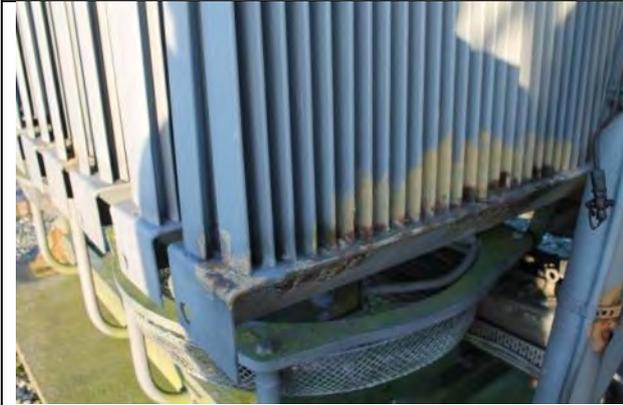
Rust was found on several locations on the radiators.

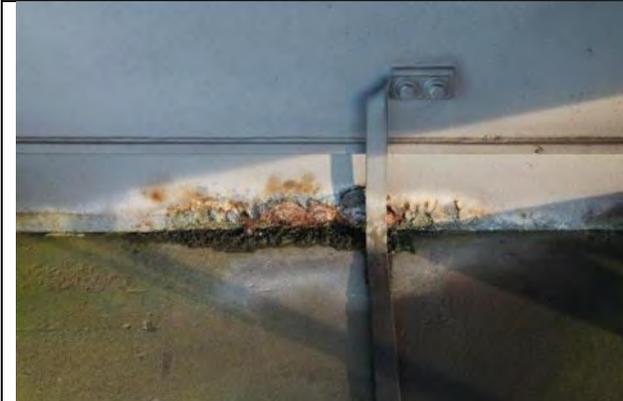
Rust formation along the bottom plate of the transformer.

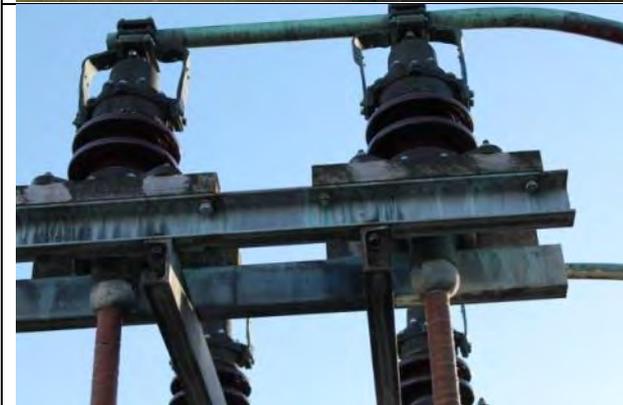
Original 11 kV cables are still in operation. Some wear on the terminations, but no signs of deterioration.

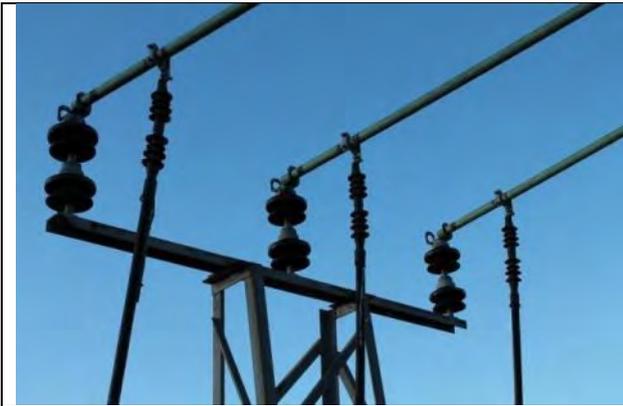
New 33 kV have been installed in 2007. No severe signs of damage, leakage and deterioration on bushings. Direct cable connection to HV transformer so no other bay components present at site.

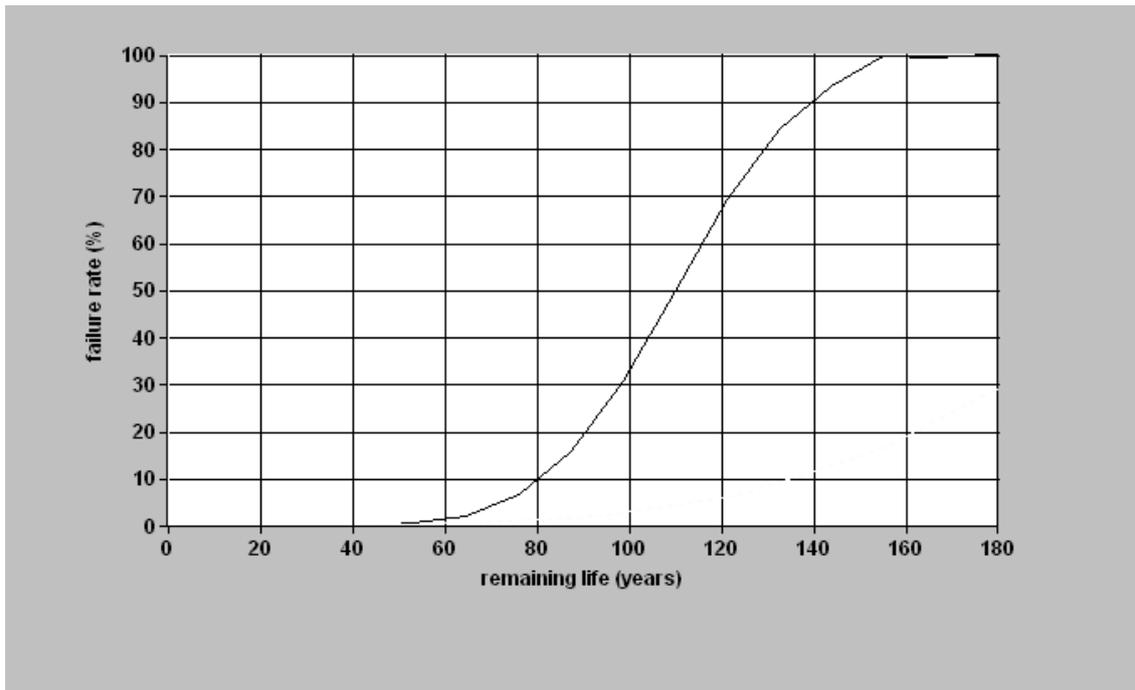
Figure 3.17 Assessed failure rate of transformer Cupar T2

In figure 3.17, the assessment of the remaining life of this transformer is given. From this figure it can be seen that the expected remaining life is very high. For a failure rate of 5%, the remaining life is 70 years.
