SWITCHGEAR TYPE:	Power Isolators Type DSB 132kV double-break (RCP) disconnector with Type PT motor powered mechanism.
ORIGINATING DNO	United Utilities
DATE:	17 May 2006
NUMBER INSTALLED IN ENERGY NETWORKS NORTH:	33
NUMBER INSTALLED IN ENERGY NETWORKS SOUTH:	51
REASON:	Grid Transformer 132kV disconnector closed of its own accord. Transformer 33kV circuit-breaker was open at the time, so no load transfer occurred and disconnector was undamaged. (See Additional Information below)
STATUS IN INITIATING DNO:	"There must be no live operation of the above switch type. There must be no access to the isolator control cabinet of the above switches. In addition, the following access restriction will apply:- Access to substation compounds containing the above switchgear is limited to essential operational activities only when the switchgear is live" (6 units affected in initiating DNO)
SPEN APPLICATION:	SOP will NOT be applied in Energy Networks at this time. (See Additional Information below)

SUSPENSION OF OPERATIONAL PRACTICE SOP 334

OPSAF-16-334 Issue No.1 July 2006

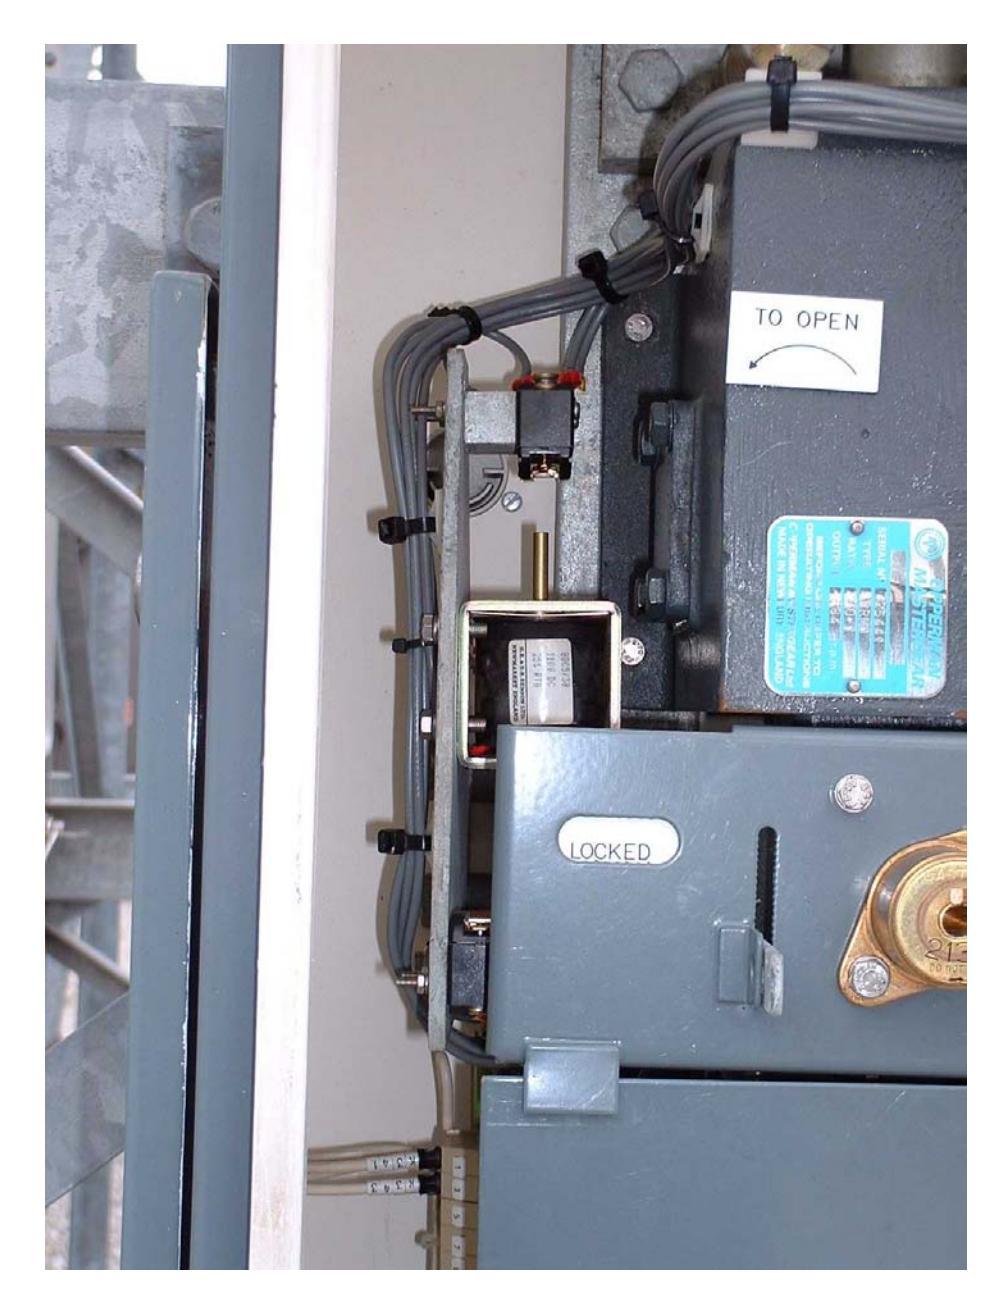
Photograph 1 shows the PT mechanism mag-bolt and "upper limit switch" in the normal position (disconnector fully open or fully closed and not under operation). Under healthy conditions, the mag-bolt would be electrically operated when a valid open or close command is given. The normally open upper limit switch is closed by the mag-bolt when the mag-bolt is fully raised. Photograph 2 shows the mag-bolt plunger, limit switch operating plate and "bottom limit switches" in the normal position. The mag-bolt plunger, which is permanently attached to the operating plate, keeps lower limit switches open. When disconnector is operated the mag-bolt lifts which allows the lower limit switches to close.

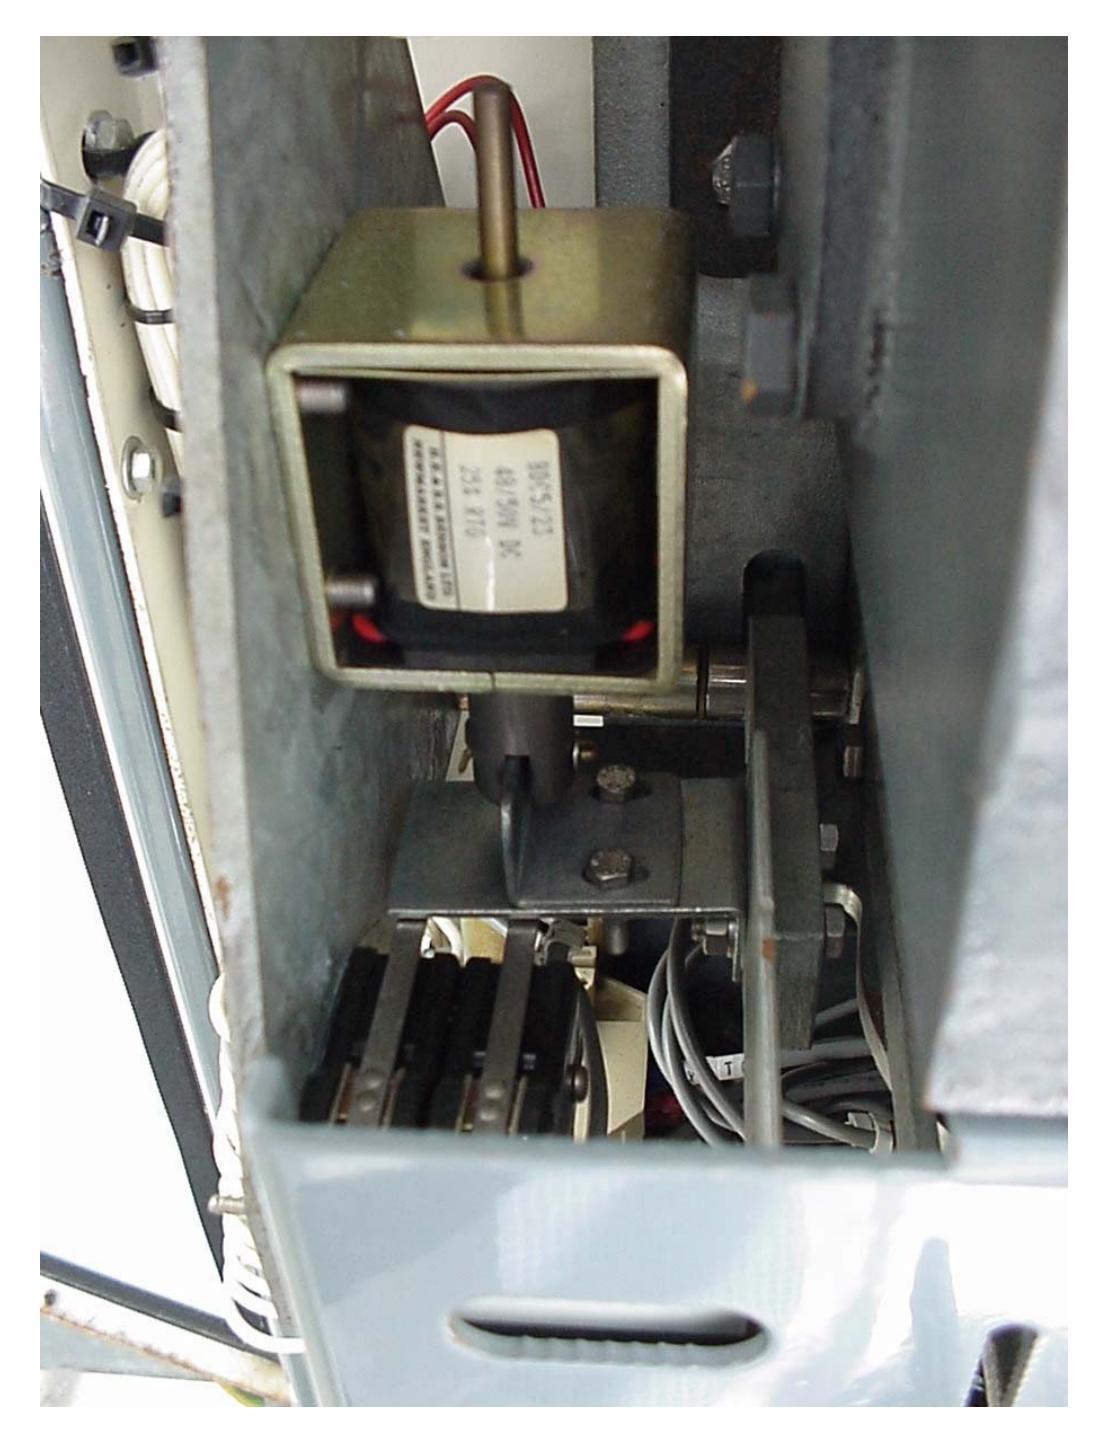
Photograph 2.

In the incident in question, a piece of the plastic moulding had broken off the side of the normally closed lower limit switch. This piece of plastic had then become wedged between the lower limit switch and the mag-bolt operating plunger. The lower limit switch was thus released to its normally closed position. The mag-bolt plunger was in a higher position than normal due to being wedged on top of the piece of plastic broken from the lower limit switch. The effect being that the mag-bolt was sufficiently raised to close the normally open upper limit switch.
