Case Study: Lead Sheath Removed From Low Voltage Electrical Main Cable

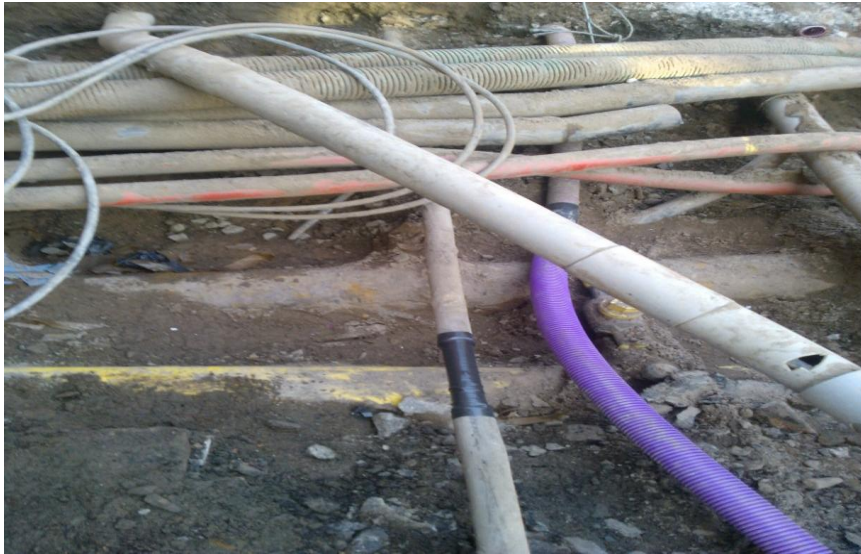
The above image highlights an incident where an operative removed the lead sheathing from a ScottishPower EnergyNetworks 0.3(4) main underground low voltage electrical cable.

The contractor's task was to establish if the cable which was assumed to be part of another utilities network was in use. Once the contractor realised that the cable was an electrical cable, black tape was placed on top of the cable papers. The contractor did not adhere to his employers processes for identifying underground utilities plant and incorrectly assumed that the cable was not an electrical cable. The consequences for the operative, other workers in the vicinity and the general public could have been serious if the cable had blown out at the locus.

**Always Assume Underground Cables Are live –
Various Underground Utilities Plant
Can Look Very Similar In Appearance
If in Doubt Contact ScottishPower
EnergyNetworks:
0845 273 4444**
