### Case Study: Removing Mature Trees From Building Sites:

### Case Study: Planting trees on top of ScottishPower cable routes

# Case Study: Cable strike to 33kV oil-filled cable with JCB

# Case Study: Tree Stump Grinding In Proximity To Electrical Networks

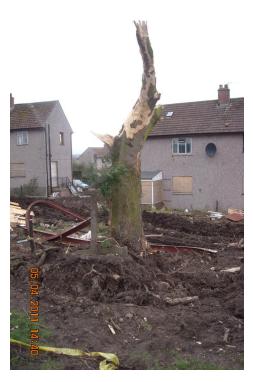
### The above image demonstrates a situation which can occur on regeneration building type projects.

The task for the demolition contractor was to demolish the existing properties and to clear the site. The demolition contractor attempted to pull the tree from the ground; however the tree roots were entwined around a high voltage wire armoured cable. During the attempted operation to remove the tree the HV cable was brought close to the surface, fortunately no actual damage to the cable took place. To prevent this type of incident occurring, cable records should always be consulted and trial holes undertaken to establish line and level of underground cables in relation to tree roots prior to undertaking operations to remove trees. Always assume cables are present.

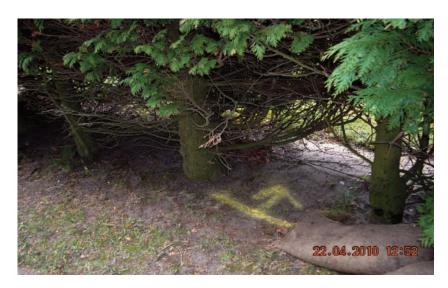
The above image highlights a situation where trees were planted on top of the route of an electricity cable.

ScottishPower would advise against this type of action, trees and tree roots will grow and in some cases can damage the underground/overhead cables. It must be highlighted that the current owner of a property may not have planted the trees. In this scenario the customer was proposing to cut the trees down and build a wall on top of the cable route to prevent flooding to the property. The customer was advised to move the proposed wall to another location away from the cable route or apply for a cable deviation. Before undertaking any projects in the garden, cable records should always be consulted prior to the removal and planting of trees or undertaking construction excavations. Cable record enquiries are to be directed to ScottishPower Data Management section on the telephone numbers opposite.

Prior to any excavations taking place cable records should always be consulted.

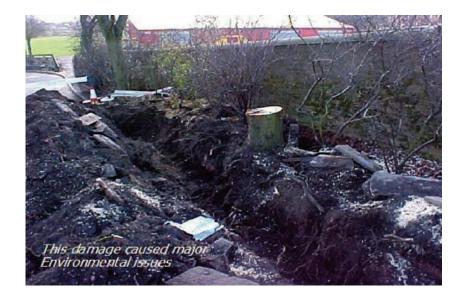
The above Image highlights the consequences of lack of planning when a JCB came into contact with a 33,000 volt oil filled cable.

The task was to install a metal post into the ground to support a gate at the location of ScottishPower underground apparatus. JCB proceeded to damage the cable with oil from the cable leaking into the surrounding excavation. To facilitate the repair to the cable a mature tree also had to be removed from the locus. The environmental issues highlighted and the cable strike could have been avoided if the correct planning processes had taken place. To avoid contact with ScottishPower underground plant adherence to HSG47 is strongly advised.

Prior to any excavations taking place cable records should always be consulted.

Reference: HSE leaflet "Avoiding Danger From Underground Services" HSG47

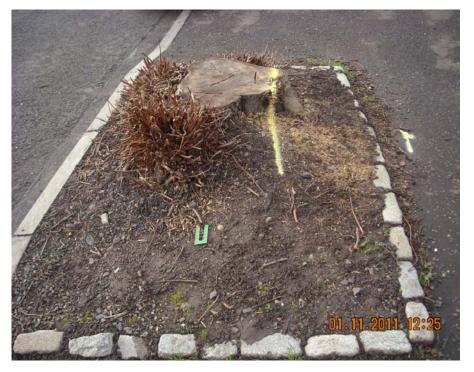
The above image demonstrates a situation which can be found on footpaths up and down the country. The lime trees were found to be diseased and the local authority took the decision to cut the trees down to stump level, with a view to stump grinding the remains of the trees. Good practice enabled the local authority to ascertain that a low voltage cable was running extremely close to the tree stumps. The local authority had implemented a policy of cat scanning the area prior to stump grinding operations taking place. Local authority contacted ScottishPower who advised that there was a real possibility of contact with the electrical network if stump grinding operations were implemented and advised that stump grinding at this location should not be undertaken. In an effort to eradicate the tree stumps: tree stump rotting chemical was applied to aid the decay of the existing stumps.

Prior to Stump Grinding Taking Place, Use Of a Cable Avoidance Tool In Conjunction With ScottishPower Cable Records Is Strongly Recommended.

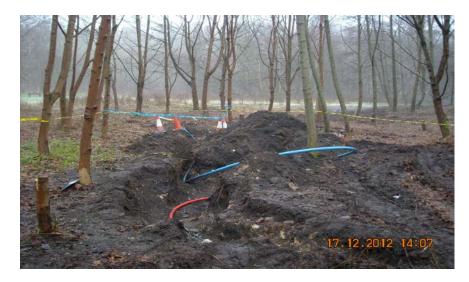
The above image demonstrates that utilities can be found at unusual locations, prior to excavations taking place it is prudent to always assume that utilities are present until proven otherwise.

Utilities can be located in obscure locations including woodland, forests, country parks, golf courses, football pitches, fields and on hills. Trial excavations as per HSG47 should always be undertaken to establish the line and level of utilities at all locations in conjunction with ScottishPower EnergyNetworks cable records.

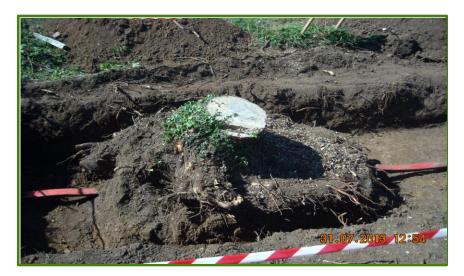
The above image demonstrates a situation where a tree has been installed on top of a high voltage cable. The task for the contractors was to remove the tree stump to enable drainage pipes to be installed beneath the cable with a view to also forming a new carriageway entrance in the future.

To ensure safety from the underground electrical network in this type of scenario, a risk assessment and method statement (RAMS) require to be forwarded to and approved by SP EnergyNetworks prior to works commencing to remove the tree stump. Construction companies could possibly fail to realise that a tree had been planted on top of an electrical cable, communication with utility companies and interpretation of cable records prior to site works commencing is crucial to avoiding utility strikes.

Communication with utilities prior to work commencing is the key to avoiding cable strikes
