## Case Study: Low Voltage Cable Strike (Flash Burn Injuries)

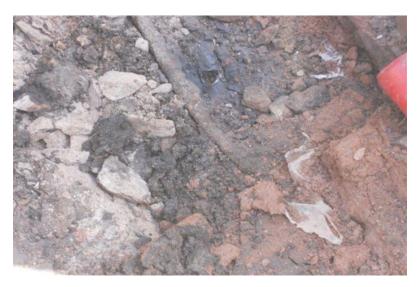
## The above image highlights a low voltage cable strike to the ScottishPower electrical network.

The task was to carry out excavations for a new service to the property. The operative came into contact with the low voltage cable when operating a kango hammer gun. Unfortunately on this occasion the operative had to attend hospital after receiving flash burns to his head, neck and lower arms. The investigation into this incident discovered that no cable records had been consulted prior to the excavations taking place and that the use of a cable locator had also not taken place.

ScottishPower cable records should always be consulted prior to any ground penetration taking place. Cable record enquiries are to be directed to ScottishPower Data Management section.

Prior to any excavations taking place cable records should always be consulted.

Always assume cables are present and live until proved otherwise.

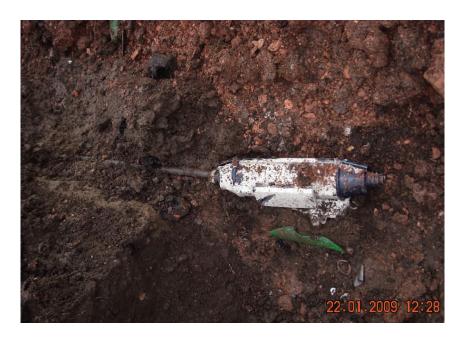
The above image highlights a low voltage cable with a straight joint attached. An operative took a hacksaw and severed the cable which was attached to the ScottishPower network.

The experienced operative wrongly assumed that the cable was out of use, fortunately on this occasion the operative received no injuries. All electricity cables are to be treated as live at all times, until proved otherwise by a ScottishPower engineer.

Prior to any excavations taking place cable records should always be consulted.

Always assume cables are present and live until proved otherwise.

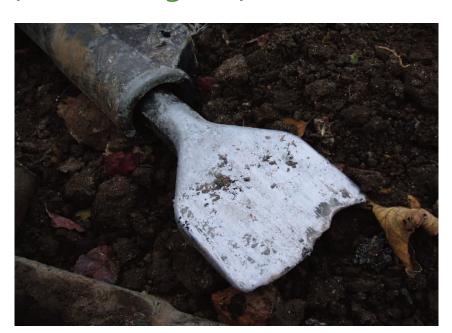
The above Image highlights a damaged spade tool on a pneumatic gun which has come into contact with a low voltage cable.

The task for the operatives was to install ducting in the footpath. During the course of the works the operative lost control of the pneumatic gun and struck the LV cable which had previously been exposed, fortunately on this occasion the operative received no injuries. Operatives knew the route and depth of the electricity cable having trial holed the footpath prior to the main excavations taking place. To prevent this type of incident a risk assessment/method statement and a safe system of work should have been established prior to works taking place.

Safe system of work is required to be in place prior to excavations taking place.

Prior to any excavations taking place cable records should always be consulted.

Always assume cables are present and live until proved otherwise.

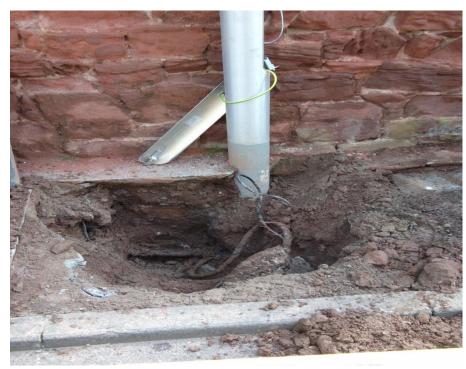
The above image highlights a situation which occurs on a regular basis to ScottishPowers underground electrical network.

Contractors who were operating for a local authority to install a new lamppost; the lamppost was placed in direct conflict with the underground low voltage main cable. To carry out the required excavation for the lamppost installation, "spoons" are the tool of choice used to keep the required lamppost hole to a minimum size.

Placing Lampposts or any other type of street furniture on top of or with no separation to the underground electrical network could lead to operatives receiving serious injuries. Cable record enquiries are to be directed to ScottishPower Data Management section.

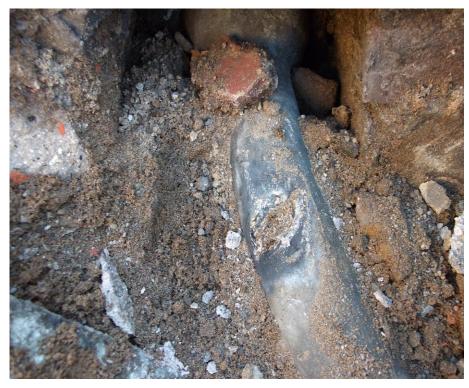
The above image demonstrates a low voltage cable damage to a Emergency lead covered .2(4) mains cable. The task for the operatives was CONTACT to remove underground apparatus and install new equipment at the locus, during the excavations the cable was damaged with a hand tool! The operatives had received all the relevant training regarding excavating around underground utilities, all the utility records had been supplied, cat & genny as standard on site with all the tools to carry out the excavations in a safe/competent manner. This cable strike could easily have been avoided, operatives require to take responsibility for their actions to ensure that no injuries will occur or damage to underground utility plant takes place. Every excavation is different and can have numerous potential hazards.

**Before Penetrating The Ground A Risk Assessment** And Safe System Of Work Should Always be implemented
