# Denny to Wishaw Network Upgrade

*Environmental Impact Assessment Report*

*Appendix 8.11 Upgraded Lines Great Crested Newt Results*

*May 2026*

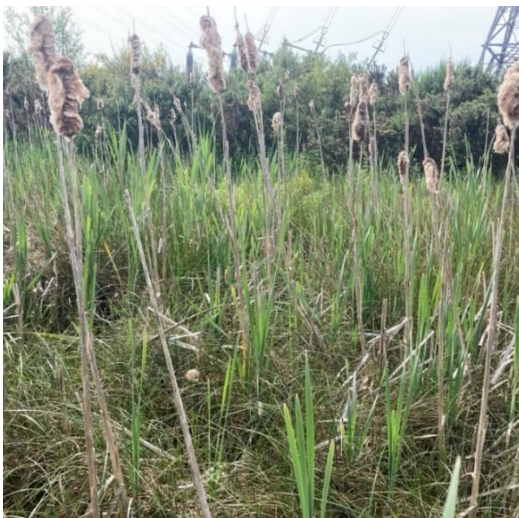
**Photograph 1. Waterbody ZG.GCN.01**

| Suitability Index | Habitat parameter | Field Score | HSI Score |
|---|---|---|---|
| Score: 0.51 (Below Average) | | | |

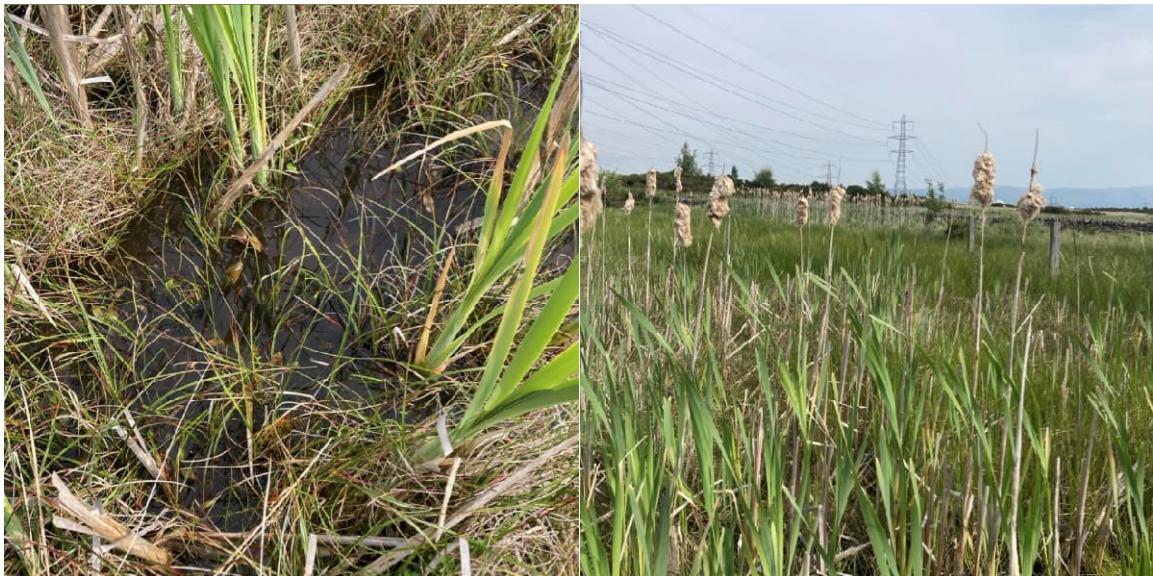
**Photographs 2 & 3. Waterbody ZG.GCN.02**

A shallow mosaic of pools containing bulrush, sphagnum moss *Sphagnum sp.*, with localised patches of pondweed *Potamogeton sp.*

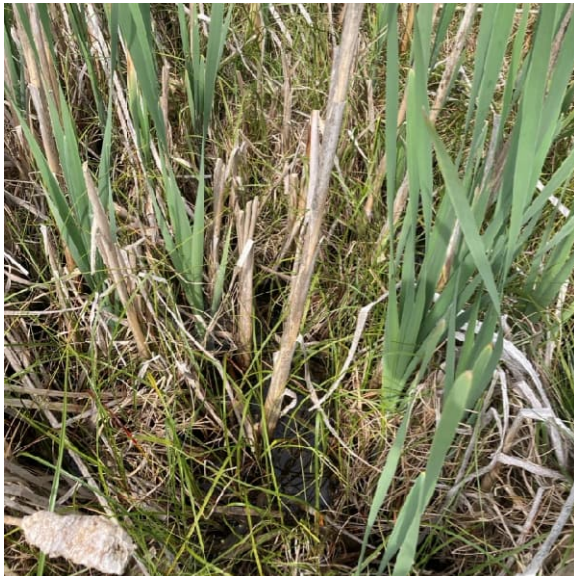
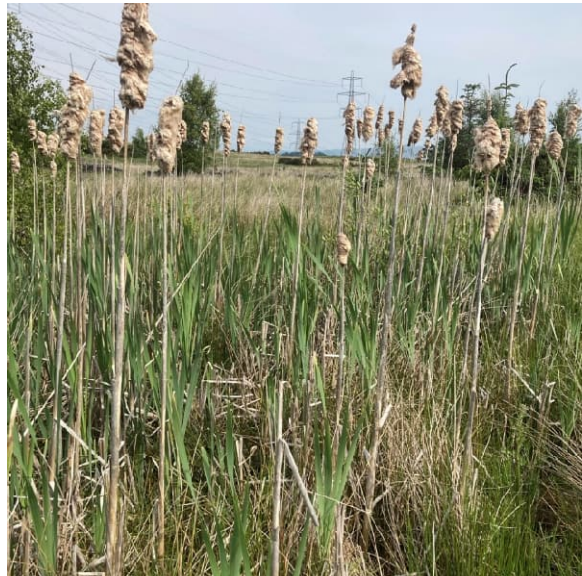
**Photograph 4 & 5. Waterbody ZG.GCN.03**

A damp depression containing bulrush, with the occasional duckweeds, lesser spearwort *Ranunculus flammula*, and pondweed sp.

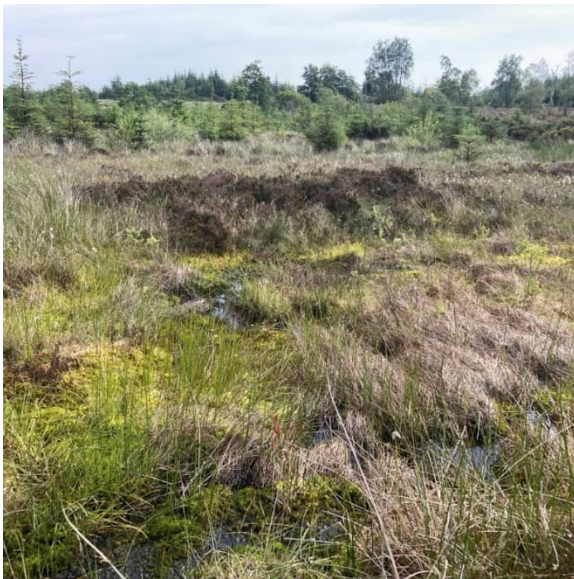
**Photograph 6. Waterbody ZG.GCN.04**

A collection of bog pools surrounded by hare's-tail cottongrass *Eriophorum vaginatum*, common cottongrass *Eriophorum angustifolium*, water horsetail *Equisetum fluviatile* and scattered immature willows *Salix* sp. Water mostly contains feathery bogmoss *Sphagnum cuspidatum*. Lesser spearwort and sundews *Drosera* sp. are occasionally found in these pools.

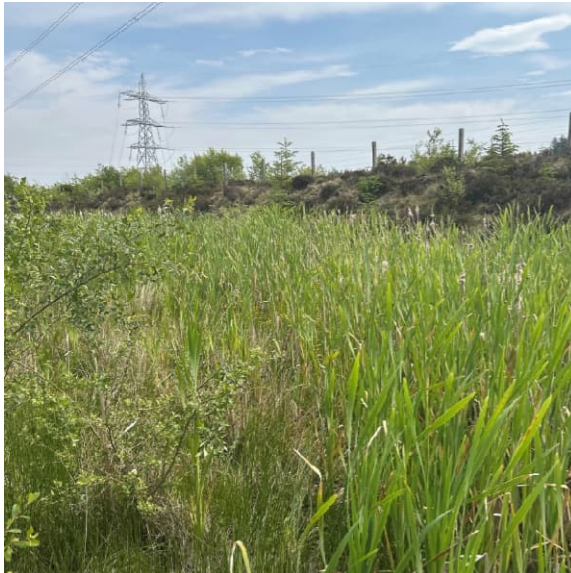
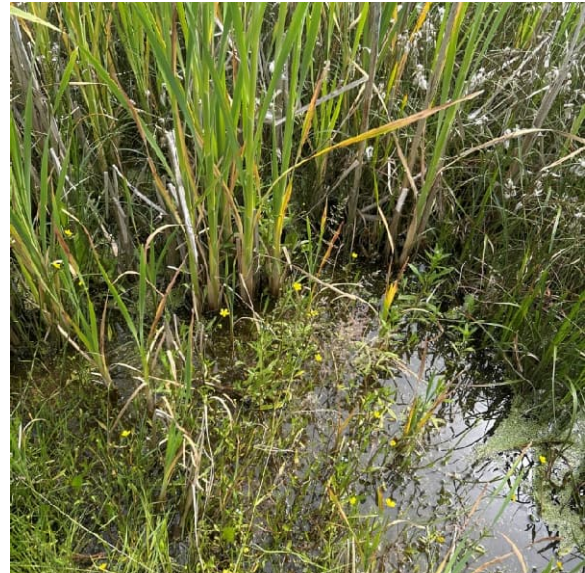
**Photograph 7 & 8. Waterbody ZG.GCN.05**

A consistently shallow SuDS pond adjacent to a substation, with steep heathery sides. The pond is dominated by bulrush, with locally abundant water horsetail. Occasionally pondweed, lesser spearwort, water forget-me-not *Myosotis scorpioides*, marsh cinquefoil *Comarum palustre* are also found.

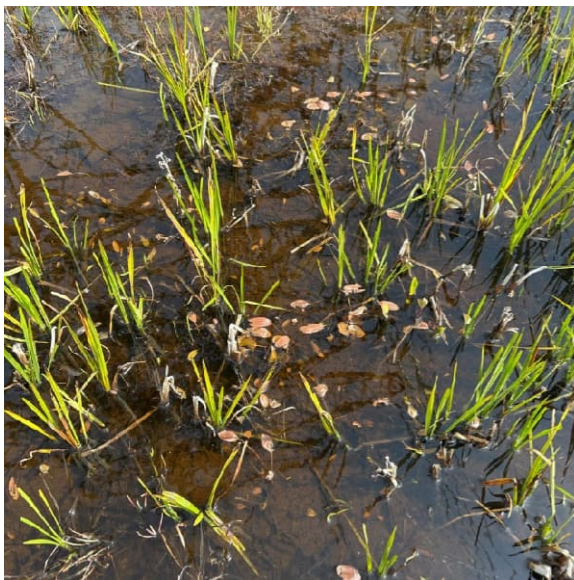
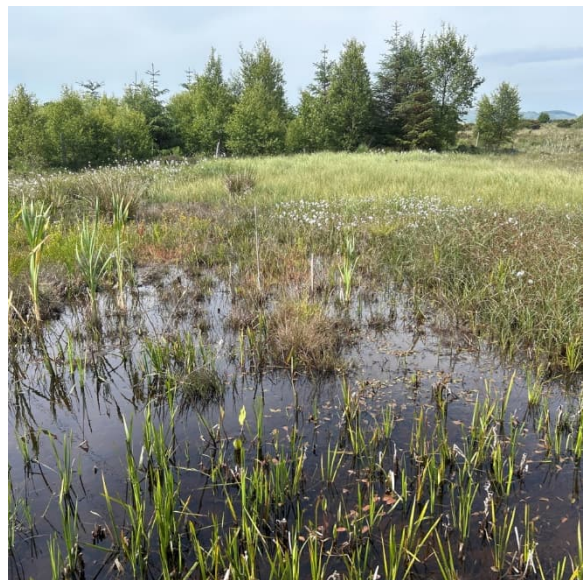
**Photograph 9 & 10. Waterbody ZG.GCN.06**

A large shallow pond with marginal common cottongrass. Bottle sedge *Carex rostrata*, spike rush *Eleocharis palustris*, and bulrush are locally abundant. Occasionally branched bur-reed *Sparganium erectum*, and water-plantain *Alisma plantago-aquatica* are also found.

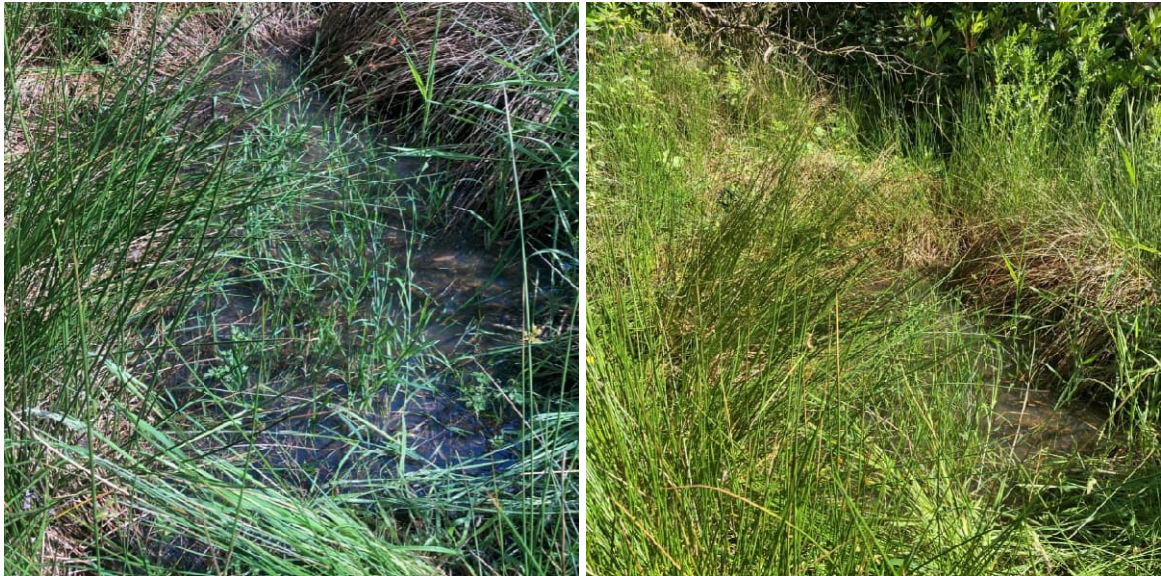
**Photograph 11 & 12. Waterbody ZG.GCN.07**

A continuous patch of wet ground surrounded by wet woodland and rhododendron *Rhododendron sp.*, consisting of two main patches of standing water connected by overground seepage.

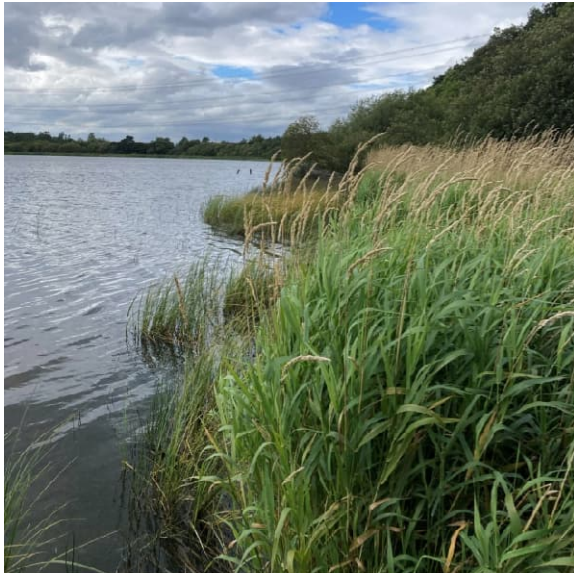
**Photograph 13. Waterbody XX.GCN.01**

| Suitability index | Habitat parameter | Field Score | HSI score |
|---|---|---|---|
| | | | <b>Score: 0.29 (Poor)</b> |

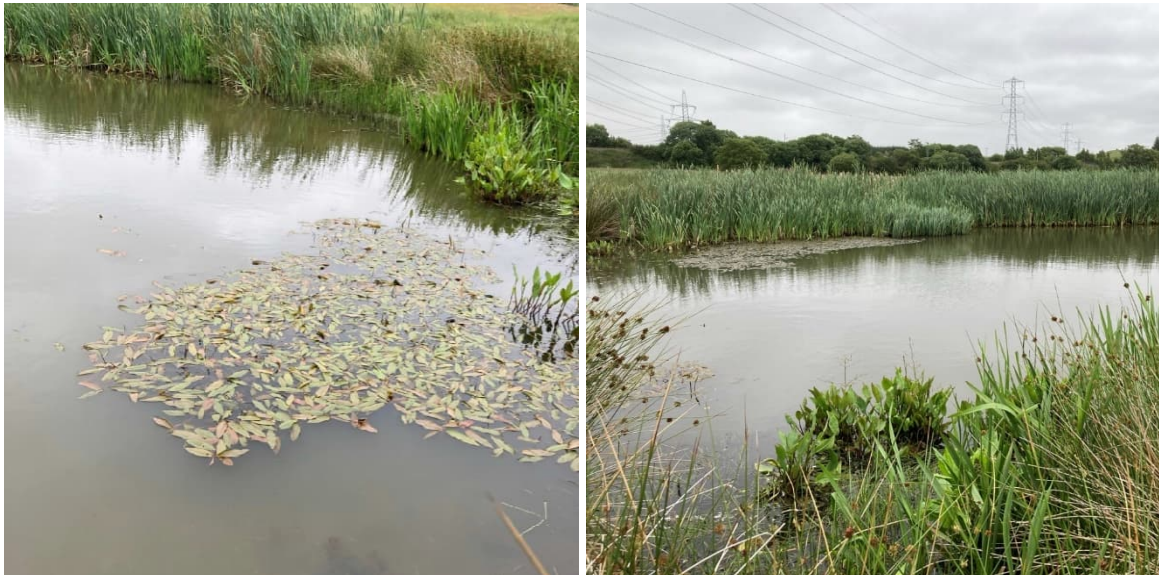
**Photograph 14 & 15. Waterbody XX.GCN.02**

A deep pond which shares water with XX.GCN.03 when the water level is high. Pond is surrounded by bulrush, soft rush and bottle sedge.

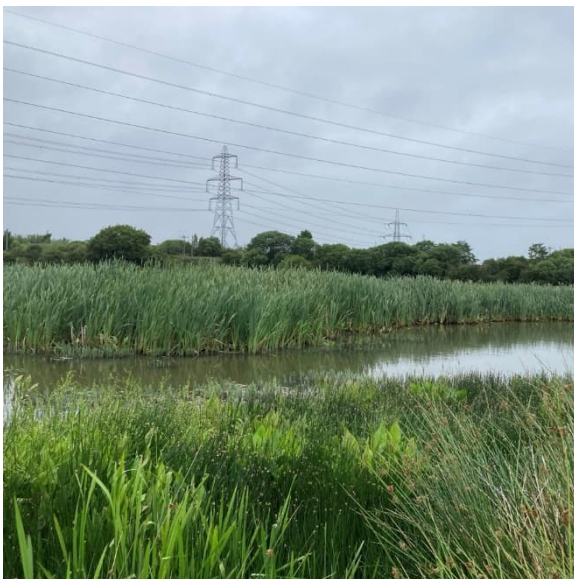
**Photograph 16. Waterbody XX.GCN.03**

A large pond, surrounded mostly by bulrush, as well as by with the rest being covered by soft rush and bottle sedge. The water in the pond is turbid with a muddy substrate and is around 1m deep. Pondweed and mare's-tail *Hippuris vulgaris*, with the occasional water-plantain, and rare sweetgrass *Glyceria sp.*, horsetails, marsh-margiold *Caltha palustris* and common spike-rush *Eleocharis palustris* are also present.

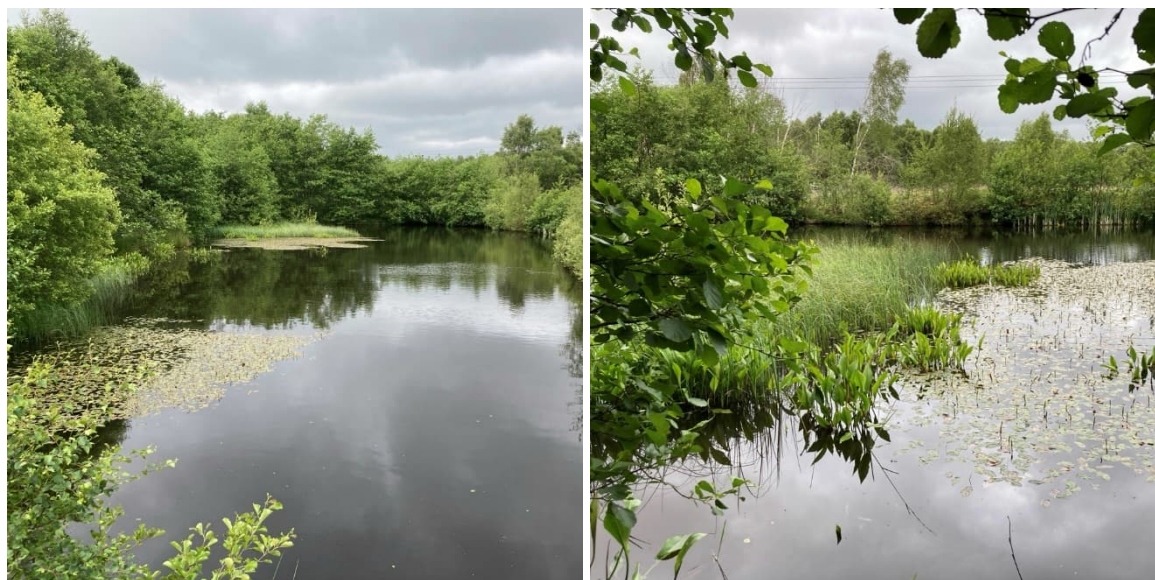
**Photograph 17 & 18. Waterbody XX.GCN.04**

A very deep, peaty pond surrounded by willows and birches *Betula* sp., located within a woodland. The pond supports localised patches of pondweed, water-plantain and bottle sedge.

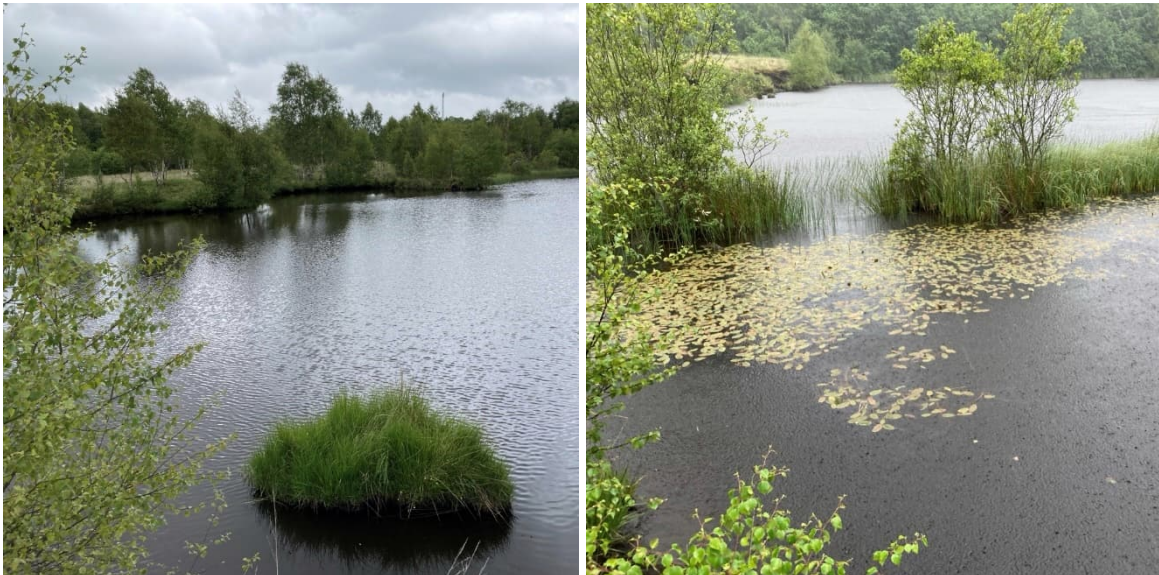
**Photograph 19 & 20. Waterbody XX.GCN.05**

A large pond within an area of degraded bog with scattered birch trees along its perimeter. The pond is likely quite deep and supports occasional bottle sedge and has locally abundant pondweed and rare bulrush throughout. There are additional two small ponds (XX.GCN.06) to the east that are likely connected to this pond when the water level rises.

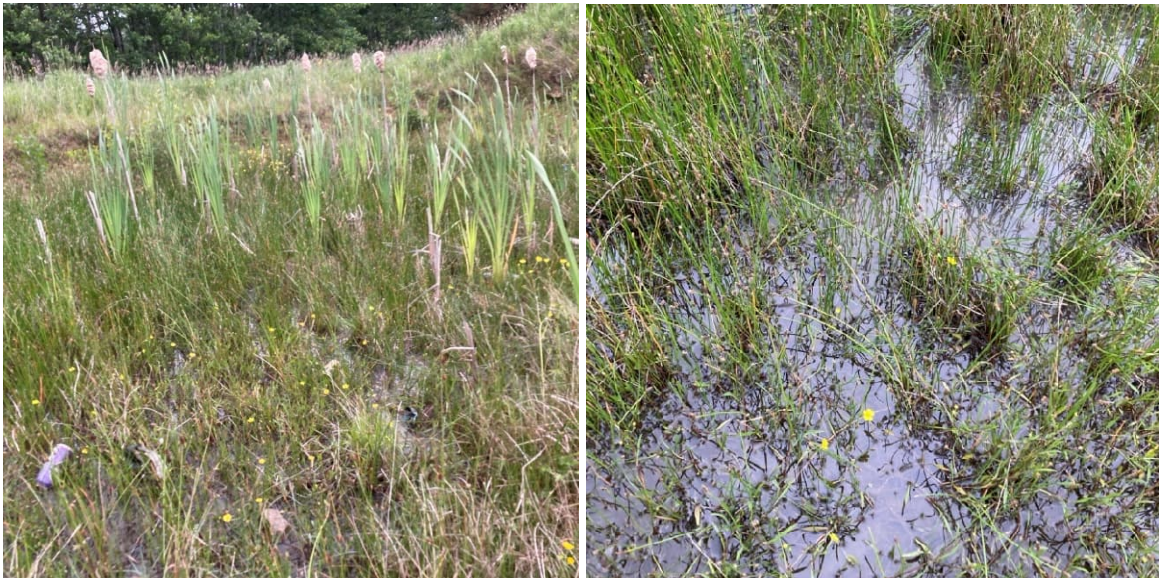
**Photograph 21 & 22: Waterbody XX.GCN.07**

| Suitability index | Habitat parameter | Field Score | HSI score |
|---|---|---|---|
| <b>Score: 0.59 (Below Average)</b> | | | |

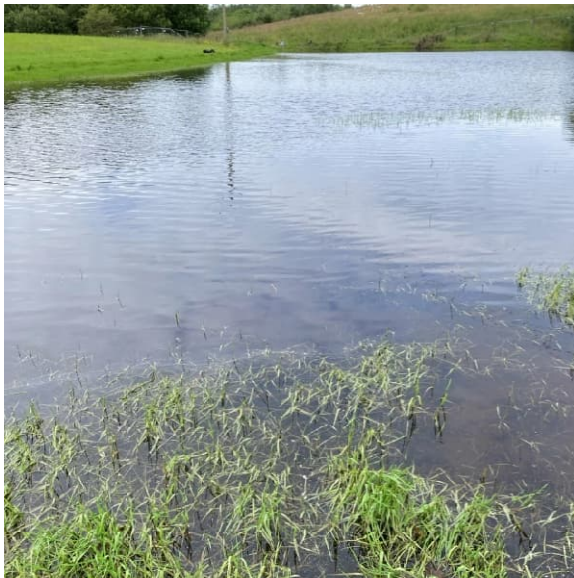
**Photograph 23. Waterbody XX.GCN.08**

A likely ephemeral pool with a muddy substrate. Marginal vegetation is dominated by sweet-grass and Yorkshire fog *Holcus lanatus*. The pond provides habitat for coots *Fulica atra* and various other waterfowl.

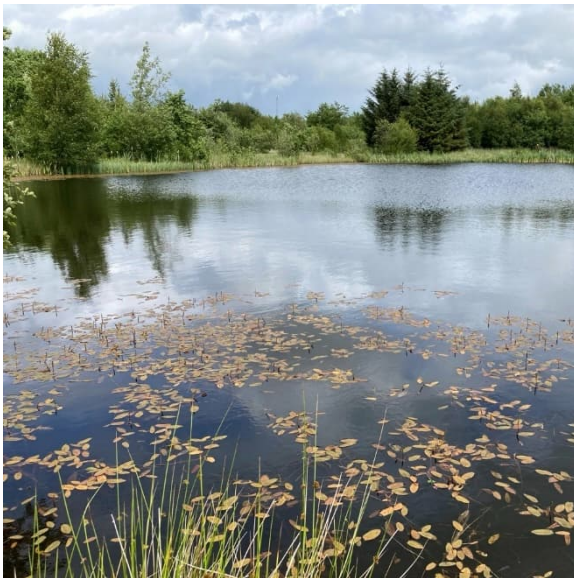
**Photograph 26. Waterbody XX.GCN.10**

A shallow depression with an outlet into a much larger water body. The depression is dominated by bottle sedge and rushes, with scattered bulrush, lesser spearwort and occasional patches of pondweed throughout.

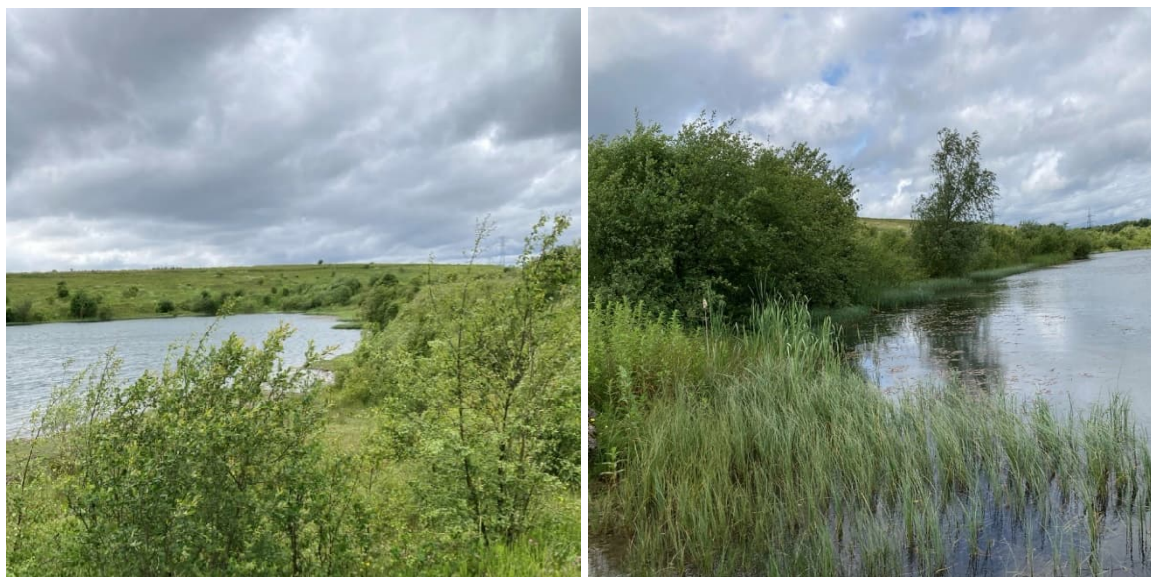
**Photograph 27 & 28. Waterbody XX.GCN.11**

A large loch, surrounded by marginal vegetation that comprises common spike-rush, bottle sedge and bulrush.

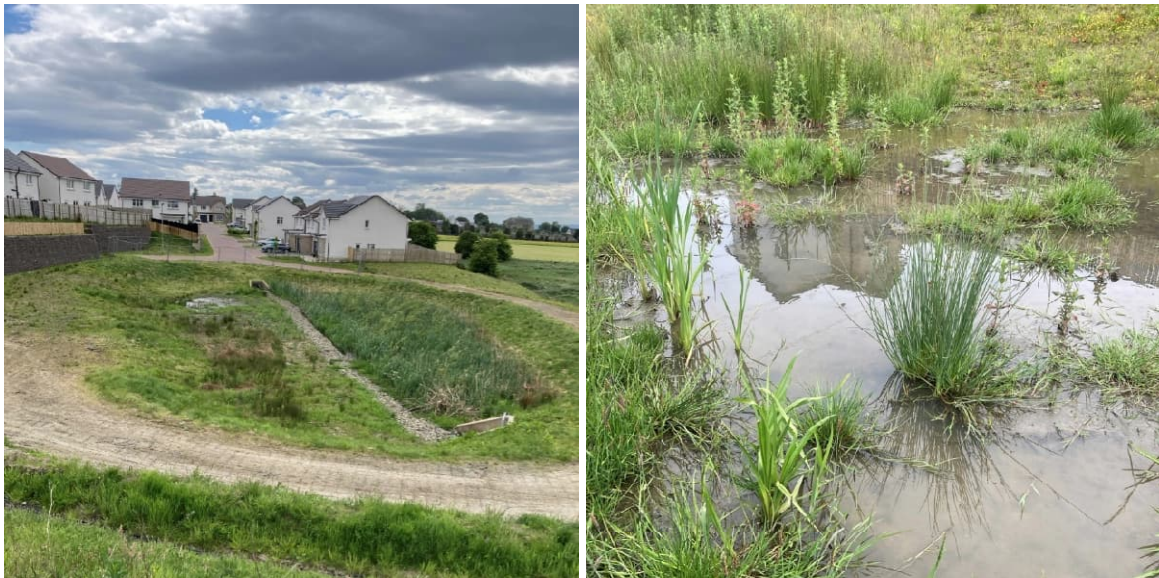
**Photographs 29 & 30 Waterbody XX.GCN.15**

| Suitability index | Habitat parameter | Field Score | HSI score |
|---|---|---|---|
| | | | <b>Score: 0.34 (Poor)</b> |

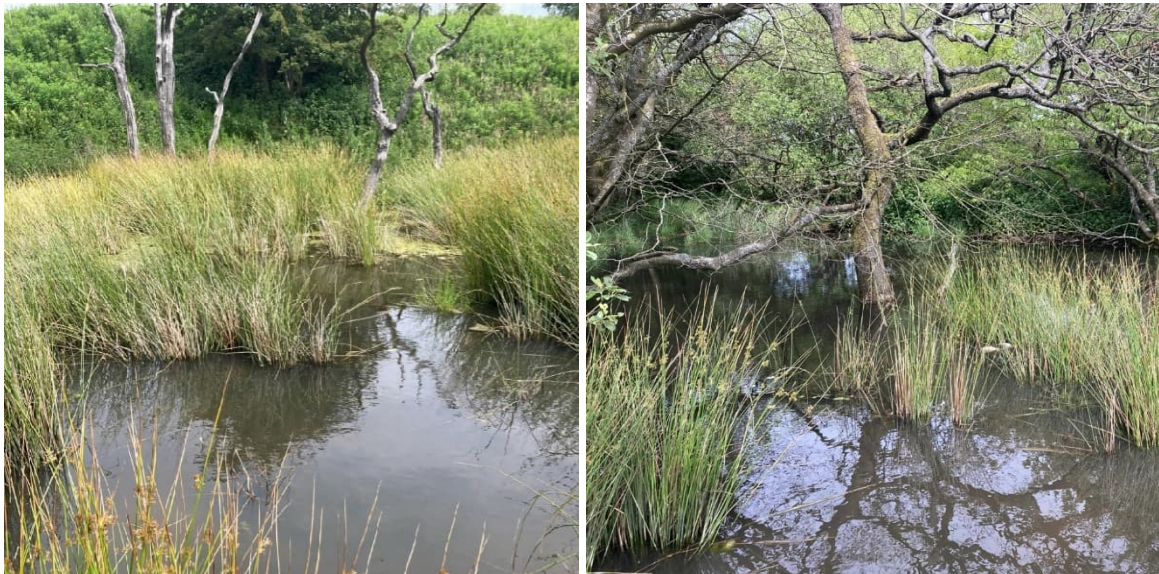
**Photographs 31 & 32 Waterbody XX.GCN.16**

A new pond formed within the spoil from a nearby construction works that at the time of survey was likely deeper than usual because of the recent rain. Lots of rush *Juncus sp.*, the occasional celery buttercup *Ranunculus sceleratus* and blanketweed *Cladophora sp.*, with rare pondweed throughout. The water contains many dead trees.

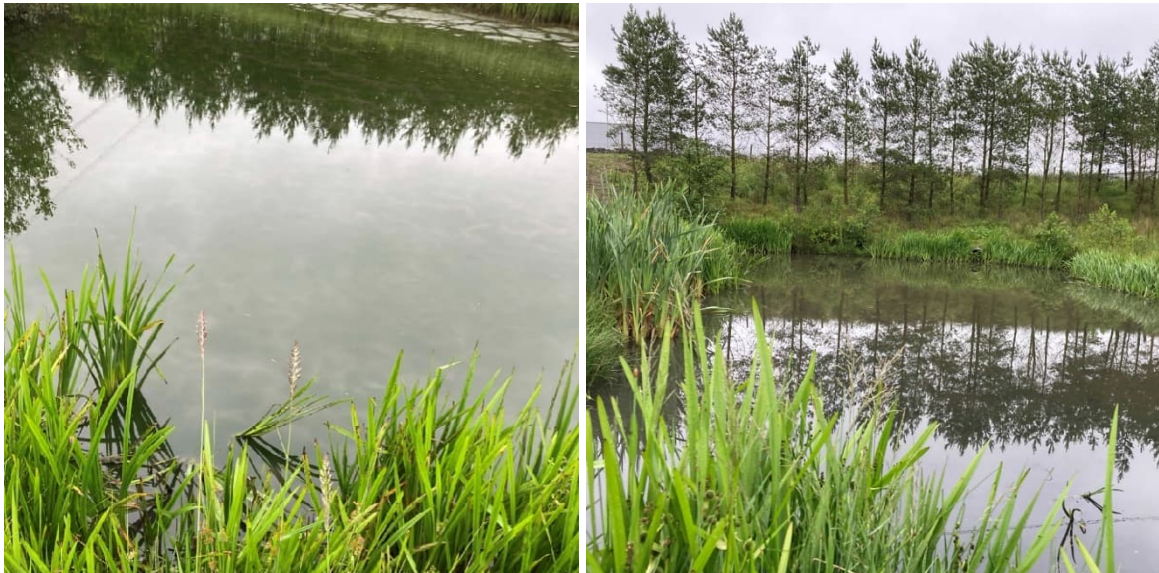
**Photographs 33 & 34. Waterbody XX.GCN.17**

Two connected shallow settling ponds with a muddy substrate. An inflow pipe feeds surface run-off to the ponds. The ponds support a variety of marginal vegetation such as bulrush and rushes, but no suitable egg laying vegetation.

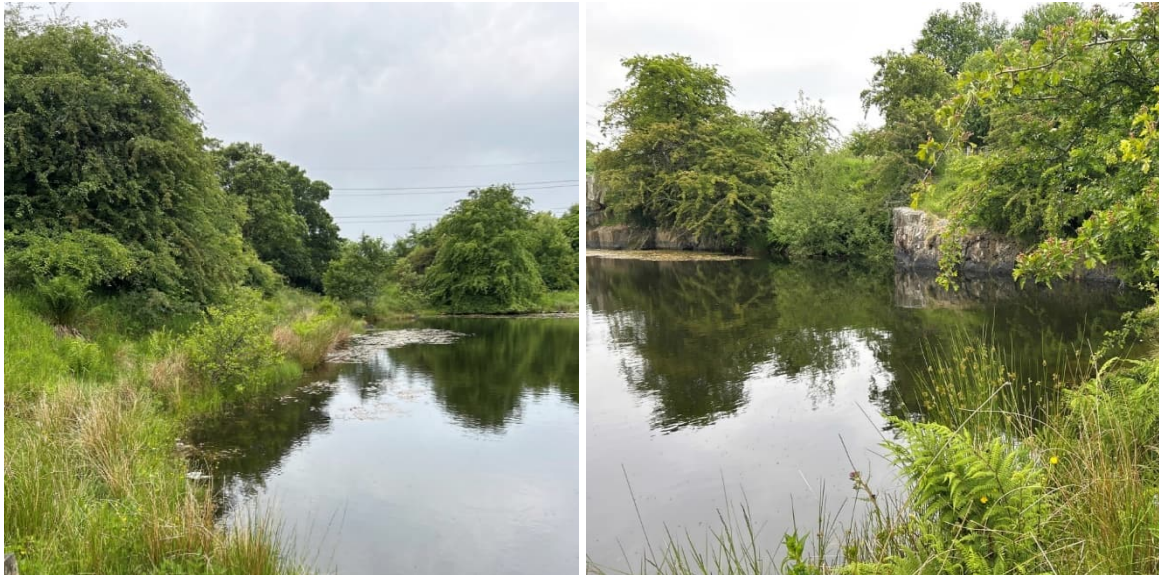
**Photographs 35 & 36. Waterbody XX.GCN.18**

A large and likely deep pond with clear water which supports a variety of macrophytes along its perimeter such as possibly parrot's-feather *Myriophyllum aquaticum*. Patches of pondweed are present within the pond. Waterfowl droppings and feathers were seen suggesting the pond is used by birds. Additionally, the pond is subject to high levels of fly-tipping.

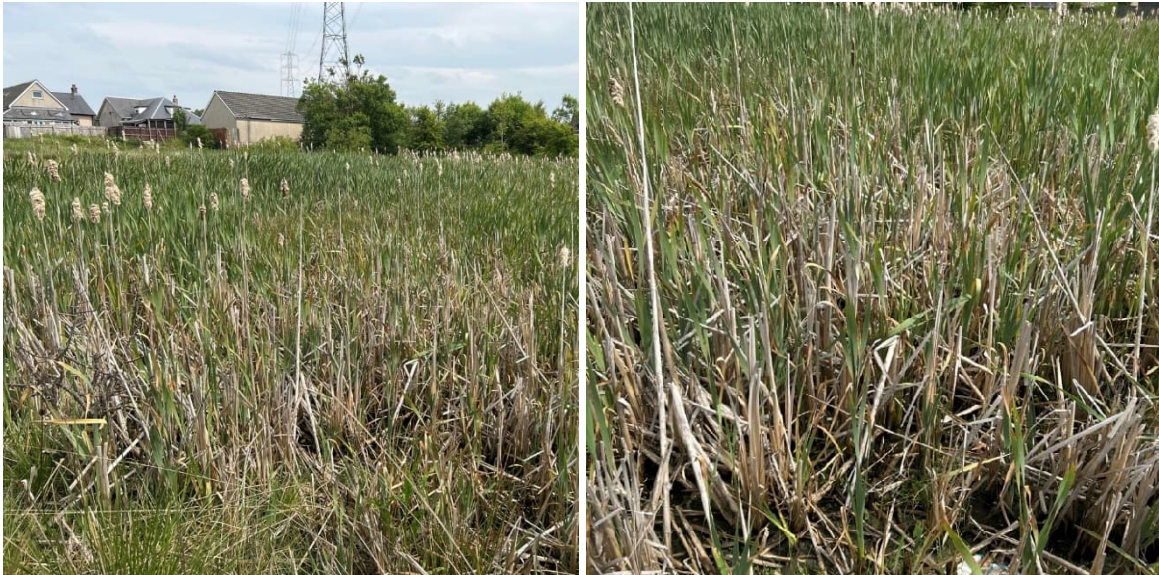
**Photographs 37 & 38. Waterbody XX.GCN.19**

A damp expanse, which is essentially dry, covered in soft rush and bulrush. Occasional pools of standing water that support pondweed.

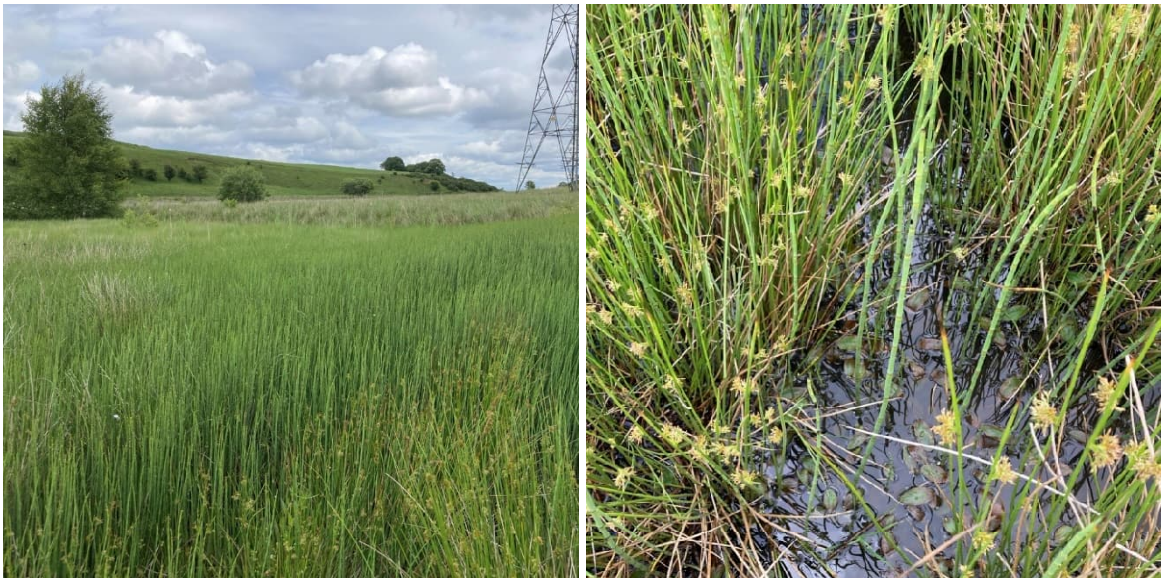
**Photographs 39 & 40. Waterbody XX.GCN.20**

A wet depression full of water horsetail, with frequent soft rush, occasional bulrush and ragged robin *Silene flos-cuculi* throughout. Occasional pools of standing water that support pondweed.

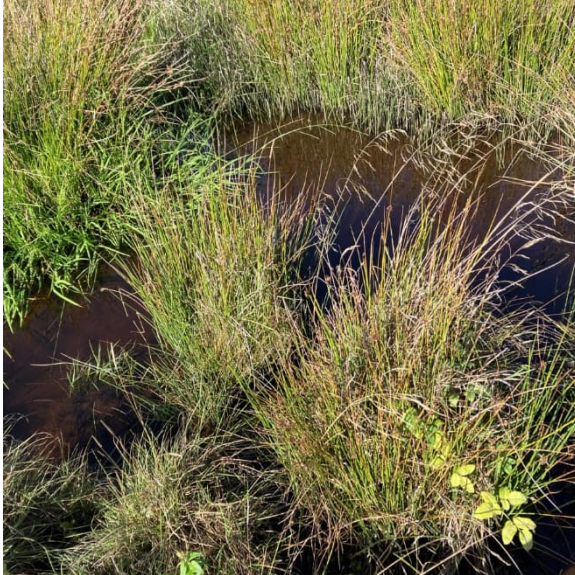
***Photograph 41. Waterbody XX.GCN.21***

A shallow wet depression within a wetland habitat, dominated by rushes. This area does not offer any suitable egg-laying habitat for GCN therefore no HSI survey has been carried out for that specific area, however, it was tested with eDNA concurrently with XX.GCN.20.

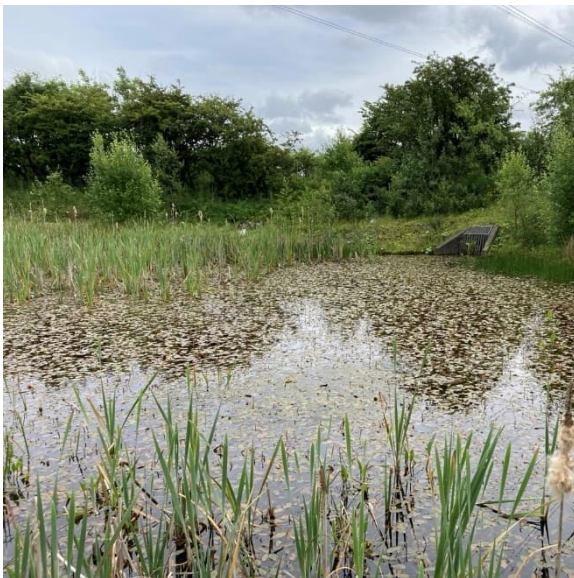
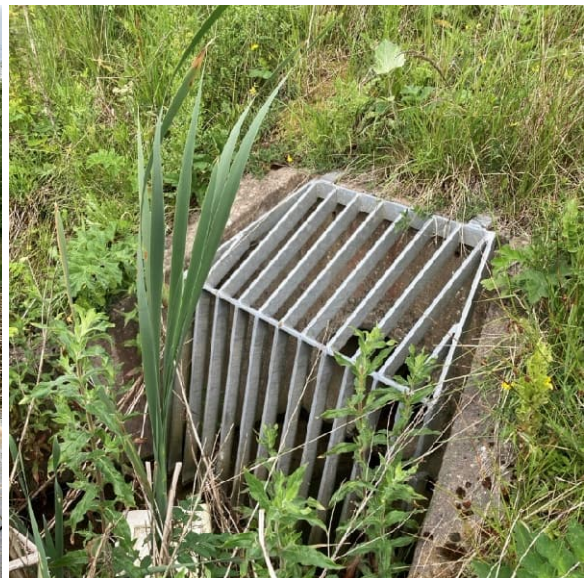
**Photographs 42 & 43. Waterbody XX.GCN.29**

| Suitability index | Habitat parameter | Field Score | HSI score |
|---|---|---|---|
| <b>Score: 0.5 (Below Average)</b> | | | |

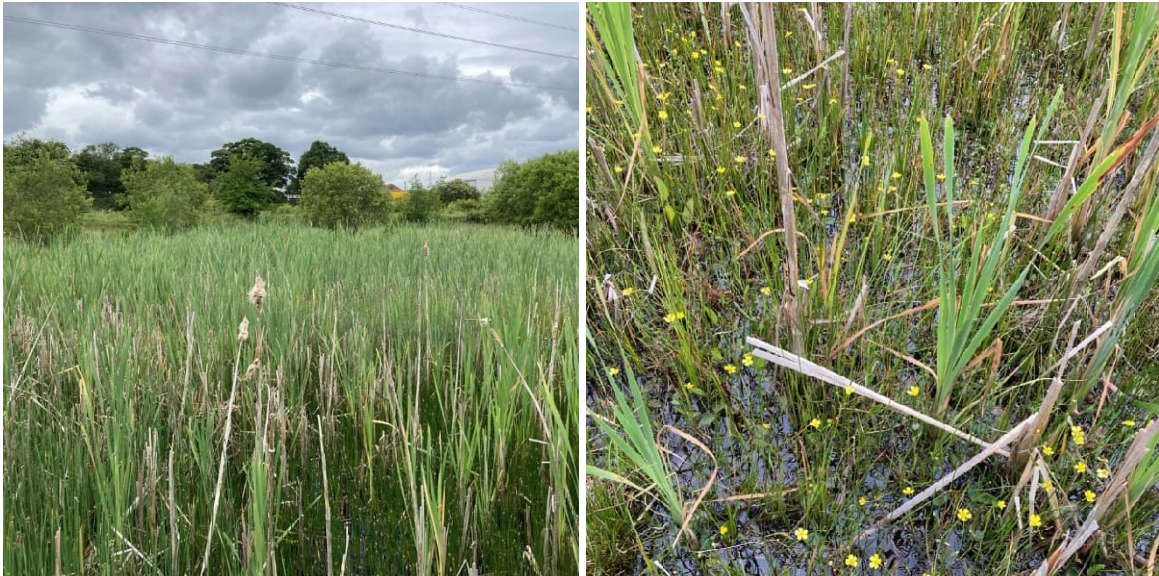
**Photographs 44 & 45. Waterbody XX.GCN.29**

A network of connected shallow depressions completely vegetated by a mixture of bulrush, rushes and sedges as well as water-plantain, lesser spearwort and water forget-me-not. Pondweed species are also found within.

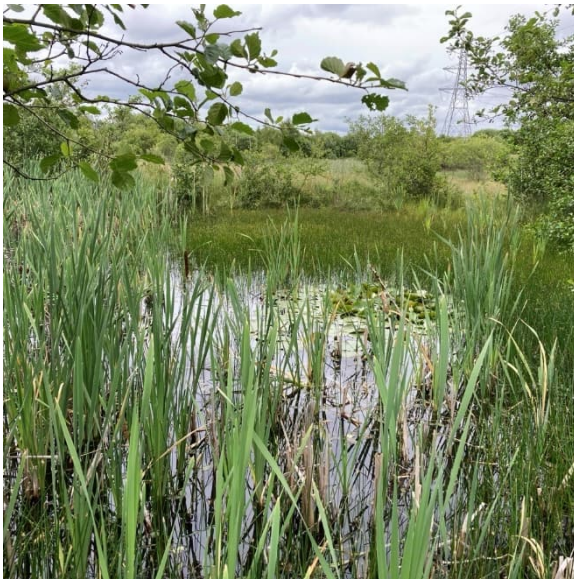
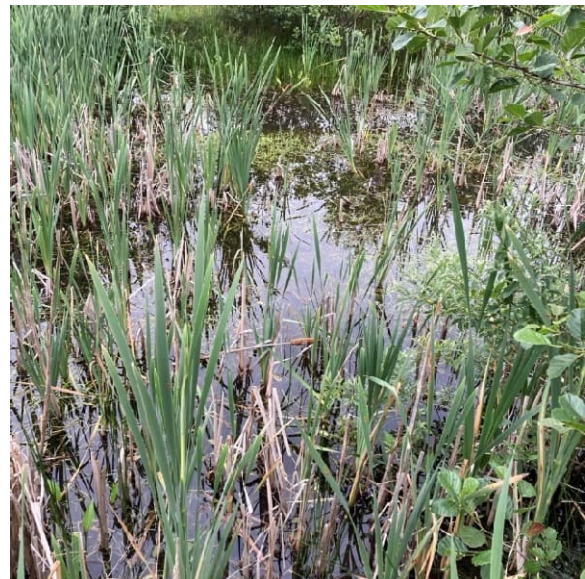
### Photographs 46 & 47. Waterbody XR.GCN.01

| Suitability index | Habitat parameter | Field Score | HSI score |
|---|---|---|---|
| <b>Score: 0.86 (Excellent)</b> | | | |

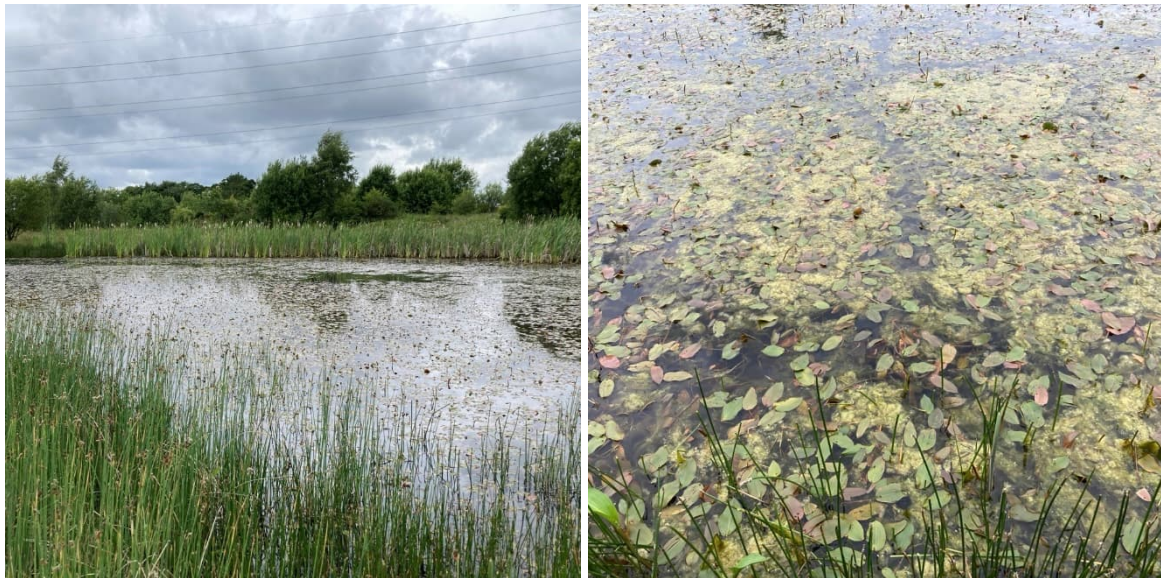
**Photographs 48 & 49. Waterbody XR.GCN.02**

A large and likely deep pond with extensive marginal vegetation including, bulrush, common spike-rush, clubrush *Schoenoplectus lacustris*, and horsetails. Most of the open water is covered in pondweed. Coots were present at the time of survey.

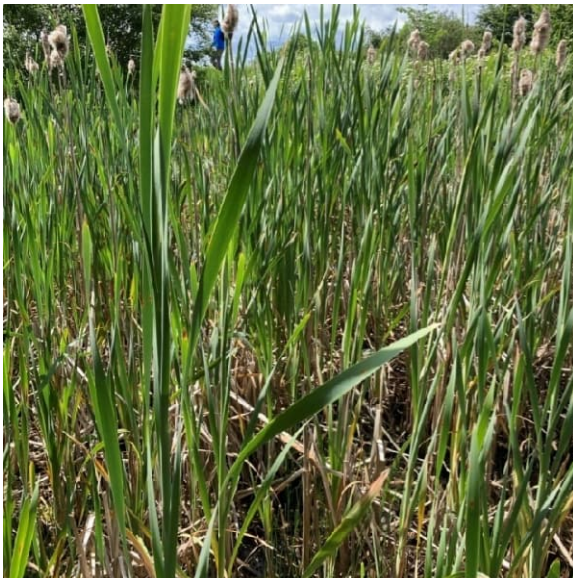
**Photograph 50. Waterbody XR.GCN.03**

A shallow pond dominated by bulrush, that was dry at the time of survey hence no eDNA sampling has been carried out.

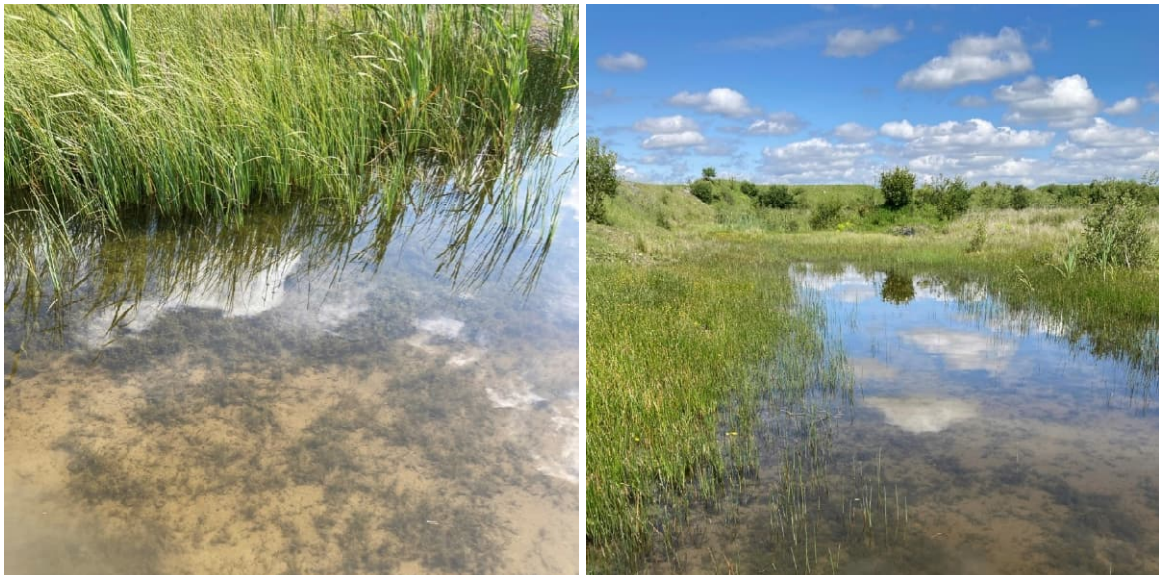
**Photographs 51 & 52. Waterbody XR.GCN.04**

A pond with a muddy substrate, surrounded by common spike-rush, bulrush, bottle sedge and lesser spearwort.

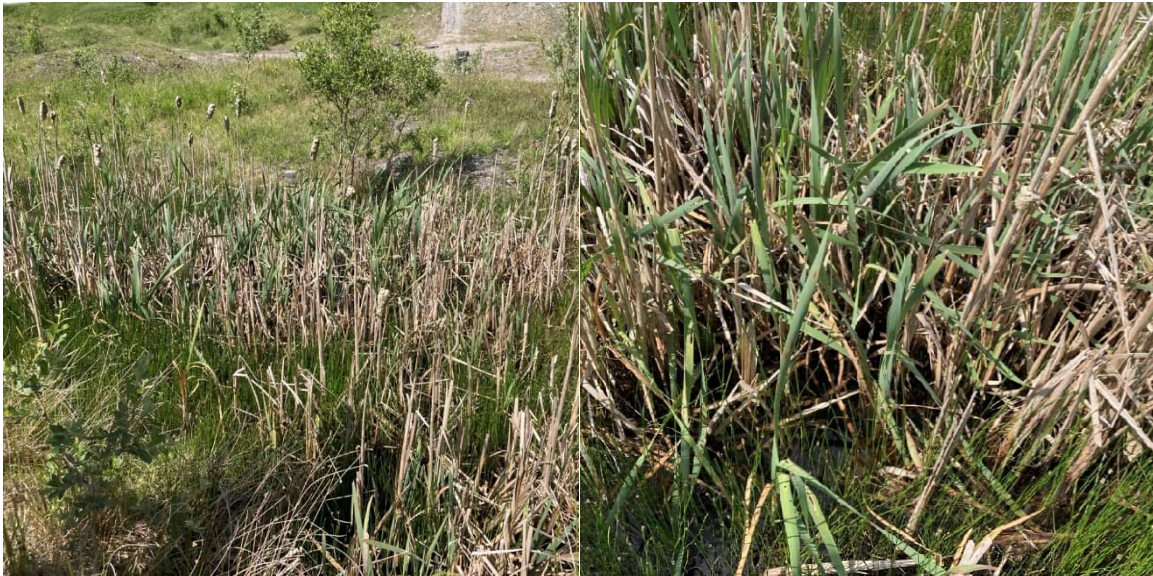
**Photographs 53 & 54. Waterbody XR.GCN.05**

Two very close ponds, one of which is densely vegetated by bulrush and the other is covered in common spike-rush. Both have likely recently dried, as each pond contains water-plantain and pondweed.

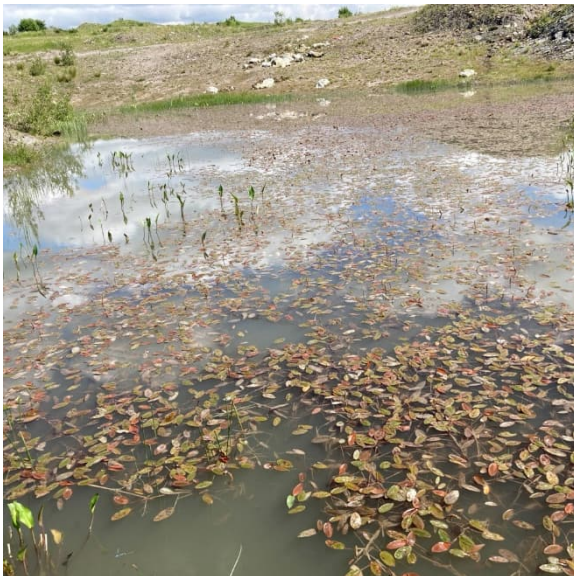
**Photographs 55 & 56. Waterbody XR.GCN.05**

A quarry pond characterized by highly turbid water and fluctuating levels, as evidenced by the dry, unvegetated upper banks. Aquatic vegetation includes locally abundant water-plantain and pondweed. Marginal areas support occasional spike-rush and locally abundant water horsetail though the surrounding banks remain largely sparse.

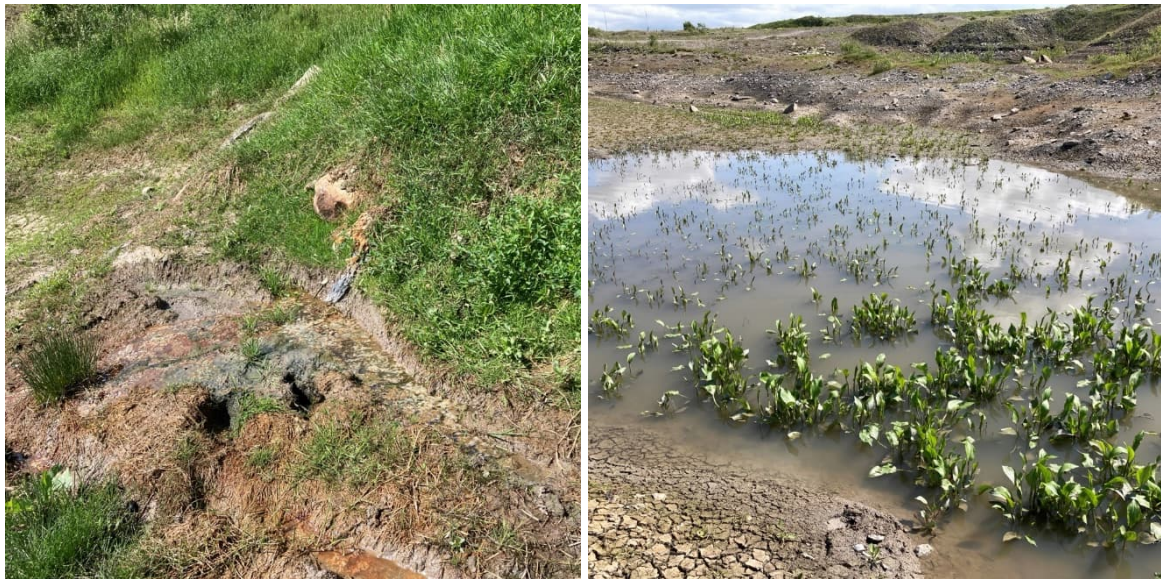
**Photographs 57 & 58. Waterbody XR.GCN.05**

A quarry pond displaying evidence of significant desiccation, with receding water levels and a perimeter of cracked mud. The water column is highly turbid and supports limited botanical diversity, though water-plantain is locally abundant. Despite signs of nutrient enrichment or pollution, the pond continues to support a modest assemblage of aquatic invertebrates.

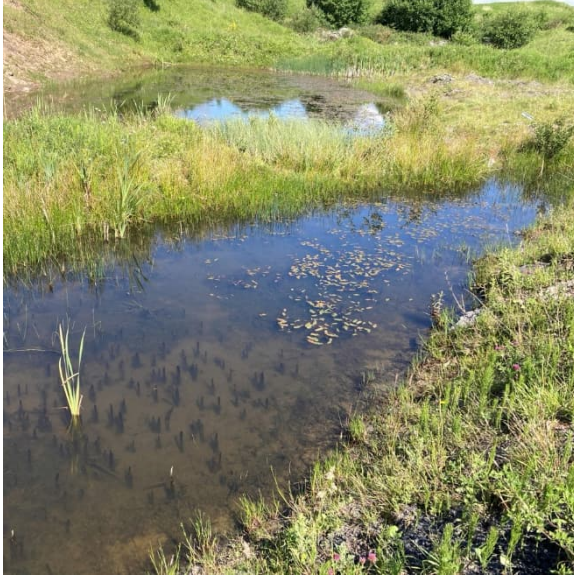
***Photograph 59. XR.GCN.10 and XR.GCN.08***

Waterbodies scoped out of further assessment due to the presence of a quarry which is a significant dispersal barrier.

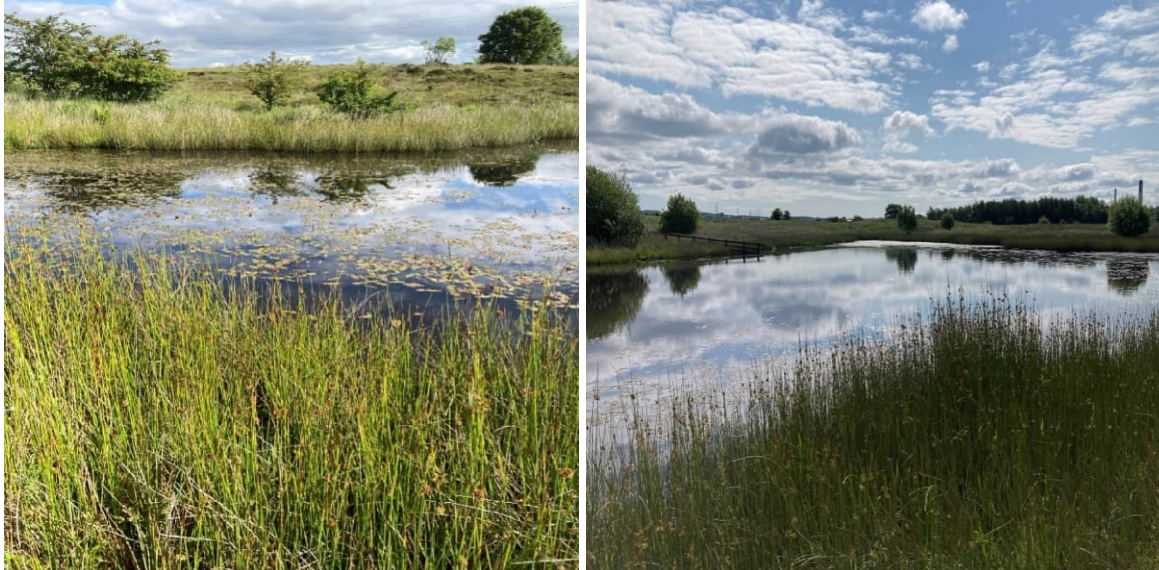
**Photographs 60 & 61. Waterbody XR.GCN.05**

A large pond and likely deep pond with marginal scattered willows, soft rush and mosses. The pond supports locally abundant bulrush. There is also rarely distributed bur-reed, lesser spearwort, bedstraws *Galium sp.*, wild angelica *Angelica sylvestris* and duckweed.

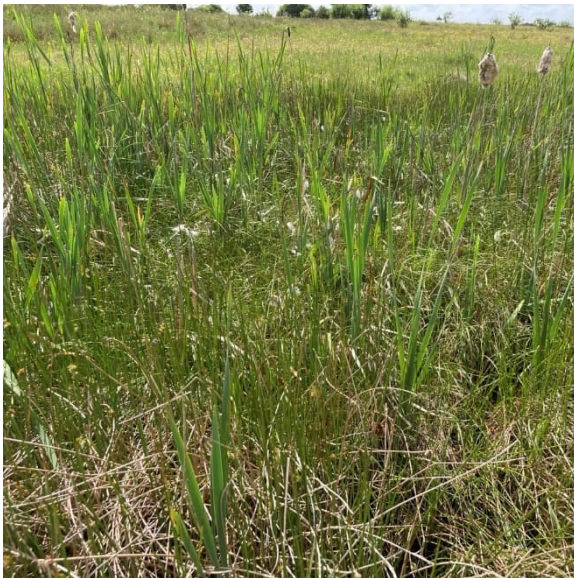
**Photograph 62. Waterbody XR.GCN.12**

A shallow pond that was likely dry before recent rains. The pond is overgrown with bulrush, common spike-rush, common cottongrass, and duckweed.

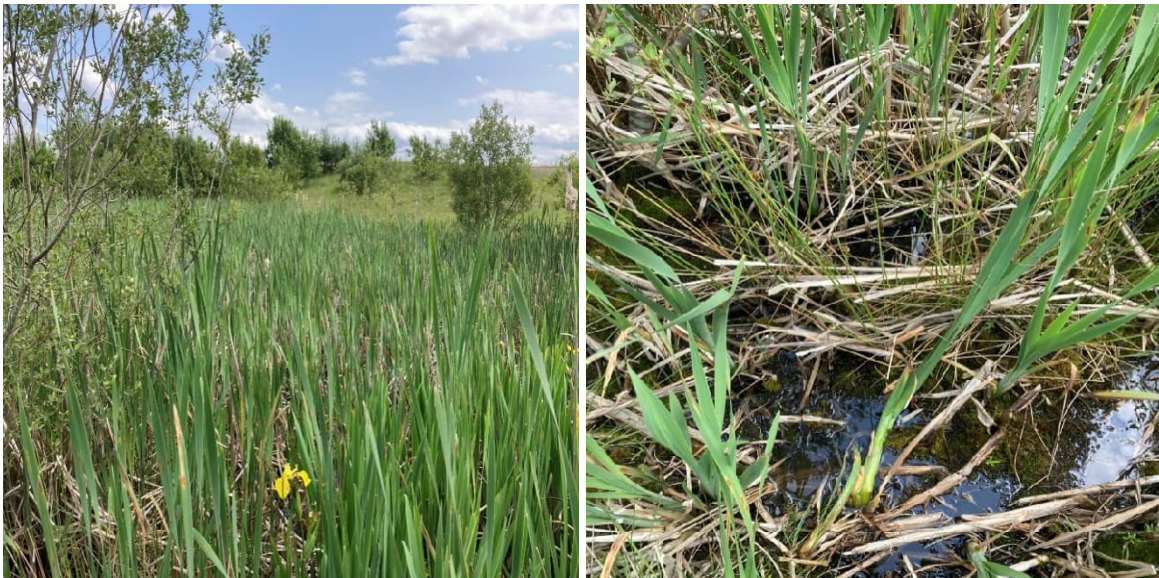
**Photographs 63 & 64. Waterbody XR.GCN.13**

A shallow pond, with scattered willows along its margin. The pond has small patches of open water, dominated by bulrush and has occasional yellow iris *Iris pseudacorus*.
