# Denny to Wishaw Network Upgrade

*Environmental Impact Assessment Report*

*Appendix 8.11 Upgraded Lines Great Crested Newt Results*

*May 2026*

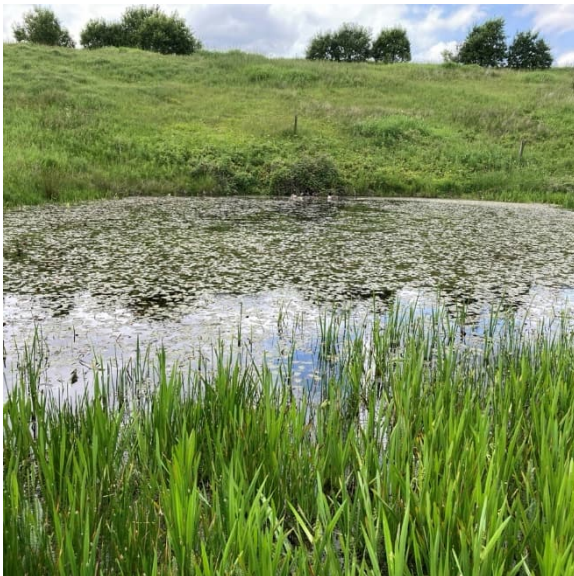
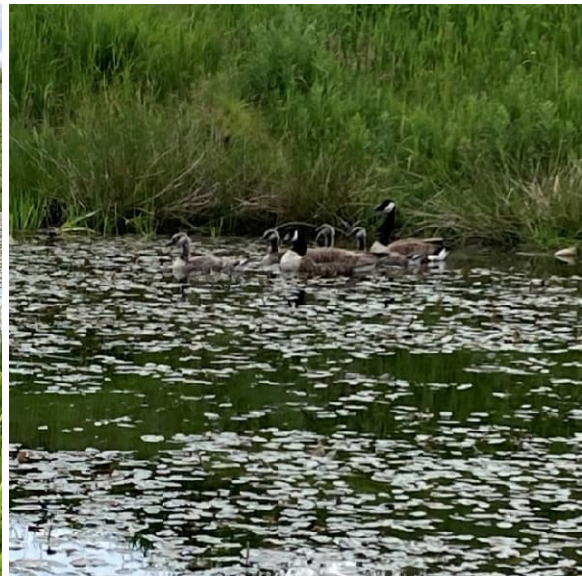
**Photographs 65 & 66. Waterbody XR.GCN.13**

A possibly artificial, but well-established pond that is very deep. The margins of the pond support mosses and bur-reed. The pond contains locally abundant bulrush and occasional pondweed. A flock of geese *Anser sp.* was recorded utilizing the waterbody at the time of the survey.

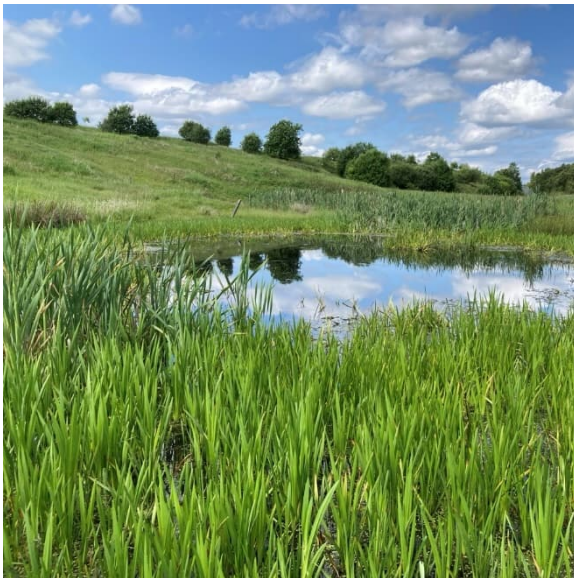
**Photograph 67. Waterbody XR.GCN.15**

A possibly artificial, but well-established pond that is very deep. The margins of the pond support mosses and bur-reed. The pond contains locally abundant bulrush.

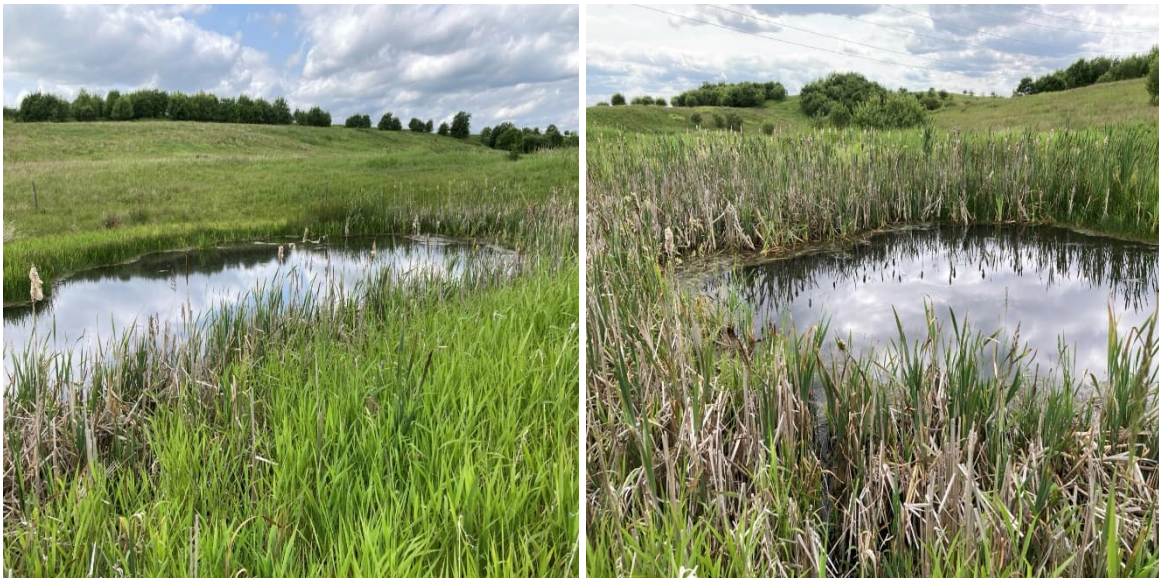
**Photographs 68 & 69. Waterbody XR.GCN.16**

| Suitability index | Habitat parameter | Field Score | HSI score |
|---|---|---|---|
| | | | <b>Score: 0.77 (Good)</b> |

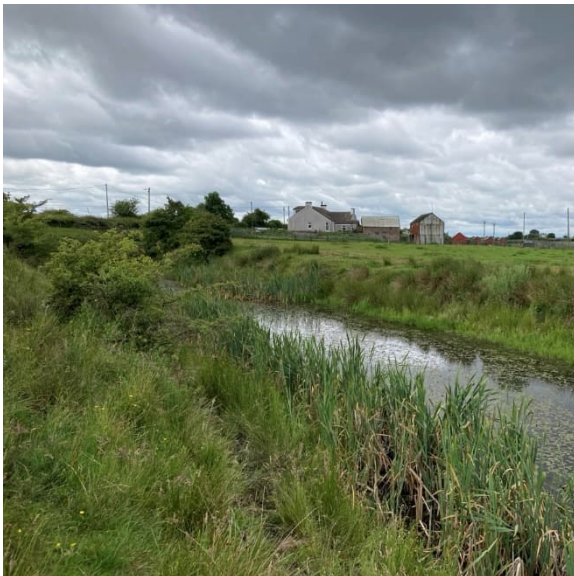
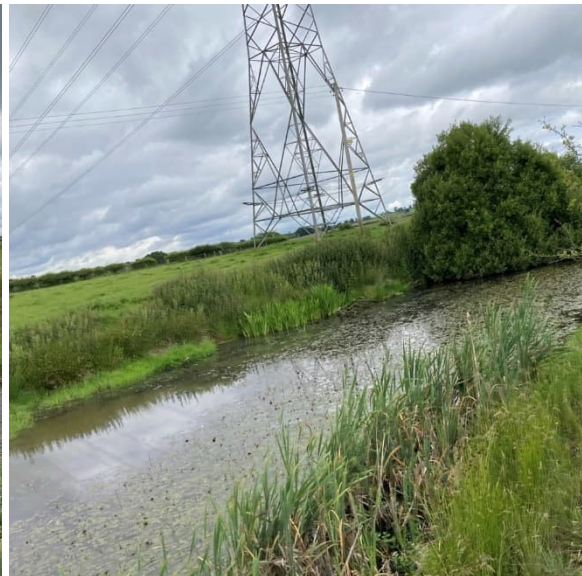
**Photographs 70 & 71. Waterbody XR.GCN.19**

| Suitability index | Habitat parameter | Field Score | HSI score |
|---|---|---|---|
| | | | <b>Score: 0.44 (Poor)</b> |

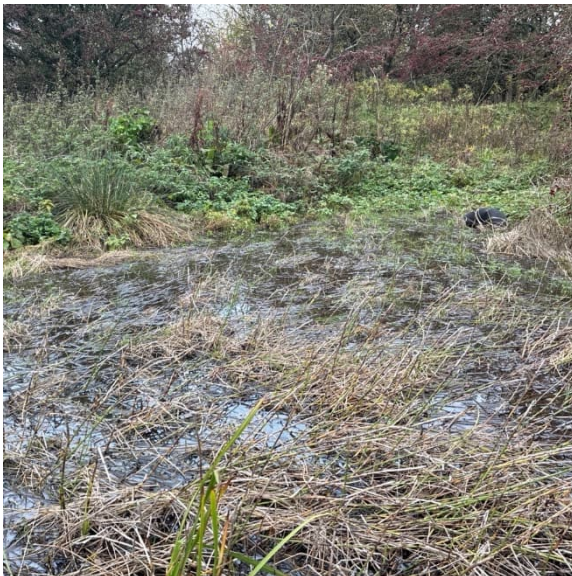
**Photograph 72. Waterbody XR.GCN.20**

A shallow, likely ephemeral pond with an average depth of 20cm. Due to its propensity for seasonal drying, it was not identified during the initial desk-based assessment. The pond is surrounded by abundantly distributed water forget-me-not. Other species present include occasional lesser spearwort, bur-reed, sweet-grass, soft rush and spike-rush.

| Suitability index | Habitat parameter | Field Score | HSI score |
|---|---|---|---|
| <b>Score: 0.57 (Below Average)</b> | | | |

Pond XR.GCN.20 and Pond XX.GCN.12 were not found during the initial desk study and were therefore not subject to eDNA sampling, though they were assessed as having 'Below Average' and 'Average' HSI ratings, respectively. However, no other waterbodies within the wider area returned a positive eDNA result, indicating that ponds XR.GCN.20 and XX.GCN.12 are not connected to ponds which support the species. Connectivity between ponds is important for GCN<sup>3</sup>, given that they occur in meta-populations, and a lack of connectivity to positive ponds reduces the likelihood that a pond would support the species. The lack of positive eDNA results as a whole (for this component of the project) suggests a broader absence of the species across the Site and Zol. Thus the species is considered absent from these ponds, and the lack of survey is not considered a significant limitation.

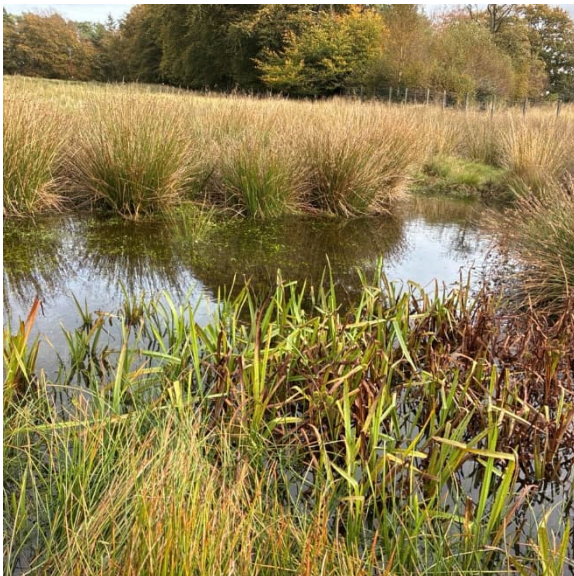
**Photograph 73. Waterbody XR.GCN.22**

| Suitability index | Habitat parameter | Field Score | HSI score |
|---|---|---|---|
| <b>Score: 0.54 (Below Average)</b> | | | |

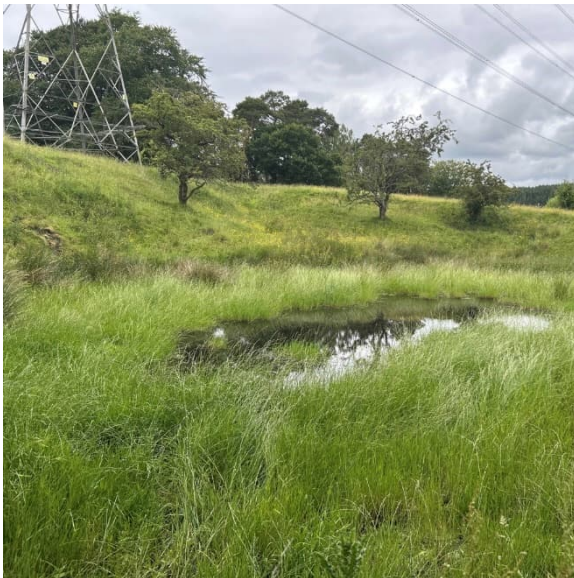
**Photograph 74. Waterbody XR.GCN.24**

| Suitability index | Habitat parameter | Field Score | HSI score |
|---|---|---|---|
| | | | <b>Score: 0.46 (Poor)</b> |

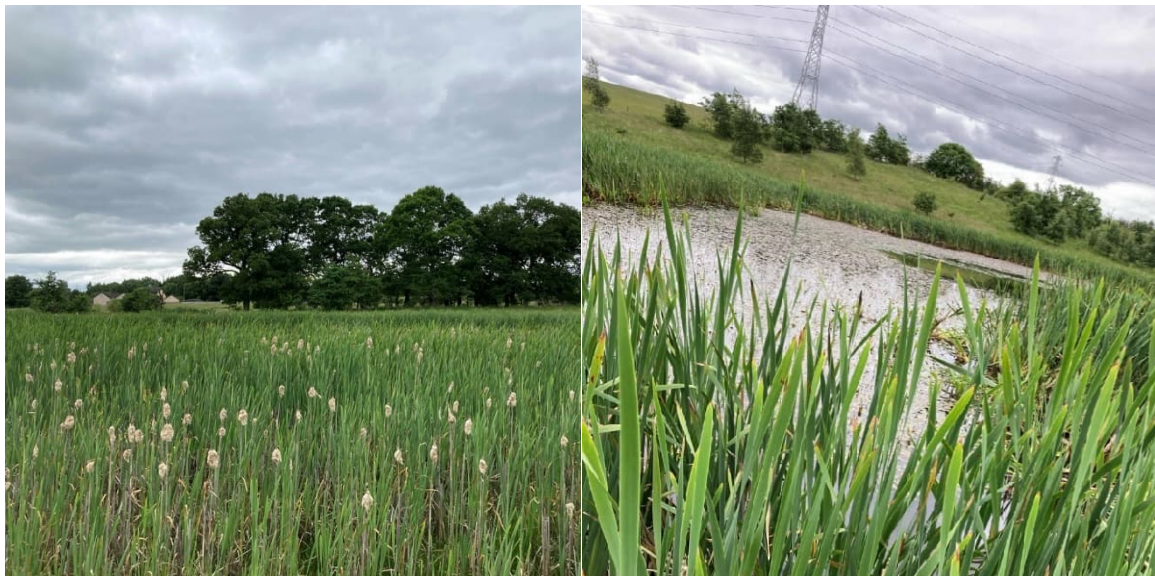
**Photographs 75 & 76. Waterbody XR.GCN.26**

A large pond within an area of marshy grassland, which likely has a deep central profile. The pond is surrounded by approximately 3m strip of inundated bulrush. The aquatic macrophyte community is dominated by pondweed and has rare water-plantain within. Ducks were observed at the time of survey.

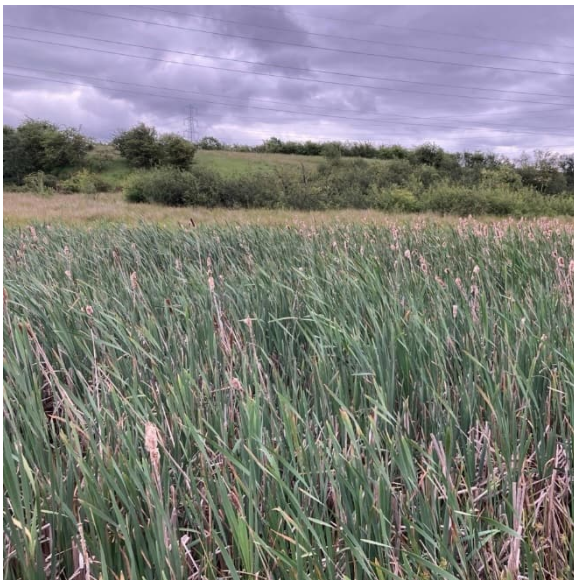
**Photograph 77. Waterbody XR.GCN.27**

| Suitability index | Habitat parameter | Field Score | HSI score |
|---|---|---|---|
| | | | <b>Score: 0.67 (Average)</b> |

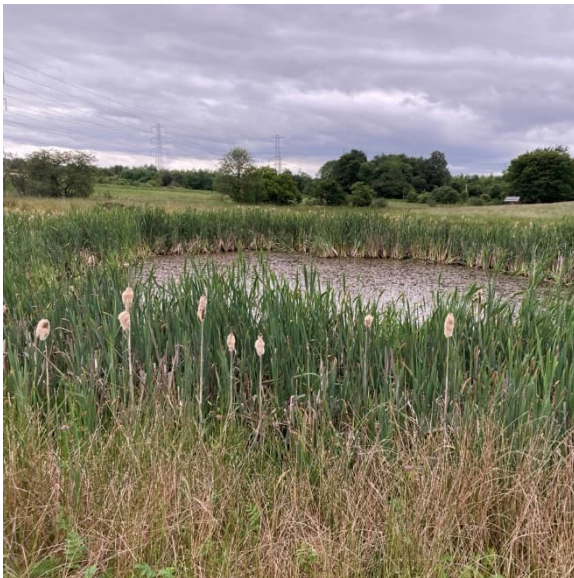
**Photograph 78. Waterbody XR.GCN.28**

A relatively deep pond surrounded by approximately 2m wide strip of dense bulrush and with localised patches of lesser spearwort and great willowherb. The surface of the pond is covered in pondweed.

| Suitability index | Habitat parameter | Field Score | HSI score |
|---|---|---|---|
| | | | <b>Score: 0.83 (Excellent)</b> |

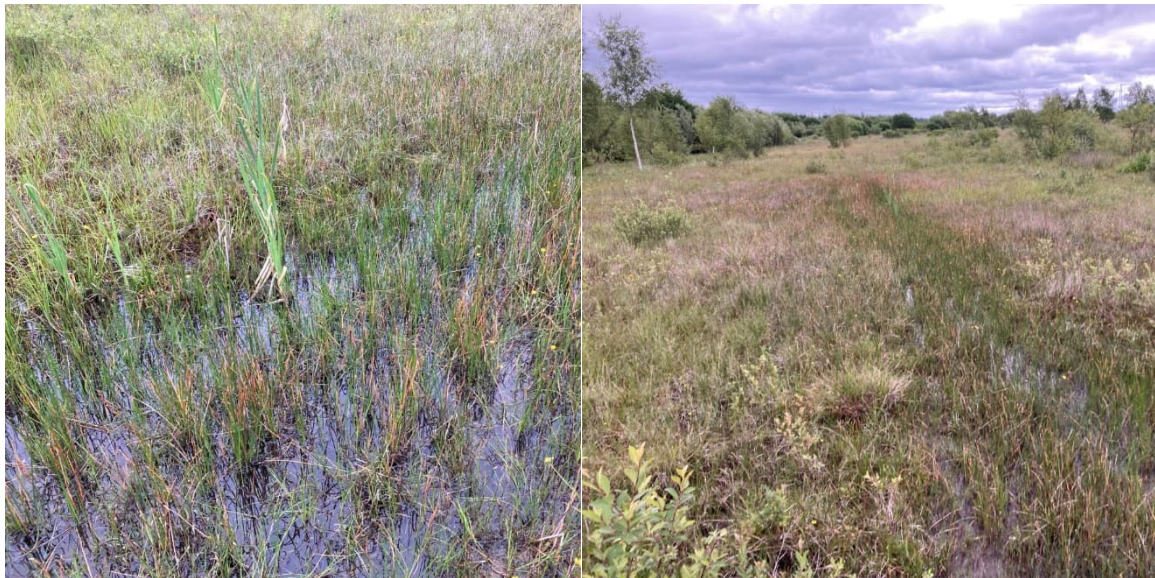
**Photographs 79 & 80. Waterbody XR.GCN.30**

| Suitability index | Habitat parameter | Field Score | HSI score |
|---|---|---|---|
| <b>Score: 0.58 (Below Average)</b> | | | |

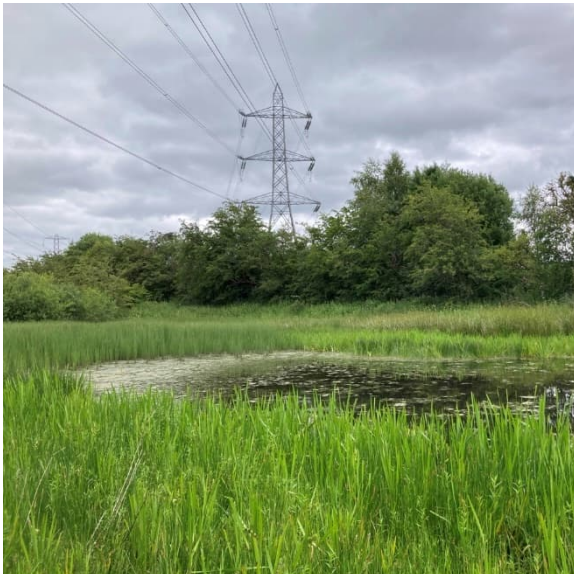
**Photograph 81. Waterbody XR.GCN.33**

| Suitability index | Habitat parameter | Field Score | HSI score |
|---|---|---|---|
| | | | <b>Score: 0.78 (Good)</b> |

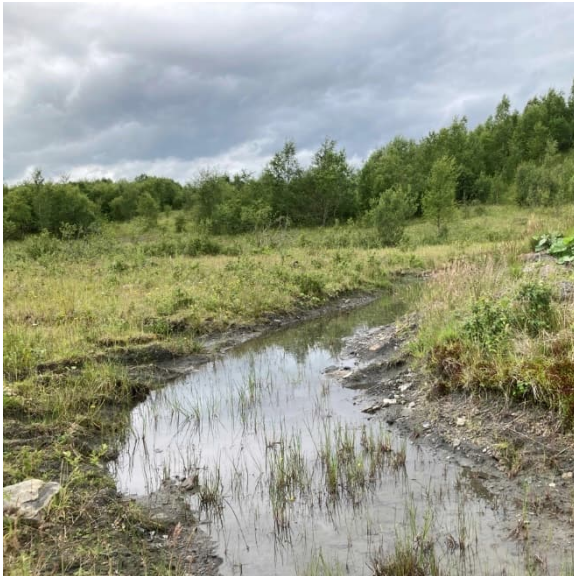
**Photograph 82. Waterbody XR.GCN.34**

A stagnant linear drainage waterbody, characterized by very shallow water levels and gently sloping, muddy banks. The substrate is predominantly silty, supporting sparse amounts of pondweed. The marginal vegetation is dominated by rushes, buttercup and horsetail species.

| Suitability index | Habitat parameter | Field Score | HSI score |
|---|---|---|---|
| | | | <b>Score: 0.49 (Poor)</b> |

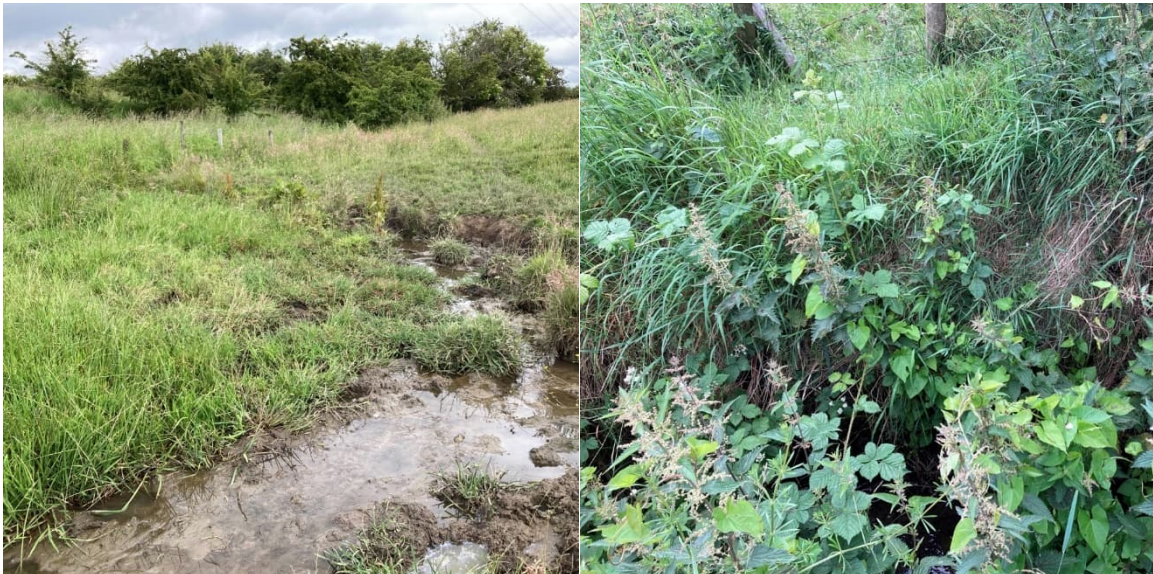
**Photographs 83 & 84. Waterbody XR.GCN.38**

| Suitability index | Habitat parameter | Field Score | HSI score |
|---|---|---|---|
| | | | <b>Score: 0.19 (Poor)</b> |

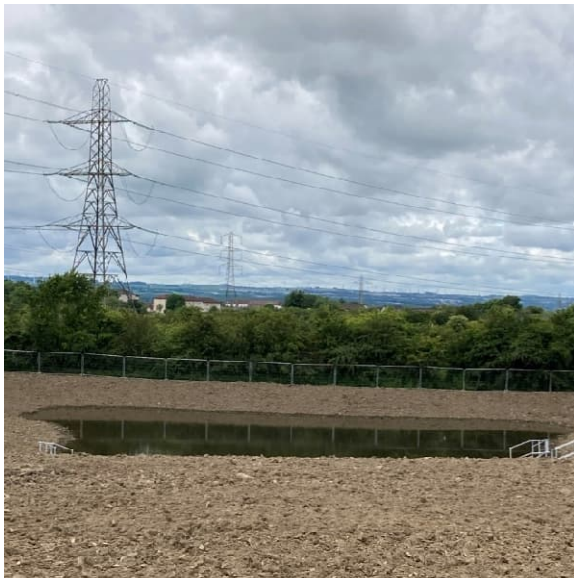
**Photograph 85. Waterbody XR.GCN.39**

A SuDS pond located within a secured construction area. The waterbody has high levels of turbidity and physical disturbance consistent with active site works. The banks are comprised of bare ground and lack any marginal vegetation.

| Suitability index | Habitat parameter | Field Score | HSI score |
|---|---|---|---|
| | | | <b>Score: 0.18 (Poor)</b> |

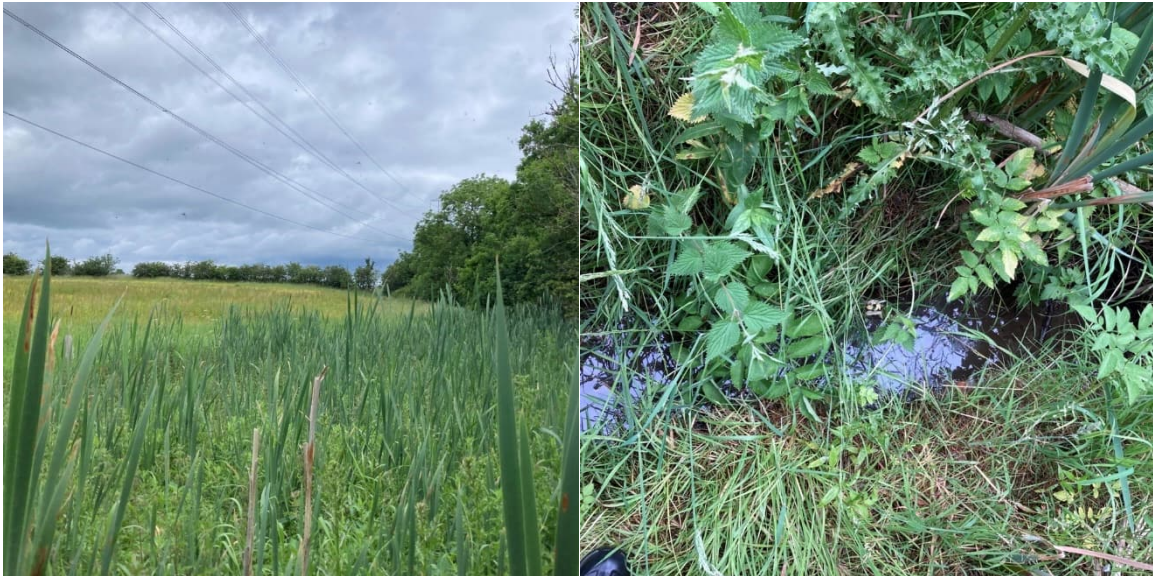
**Photographs 86 & 87. Waterbody XR.GCN.40**

A pond that is overgrown with bulrush. Other marginal vegetation includes meadowsweet *Filipendula ulmaria*, marsh-bedstraw *Galium palustre*, common nettle *Urtica dioica* and forget-me-not species.

| Suitability index | Habitat parameter | Field Score | HSI score |
|---|---|---|---|
| <b>Score: 0.64 (Average)</b> | | | |

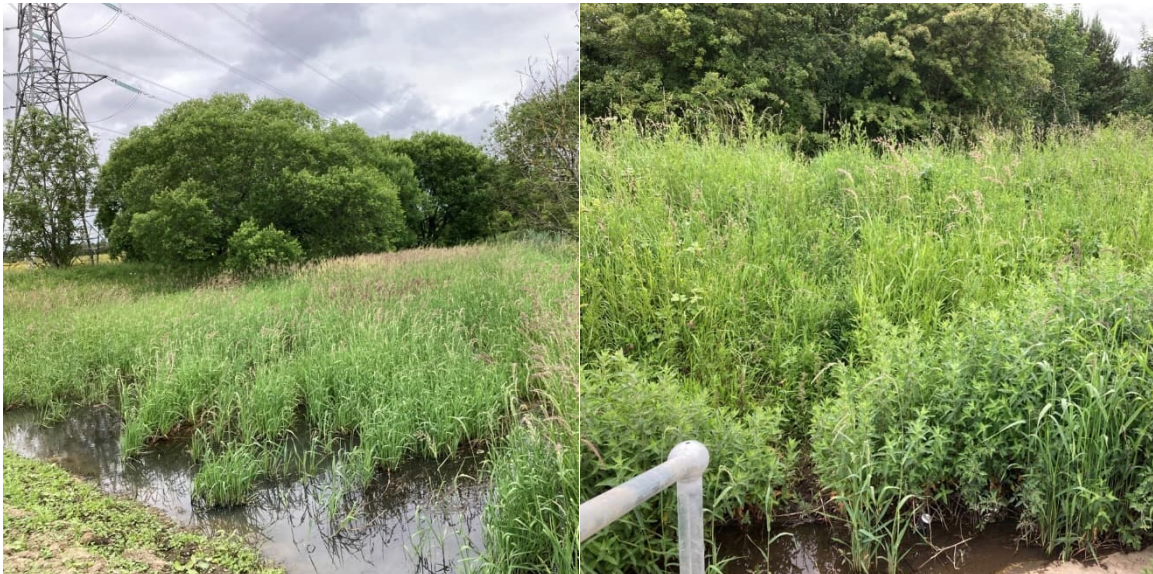
**Photographs 88 & 89. Waterbody XR.GCN.41**

An area of inundation resulting from overflow from an adjacent drainage ditch. The area is shallow and has a muddy substrate. The vegetation is dominated by reed canary-grass and has a marginal assemblage consisting of meadowsweet and creeping thistle *Cirsium arvense*.

| Suitability index | Habitat parameter | Field Score | HSI score |
|---|---|---|---|
| | | | <b>Score: 0.64 (Average)</b> |
