# Denny to Wishaw Network Upgrade

*Environmental Impact Assessment Report*

*Appendix 8.2 – Bat Survey Results – AA, CB and WB  
Lines*

*May 2026*

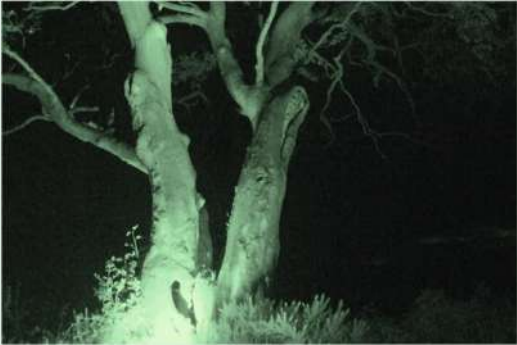
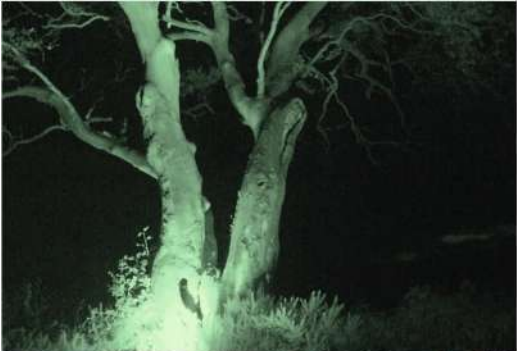
| Tree reference | Survey date | Photograph of the darkest point |
|---|---|---|
| WB.BT.46 | 27/08/2025 | |

| Tree Reference | Description | Feature Description | Location (OSGR) | Relationship to the Project | GLTA Suitability | Further assessment undertaken (Aerial) | Final suitability |
|---|---|---|---|---|---|---|---|
| WB.BT.46 | Mature beech | A large multi-stemmed tree with a DBH of approximately 2m. A south-facing rot feature at around 4m extends into a large internal cavity with additional openings suggesting the trunk may be hollow and potentially connected internally, resulting in damp conditions. Additionally at 2m, there is a north-east-facing opening that may extend into the above feature. | NS 84783 78710 | Located 4m east of the WB proposed access and 4m east of the WB access | PRF-M | Yes | PRF-M (but no emergence after 2 survey visits) |

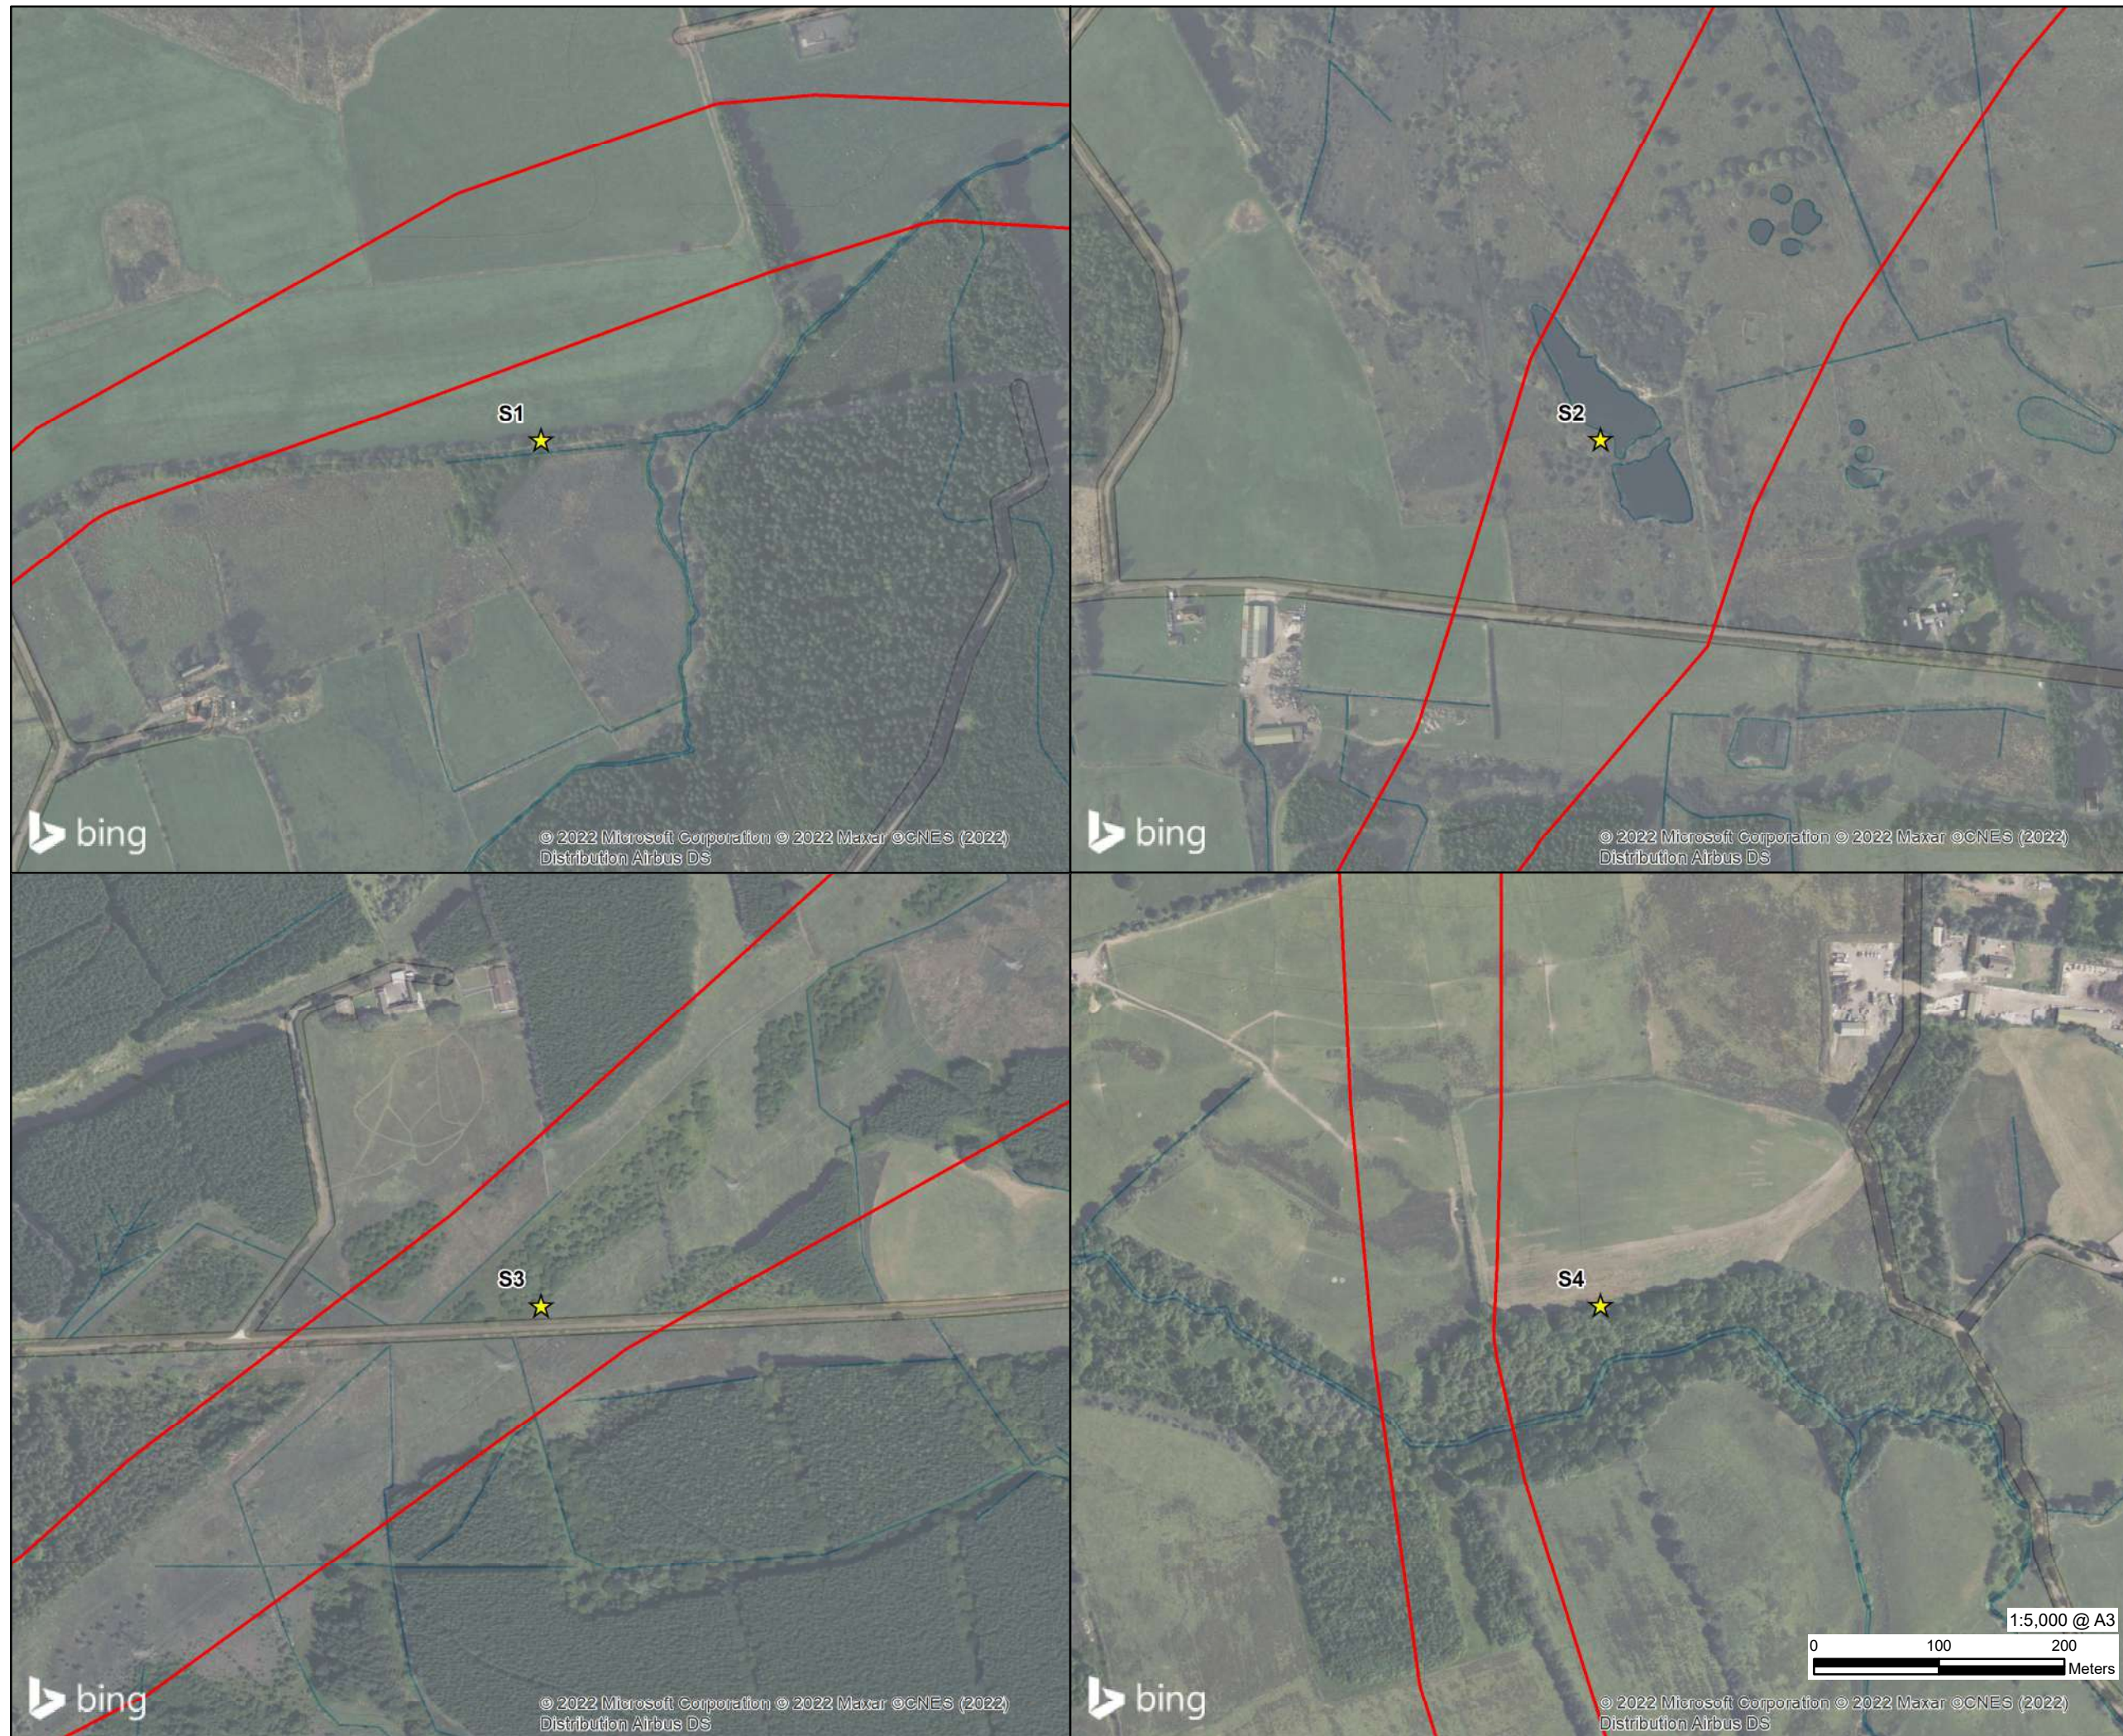
**FIGURE NUMBER**  
Figure 2

Figure 2 – Bat Survey Area

The transects are shown on Figure 2. Details of the transect surveys are given in Tables 5 and 6.

Static detectors were deployed to record general bat activity within the PRC over an extended period of time. The static detector locations were chosen to be representative of typical and more suitable bat habitat within the PRC, with two locations per transect. Static detector locations are shown on Figure 2 and Figure 3 (to give habitat context) and described in Table 7 along with details of deployment and recording periods. See limitations regarding deployments below.
