# Denny to Wishaw Network Upgrade

*Environmental Impact Assessment Report*

*Appendix 9.2 Watercourse Crossings*

*May 2026*

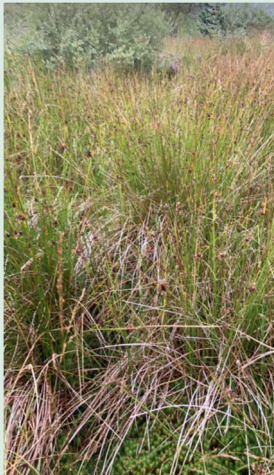
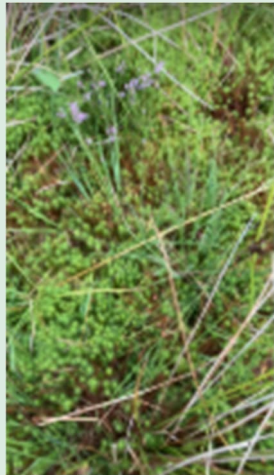
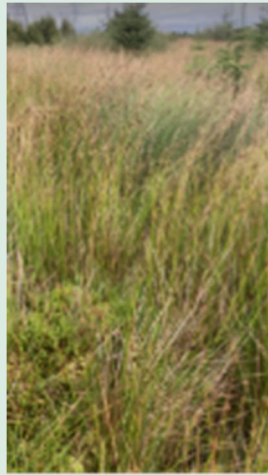
| Crossing ID | Watercourse ID | Location (NGR) | Weather and Flow Conditions | Channel Form and Riverbed Material | Estimated Channel Width and Depth | Existing WCC and Morphological Impacts | Vegetation/ Habitat and Poaching | Proposed Crossing Type and Proposed Mitigation | Photograph Upstream | Photograph Downstream | Photograph of Riverbed |
|---|---|---|---|---|---|---|---|---|---|---|---|
| Cr1 | RC1-1 | NS 82409 84312 | Dry, mild, overcast. | Artificial drainage channel. | Width 0.5 m<br>Depth undetermined due to vegetation growth. | No visible crossing at assessment point. | Grass, moss and a few conifers. | New temporary culvert to be installed.<br><br>To be constructed during dry period where possible, and flow over pumped where necessary to mitigate contamination. | | | |
| | | | No Flow. | Riverbed material obscured by dense vegetation and limited access. | | | No evidence of poaching. | | | | |

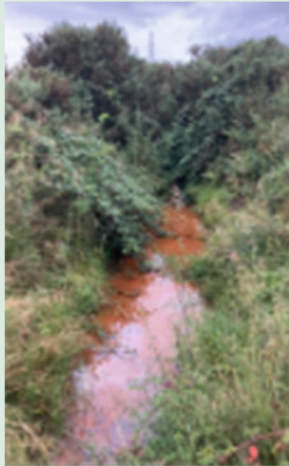
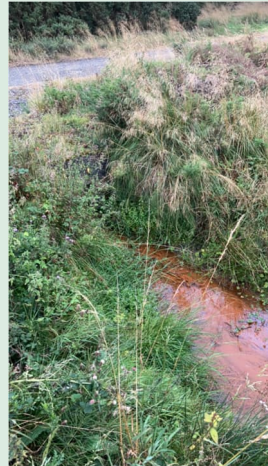
| Crossing ID | Watercourse ID | Location (NGR) | Weather and Flow Conditions | Channel Form and Riverbed Material | Estimated Channel Width and Depth | Existing WCC and Morphological Impacts | Vegetation/ Habitat and Poaching | Proposed Crossing Type and Proposed Mitigation | Photograph Upstream | Photograph Downstream | Photograph of Riverbed |
|---|---|---|---|---|---|---|---|---|---|---|---|
| Cr2 | PB-5 | NS 84130 83785 | Dry, mild, overcast. | Artificial drainage channel. | Width 2 m<br>Depth 2 m | Concrete culvert under road. | Grass, gorse, brambles and nettles. | Existing – none required. | | | |
| | | | No Flow. | Riverbed material obscured by dense vegetation and limited access. | | | No evidence of poaching. | | | | |

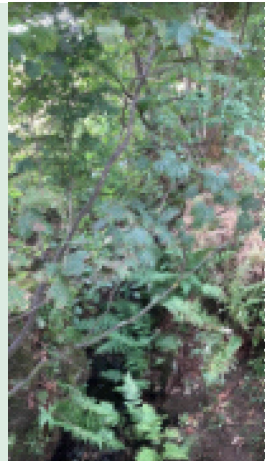
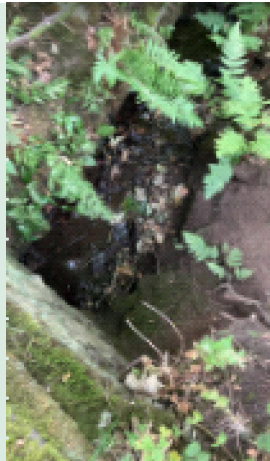
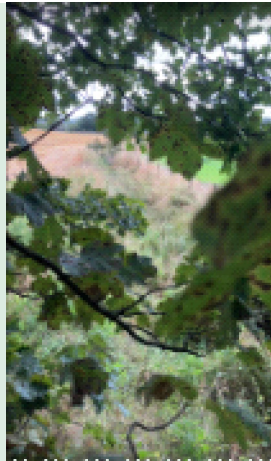
| Cr3 | RC2-1 | NS 83931 81896 | Dry, mild, overcast. | Artificial drainage channel. | Width 0.7 m<br>Depth 1 m | Stone culvert under road. | Trees, ferns and grass. | Existing – none required. | | | |
| | | | No Flow. | Cobbles and vegetation. | | | No evidence of poaching. | | | | |

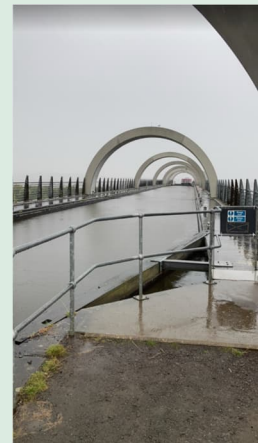
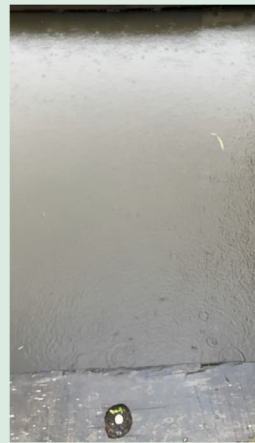
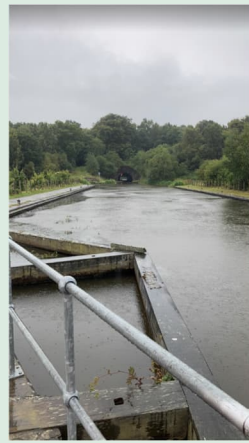
| Cr4 | UC (Union Canal) | NS 85246 80042 | Rain, cold. | Artificial canal. | Width 6 m<br>Depth 1.5 m | Tunnel to the South and rotating lock to the North. | Trees, grass. | Existing – none required. | | | |
| | | | Normal flow, normal energy. | Undetermined due to water level. | | | No evidence of poaching. | | | | |

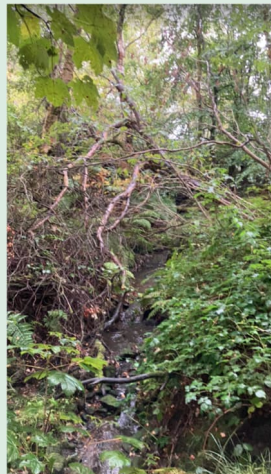
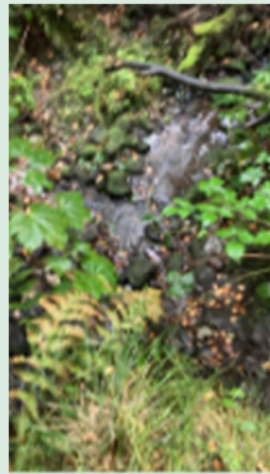
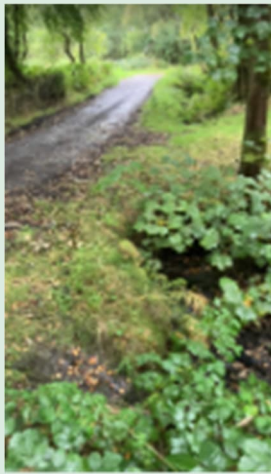
| Cr5 | BW-6 | NS 84490 78777 | Rain. | Step-pool river. | Width 2 m<br>Depth 1 m | Plastic culvert under road. | Trees, brambles, ferns. | New temporary culvert to be installed.<br><br>To be constructed during dry period where possible, and flow over pumped where necessary to mitigate contamination. | | | |
| | | | Moderate energy, moderate flow. | Cobbles and boulders. | | | No evidence of poaching. | | | | |

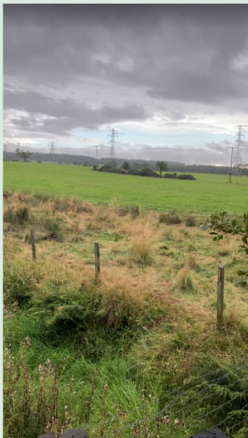
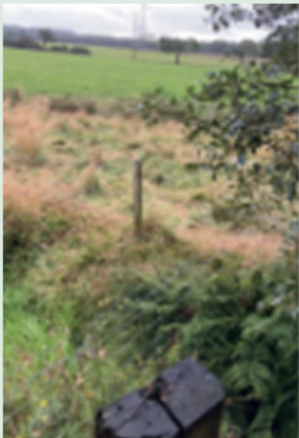
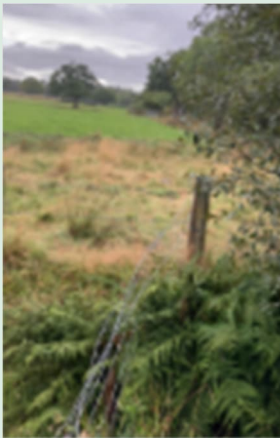
| Cr6 | BW-6 | NS 84489 78762 | Rain. | Artificial drainage channel. | Width 1 m | No visible crossing at assessment point. | Grass. | New temporary culvert to be installed. | | | |
| | | | No flow. | Riverbed material obscured by dense vegetation and limited access. | Poaching likely as in pasture field. | | To be constructed during dry period where possible, and flow over pumped where necessary to mitigate contamination. | | | | |

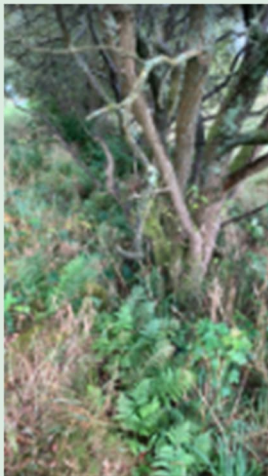
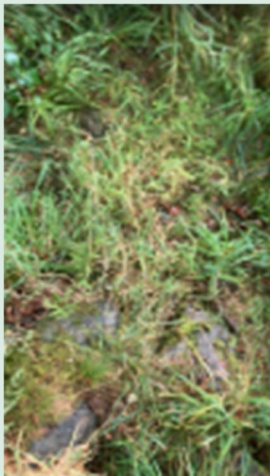
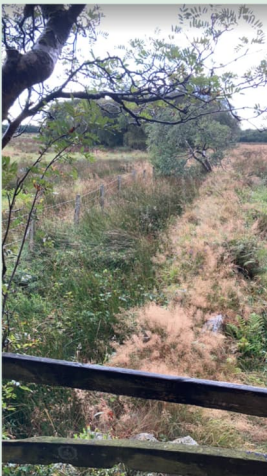
| Cr7 | BW-9 | NS 82980 78350 | Rain. | Artificial drainage channel. | Width 1 m | No visible crossing at assessment point. | Grass, ferns, trees. | New temporary culvert to be installed. | | | |
| | | | No flow. | Boulders and vegetation. | No evidence of poaching. | | To be constructed during dry period where possible, and flow over pumped where necessary to mitigate contamination. | | | | |

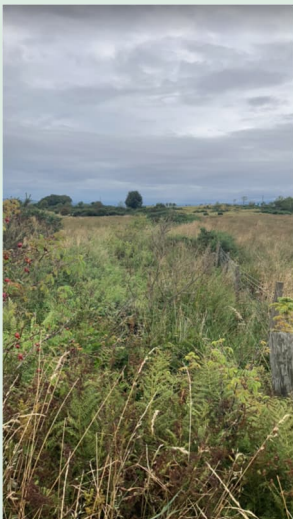
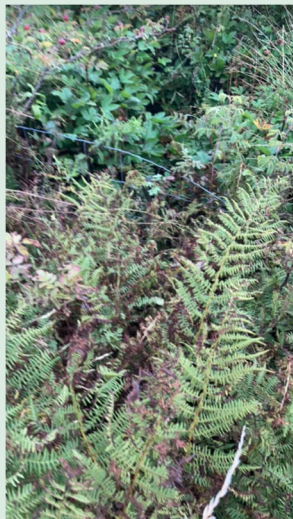
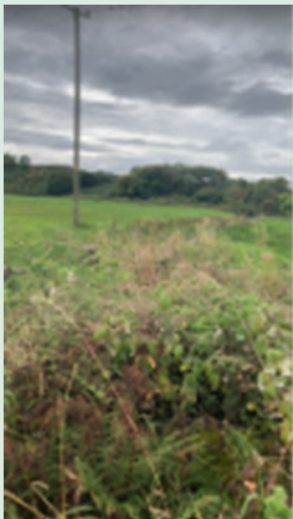
| Cr8 | BW-10 | NS 82573 77942 | Dry, overcast. | Artificial drainage channel. | Width 0.5 m | No visible crossing at assessment point. | Reeds, gorse, grass, ferns. | New temporary culvert to be installed. | | | |
| | | | No flow. | Riverbed material obscured by dense vegetation and limited access. | Poaching likely as in pasture field. | | To be constructed during dry period where possible, and flow over pumped where necessary to mitigate contamination. | | | | |

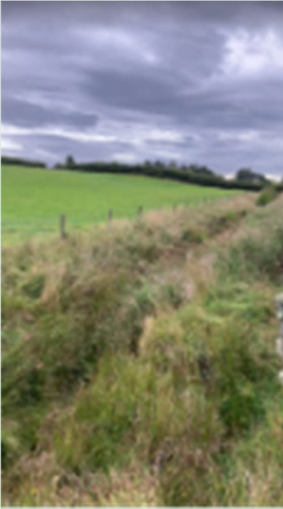
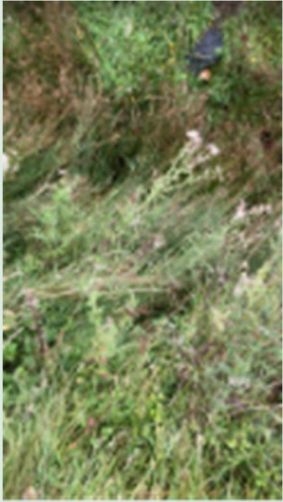
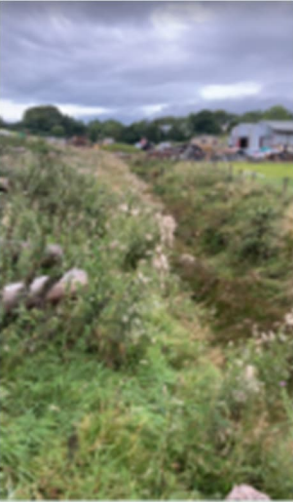
| Cr10 | BW-11 | NS 82176 77255 | Overcast, mild. | Artificial drainage channel. | Width 2 m<br>Depth 1 m | No visible crossing at assessment point. | Grass, gorse, thistles. | Existing – none required. | | | |
| | | | No flow. | Riverbed material obscured by dense vegetation and limited access. | | | | | | | |

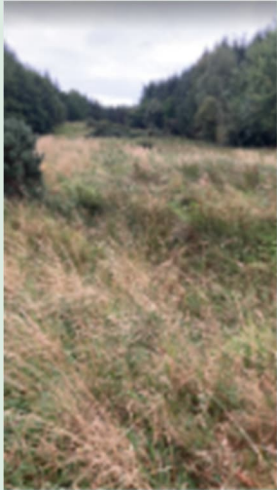
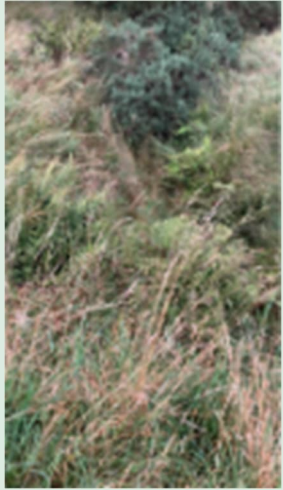
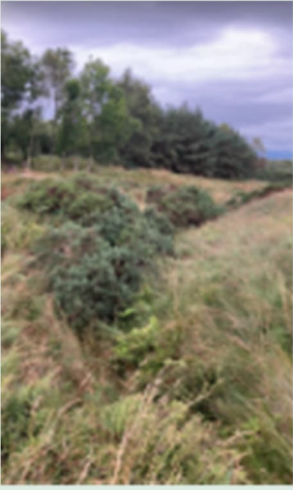
| Cr11 | BW-11 (Skipperton Burn) | NS 82171 77056 | Overcast, mild. | Artificial drainage channel. | Width 1.5 m<br>Depth 1.5 m | Not confirmed if there is an existing crossing at crossing point. | Grass, ferns, gorse. | Existing – none required. | | | |
| | | | No flow. | Riverbed material obscured by dense vegetation and limited access. | | | | | | | |

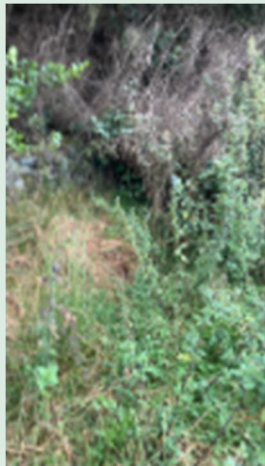
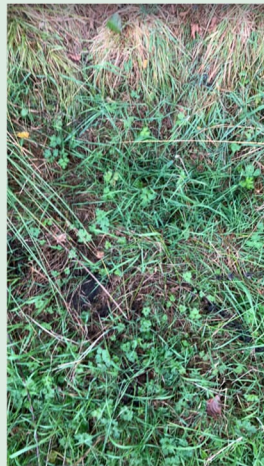
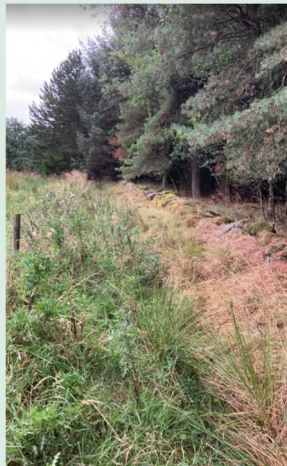
| Cr13 | BW-11<br>(Skipperton Burn) | NS 82024<br>76715 | Overcast, mild. | Artificial drainage channel. | Width 0.5 m<br>Depth 0.5 m | No visible crossing at assessment point. | Grass, nettles, trees. | necessary to mitigate contamination. | | | |
| | | | No flow. | Riverbed material obscured by dense vegetation and limited access. | | | No evidence of poaching. | To be constructed during dry period where possible, and flow over pumped where necessary to mitigate contamination. | | | |

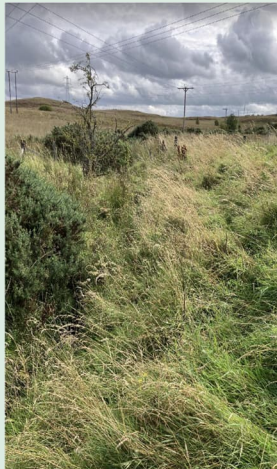
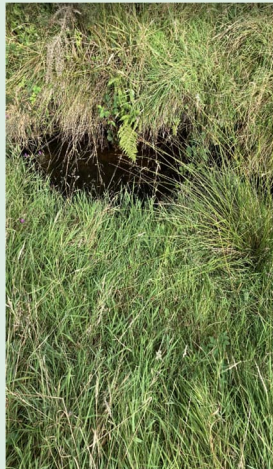
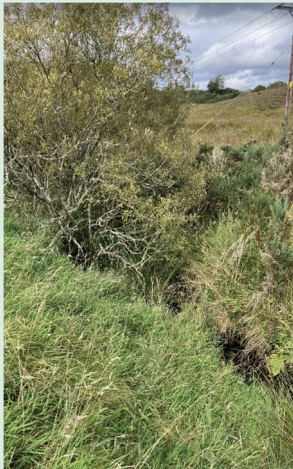
| Cr14 | BW-12<br>(Walton Burn) | NS 80699<br>75823 | Overcast, hot. | Bedrock channel. | Width 0.8 m<br>Depth 1.2 m | No visible crossing at assessment point. | Grass, trees, gorse. | New temporary culvert to be installed. | | | |
| | | | Low energy, low flow. | Low gradient passively meandering. | | | No evidence of poaching. | To be constructed during dry period where possible, and flow over pumped where necessary to mitigate contamination. | | | |
| | | | | Gravel, cobbles, vegetation. | | | | | | | |

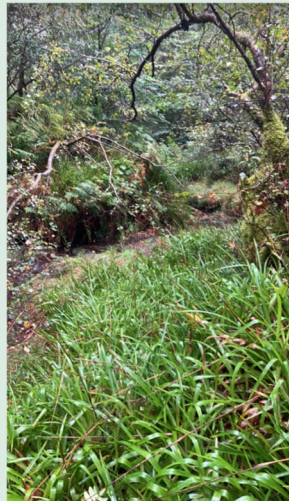
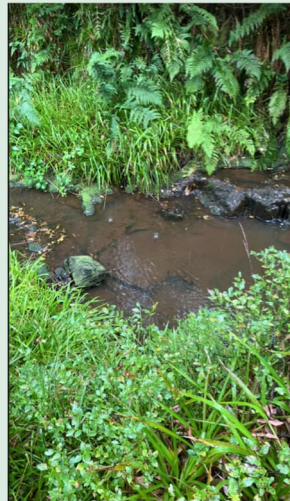
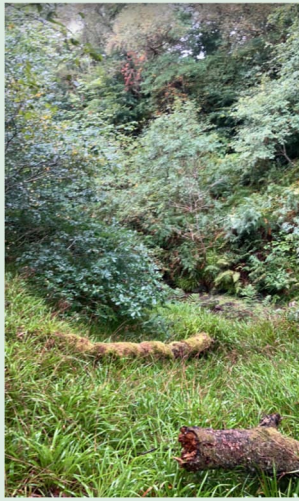
| Cr15 | BW-27<br>(Glencryan Burn) | NS 78116<br>73877 | Rain. | Bedrock channel. | Width 1.5 m<br>Depth 0.4 m | Not confirmed if there is an existing crossing at crossing point. | Trees, ferns, moss. | New temporary culvert to be installed. | | | |
| | | | Low flow, moderate energy. | Boulders, cobbles, bedrock. | | | No evidence of poaching. | To be constructed during dry period where possible, and flow over pumped where necessary to mitigate contamination. | | | |

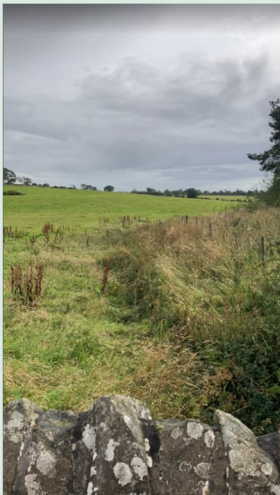
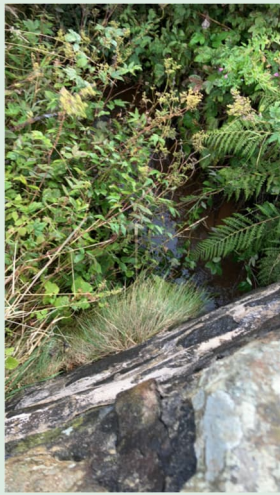
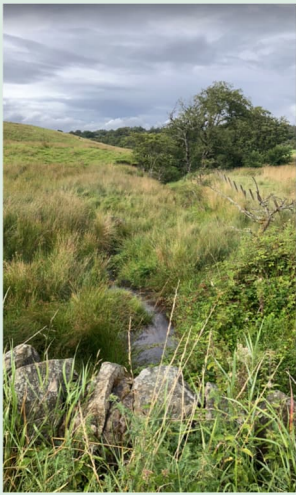
| Cr16 | LW-13 | NS 78250 71828 | Rain, cold. | Bedrock channel. | Width 1 m<br>Depth 0.8 m | Culvert under road. | Grass. | New temporary culvert to be installed. | | | |
| | | | Low flow, low energy. | Low gradient passively meandering. | | Not confirmed if there is an existing crossing at crossing point. | Poaching likely as in pasture field. | To be constructed during dry period where possible, and flow over pumped where necessary to mitigate contamination. | | | |
| | | | | Riverbed material obscured by dense vegetation and limited access. | | | | | | | |

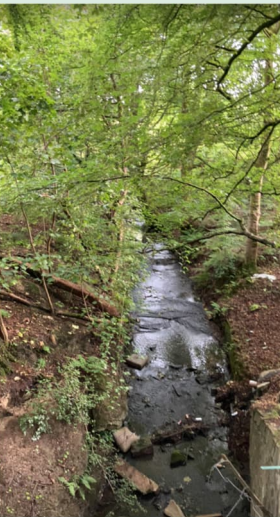
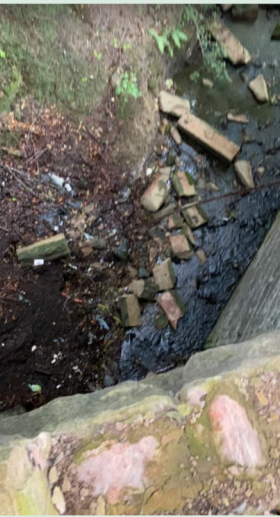
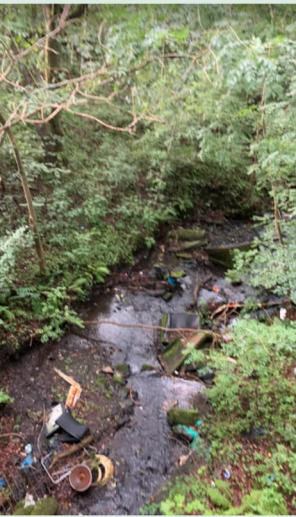
| Cr18 | LW-4<br>(Shank Burn) | NS 76100 69946 | Rain, cold. | Bedrock channel. | Width 3 m<br>Depth 4 m | Walled banks and bridge. | Trees, ferns. | New temporary culvert to be installed. | | | |
| | | | Moderate. | Bedrock, cobbles. | | Not confirmed if there is an existing crossing at crossing point. | No evidence of poaching. | To be constructed during dry period where possible, and flow over pumped where necessary to mitigate contamination. | | | |

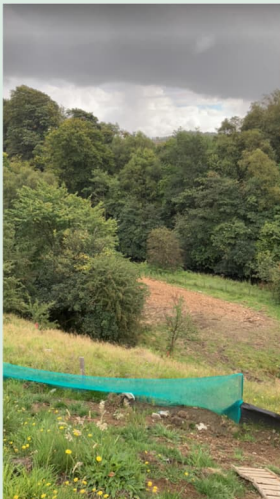
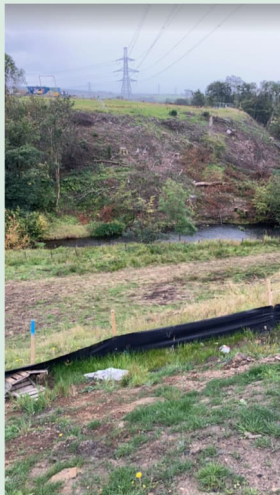
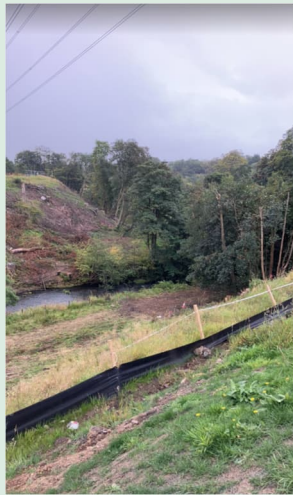
| Cr19 | NCW1<br>(North Calder Water) | NS 79044<br>65898 | Overcast, mild. | Low gradient passively meandering. | Width 4 m<br>Depth 1 m | Not confirmed if there is an existing crossing at crossing point. | Grass, reed, trees. | Existing – none required. | | | |
| | | | Normal flow, moderate energy. | Boulders. | No evidence of poaching. | | | | | | |

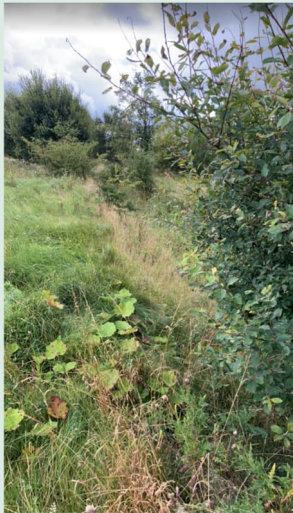
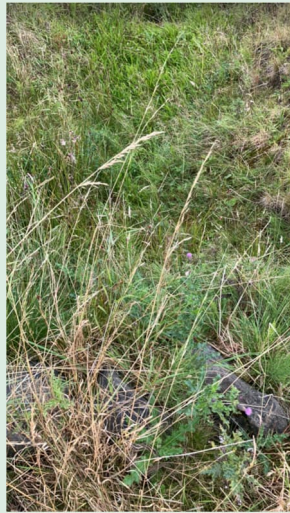
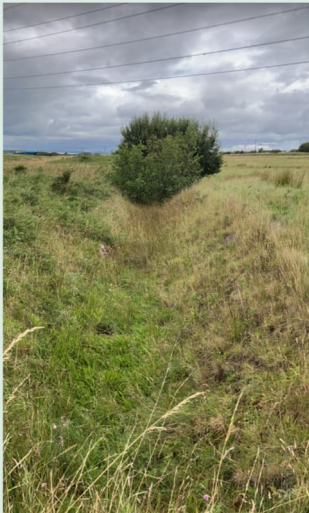
| Cr21 | ShirrelB<br>(Shirrel Burn / Thankerton Burn / Legbranock Burn) | NS 79065<br>60676 | Sunny, dry. | Artificial drainage channel. | Width 2.5 m<br>Depth 1 m | Existing road crossing. | Trees, grass. | New temporary culvert to be installed. | | | |
| | | | No flow. | Riverbed material obscured by dense vegetation and limited access. | No evidence of poaching. | | To be constructed during dry period where possible, and flow over pumped where necessary to mitigate contamination. | | | | |

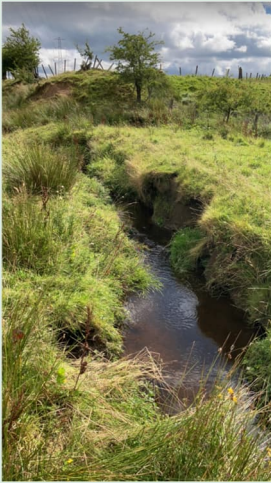
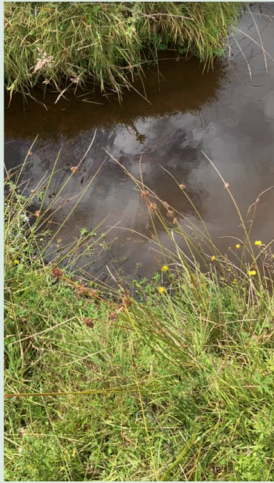
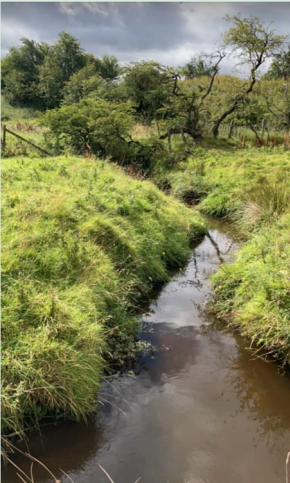
| Cr22 | TB (Tillan Burn) | NS 80243 60164 | Sunny, dry, hot. | Low gradient passively meandering. | Width 1 m<br>Depth 1 m | No visible crossing at assessment point. | Grass, trees.<br><br>Poaching likely as in pasture field. | New temporary culvert to be installed.<br><br>To be constructed during dry period where possible, and flow over pumped where necessary to mitigate contamination. | | | |
| | | | Low flow, low energy. | Gravel, sand. | | | | | | | |

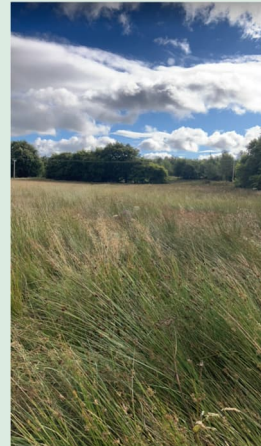
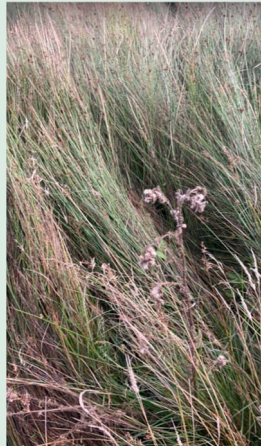
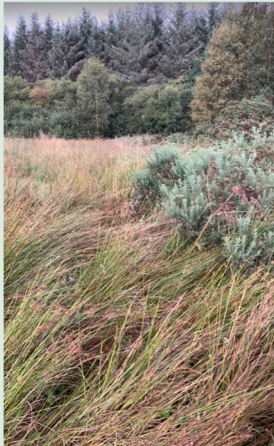
| Cr23 | AW-9 | NS 84747 56901 | Sunny, dry. | No watercourse identified at location. | Unknown. | No visible crossing at assessment point. | Grass, reeds.<br><br>No evidence of poaching. | New temporary culvert to be installed.<br><br>To be constructed during dry period where possible, and flow over pumped where necessary to mitigate contamination. | | | |
| | | | No flow. | | | | | | | | |

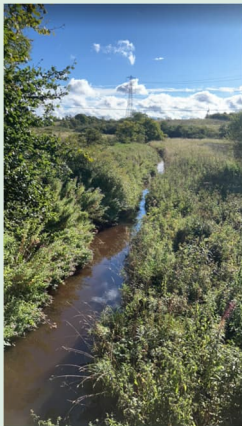
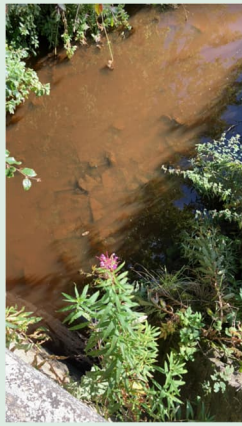
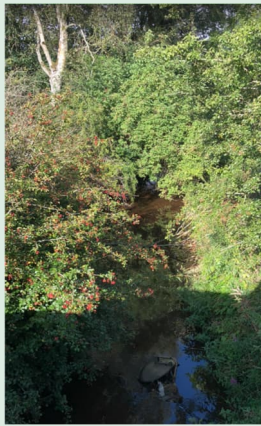
| Cr24 | AW (Auchter Water) | NS 83511 54989 | Sunny, dry. | Low gradient passively meandering. | Width 1.5 m<br>Depth 1.5 m | Bridge at road. Aerial imagery shows there to be an existing crossing at crossing point. | Trees, grass, nettles.<br><br>No evidence of poaching. | Existing – none required. | | | |
| | | | Low flow, low energy. | Gravel, boulders. | | | | | | | |
