# **ECU – LWUP XL Route Refurbishment**

## **Ecological Walkover**

| <b>Document:</b> | <b>BOWS23.097 ECU – LWUP XL Route Ecological Walkover Report</b> | | | |

- 1.1 Bowland Ecology Ltd. was commissioned by Scottish Power Energy Networks (SPEN) to undertake an ecological walkover of the XL overhead line (OHL) running between the former Kincardine Power Station (NS923885) and the transmission license boundary at Blairingone (NS981966). This pertains to scheduled reconductoring works along the route, including the replacement of existing conductors between XL001A to XL006, the replacement of existing conductors between XL007 to XL031 (excluding XL006 to XL007), the replacement of existing downloads and associated fittings at Kincardine substation and the replacement and/or upgrade of damaged / corroded tower steelwork where required between XL001A-XL006 and XL007-XL031. The commencement of works is scheduled for Autumn 2024.

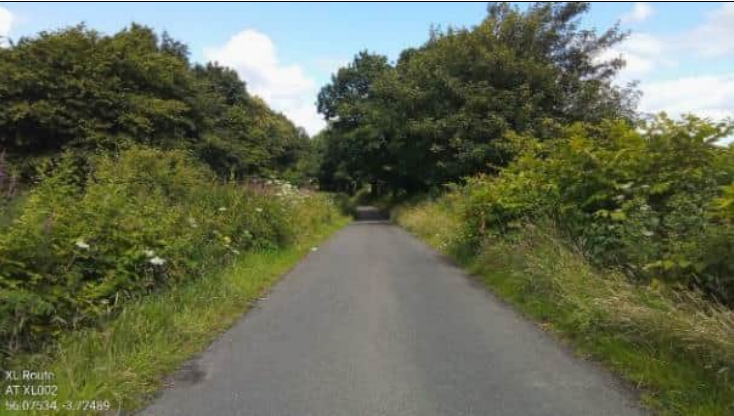
| XL002 | | <p><b>Access Track</b><br/>The access track to the tower is a paved B-road, lined with neutral grasses and ruderals on the west verge and a species-poor intact <b>hedgerow with mature trees</b> on the east verge. Tree species include oak, sycamore, and ash. Several trees have features including knot holes, lifted bark and cavities offering <b>bat roost potential for multiple bats (PRF-M; TN1)</b>. At the junction of the A977, there is a parcel of <b>mixed broadleaf plantation woodland</b>. The plantation is listed on the <b>AWI as long-established</b> and includes oak, willow, birch and beech. No features suitable for roosting bats was observed.</p> <p>The hedgerow and trees also provide habitat for <b>nesting birds, foraging and commuting bats, and foraging and commuting badger</b>.</p> <p>Two stands of <b>Japanese knotweed</b> are present on the verge of the B-road (TN2/3).</p> <p><b>XL002</b><br/><u>Access was not possible within the substation compound.</u> The area surrounding the tower comprises an arable field, a species-poor intact <b>hedgerow with mature trees</b>, and a paved road to the north, and an area of previously disturbed ground covered in scrub and ruderal species to the south within the substation grounds. The scrub includes birch, ash, and rose sp. The scrub provides habitat for <b>nesting birds</b>. There are still some areas of hardstanding, hardcore and boulders which provide suitable basking habitat for <b>reptiles</b>.</p> | <b>Priority Habitat Loss:</b> potential loss or damage of <b>hedgerow</b> around base of tower and along access track may result in the fragmentation of habitats in the area. Impacts to retained hedgerows may include physical damage to root systems during the works. | <b>Hedgerow retention where possible.</b> If not possible, replace the lost habitat. Implement best practice measures detailed in the report above. |

| | | | <b>Long-Established Plantation:</b> potential loss or damage of <b>woodland</b> habitat along access track. While it is unknown if tree felling or pruning is anticipated, impacts to trees can also include physical damage to root systems during the works. | <b>Woodland retention where possible.</b> If not possible, replace the lost habitat. Implement best practice measures detailed in the report above. |

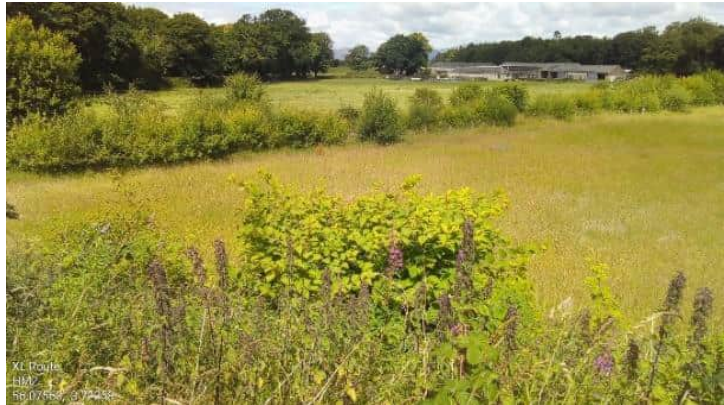
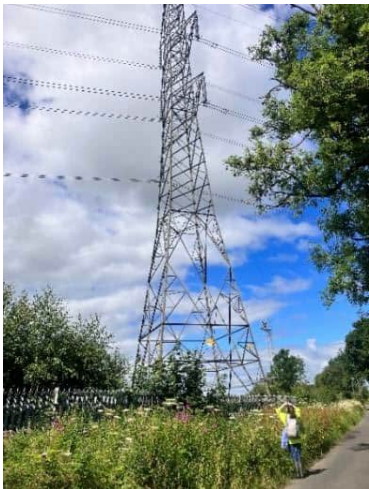
| | | | <b>Roosting Bats:</b> it is unknown whether tree felling or pruning is anticipated; however, if required, the removal or pruning of a tree may result in the disturbance, killing and injury of bats. | <b>Avoid felling/pruning of tree/branches.</b> If not possible, then further bat surveys (e.g., aerial tree assessment, emergence surveys) should be undertaken. |

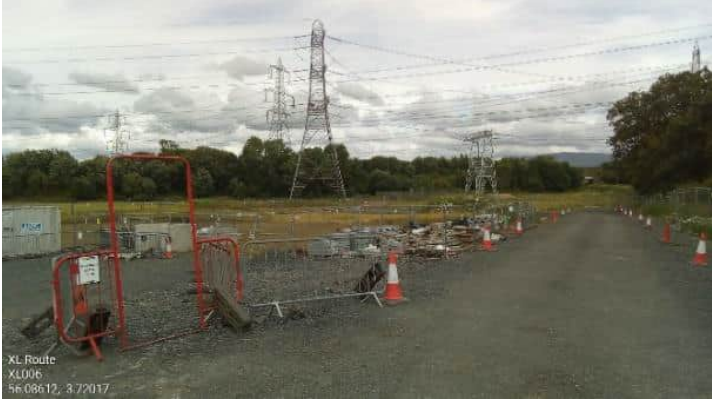
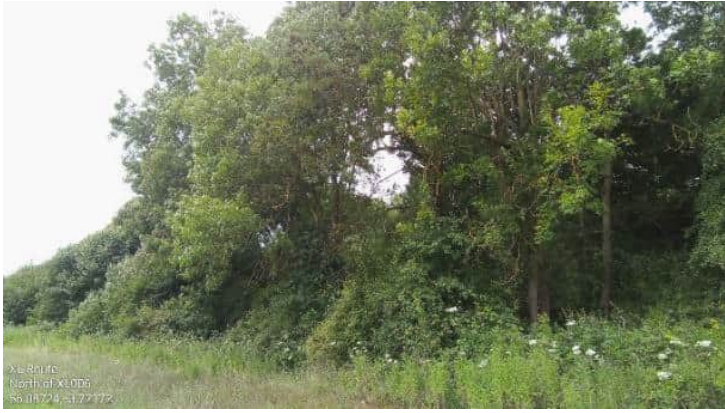
| XL006 | | <p><u>Access Track</u><br/>The access track to the tower is located within a SPEN CDM compound, and passes through an area of gravel, and previously disturbed ground with short grass and ruderal species pushing through.</p> <p><u>XL006</u><br/>The area surrounding the tower comprises predominantly gravel surface and disturbed ground with short grass and ruderal species pushing through. A metal fence surrounds the CDM area. To the south, there is an arable field (wheat), to the north there is an enclosed sealing end platform, and to the west there is a strip of semi-improved grassland, <b>scrub and semi-natural deciduous woodland</b> running alongside the banks of the railway line. <b>No bat roost potential was found within these trees.</b></p> <p>The scrub/woodland provides habitat for <b>nesting birds, foraging/commuting bats, and foraging/commuting badgers.</b> The steep banks also offer suitable habitat for <b>badger sett construction</b>; however, a dedicated search of this area was not undertaken due to access issues.</p> | <p><b>Priority Habitat Loss:</b> potential loss or damage of <b>woodland</b> habitat around base of tower and along access track. While it is unknown if tree felling or pruning is anticipated, impacts to trees can also include physical damage to root systems during the works.</p> <p><b>Nesting Birds:</b> any potential vegetation clearance (trees, scrub, and grassland), and vehicle tracking have the potential to damage/destroy nests and kill/injure nesting birds. <b><u>Birds may also nest within the tower at any time.</u></b></p> <p><b>Commuting/Foraging Badger:</b> commuting/foraging badger may be present along the woodland strip and grassland. Activities associated with the works carry a risk of short-term disturbance to badger through increased noise, vibrations, and human presence. There is potential for holes to be excavated by badgers.</p> <p><b>Commuting/Foraging Bats:</b> any potential removal of trees may result in a reduction in the availability of bat foraging and commuting habitat within the site and in the immediate vicinity. Any lighting associated with works has the potential to deter bats from using foraging and commuting habitats.</p> <p><b>Sett-Building Badger:</b> there is potential for holes to be excavated by badgers, especially along the steep wooded bank.</p> | <p><b>Woodland retention where possible.</b> If not possible, replace the lost habitat. Implement best practice measures detailed in the report above.</p> <p>Prior to any vegetation clearance/works to the tower and vehicular tracking, <b>a pre-works check for nesting birds will be required</b> by an ecologist, if the works will occur within nesting bird season (March to September).</p> <p>Implementation of precautionary measures with respect to commuting/ foraging badger detailed in the report above.</p> <p><b>Avoid/minimise any loss or fragmentation of foraging and commuting habitat.</b> Where this is not possible replace the lost habitat. Trees should remain dark to allow bats to commute.</p> <p>Prior to any vegetation clearance/works to the tower and vehicular tracking, <b>a pre-works check for badger signs, including any sett entrances, is advised.</b> This should be undertaken by a qualified ecologist.</p> |

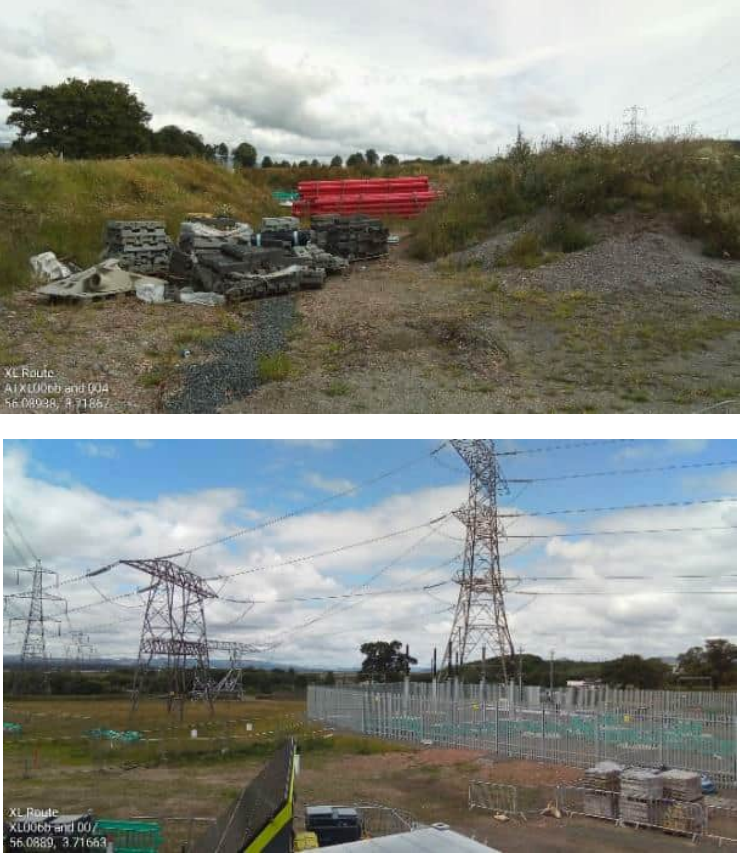
| XL006B | | <p><u>Access Track</u><br/>The access track to the tower is located within a SPEN CDM compound, and passes through an area of gravel, and previously disturbed ground (large spoil heaps) with short grass and ruderal species pushing through.</p> <p><u>XL006B</u><br/>The area surrounding the tower comprises predominantly semi-improved neutral grassland, with some bare ground, gravel, and an enclosed platform surrounded by a metal palisade fence. A representative from SPEN noted that <b>brown hares</b> are frequently observed in the grassland.</p> | <p><b>Nesting Birds:</b> any potential vegetation clearance (grassland), and vehicle tracking have the potential to damage/destroy nests and kill/injure nesting birds. <b><u>Birds may also nest within the tower at any time.</u></b></p> <p><b>Commuting/Foraging Badger:</b> commuting/foraging badger may be present within the grassland. Activities associated with the works carry a risk of short-term disturbance to badger through increased noise, vibrations, and human presence. There is potential for holes to be excavated by badgers.</p> <p><b>Small Mammals:</b> vegetation clearance and vehicle tracking risk causing harm or mortality to brown hares.</p> | <p>Prior to any vegetation clearance/works to the tower and vehicular tracking, <b>a pre-works check for nesting birds will be required</b> by an ecologist, if the works will occur within nesting bird season (March to September).</p> <p>Implementation of precautionary measures with respect to commuting/ foraging badger detailed in the report above.</p> <p>Implementation of precautionary measures with respect to small mammals detailed in the report above.</p> |

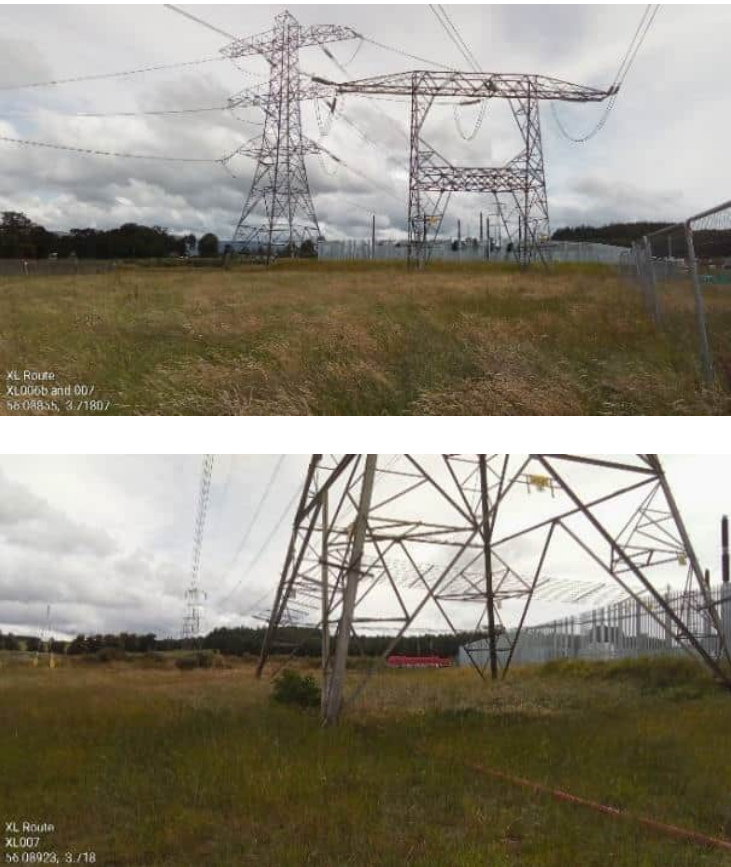
| XL007 | | <p><u>Access Track</u><br/>The access track to the tower is the same as described under XL006B.</p> <p><u>XL007</u><br/>The tower is adjacent to XL006B and is surrounded by the same habitats including semi-improved neutral grassland, bare ground, gravel, and enclosed electrical platforms surrounded by metal palisade fences.</p> | <p><b>Nesting Birds:</b> any potential vegetation clearance (grassland), and vehicle tracking have the potential to damage/destroy nests and kill/injure nesting birds. <b><u>Birds may also nest within the tower at any time.</u></b></p> | <p>Prior to any vegetation clearance/works to the tower and vehicular tracking, <b>a pre-works check for nesting birds will be required</b> by an ecologist, if the works will occur within nesting bird season (March to September).</p> |

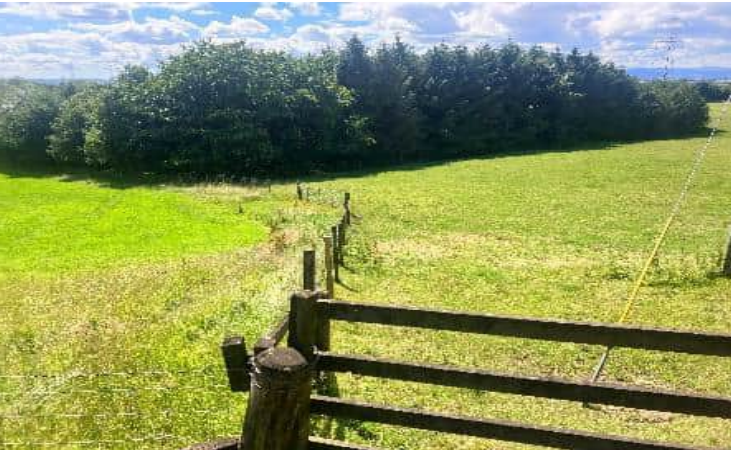
| XL008 | | <p><b>Access Track</b><br/>The access track follows a paved road to Tulafale Farm, bordered by a <b>drystone wall</b> and <b>mixed plantation woodland</b> to the north, and a <b>line of mature trees</b> including oak, horse chestnut, sycamore, and lime to the south. Due to their age, several of these trees likely have features offering <b>bat roost potential</b>, however, a thorough ground search was not possible due to leaf coverage (TN10). The drystone wall offers suitable refugia habitat for <b>small mammals, amphibians and reptiles</b>.</p> <p><u>XL008</u><br/>The area surrounding the tower comprises predominantly poor semi-improved grassland grazed by cattle, with an enclosed parcel of Douglas fir plantation to the southeast.</p> <p>Grassland, trees and plantation woodland provide habitat for <b>nesting birds, foraging/commuting bats, and foraging/commuting/sett-constructing badgers</b>. The plantation may also offer suitable habitat for <b>red squirrels</b> as an individual was observed nearby at XL010.</p> | <p><b>Roosting Bats:</b> It is unknown if any tree felling or pruning is anticipated; however, if required, the removal or pruning of a tree may result in the disturbance, killing and injury of bats.</p> <p><b>Drystone Wall:</b> any removal of the wall, if required, has the potential to damage and destroy nests and kill/injure nesting birds, small mammals, amphibians, and reptiles.</p> <p><b>Nesting Birds:</b> any potential vegetation clearance (trees, woodland, grassland), and vehicle tracking have the potential to damage/destroy nests and kill/injure nesting birds. <b><u>Birds may also nest within the tower at any time.</u></b></p> <p><b>Commuting/Foraging Badger:</b> commuting/foraging badger may be present within the plantation and grassland. Activities associated with the works carry a risk of short-term disturbance to badger through increased noise, vibrations, and human presence. There is potential for holes to be excavated by badgers.</p> <p><b>Sett-Building Badger:</b> there is potential for holes to be excavated by badgers, especially within the plantation woodland.</p> | <p><b>Avoid felling/pruning of tree/branches.</b> If not possible, then further bat surveys (e.g., aerial tree assessment, emergence surveys) should be undertaken.</p> <p><b>Retain wall where possible.</b> If required, removal and deconstruction of the wall should be undertaken by hand with an ECoW present as there is a risk of individuals present at any time during the year.</p> <p>Prior to any vegetation clearance/works to the tower and vehicular tracking, <b>a pre-works check for nesting birds will be required</b> by an ecologist, if the works will occur within nesting bird season (March to September).</p> <p>Implementation of precautionary measures with respect to commuting/ foraging badger detailed in the report above.</p> <p>Prior to any vegetation clearance/works to the tower and vehicular tracking, <b>a pre-works check for badger signs, including any sett entrances, is advised.</b> This should be undertaken by a qualified ecologist.</p> |

| | | | | <p><b>Red Squirrel:</b> activities associated with the works carry a risk of short-term disturbance to red squirrel through increased noise, lighting and human presence. Any tree felling/pruning, if required, has the potential to damage or destroy a drey, or disturb/injure/kill a red squirrel.</p> | Implementation of precautionary measures with respect to red squirrel as detailed in the report above. Prior to any tree felling/pruning, a <b>pre-works check</b> for squirrel signs, including dreys, is advised. This should be undertaken by a qualified ecologist. |

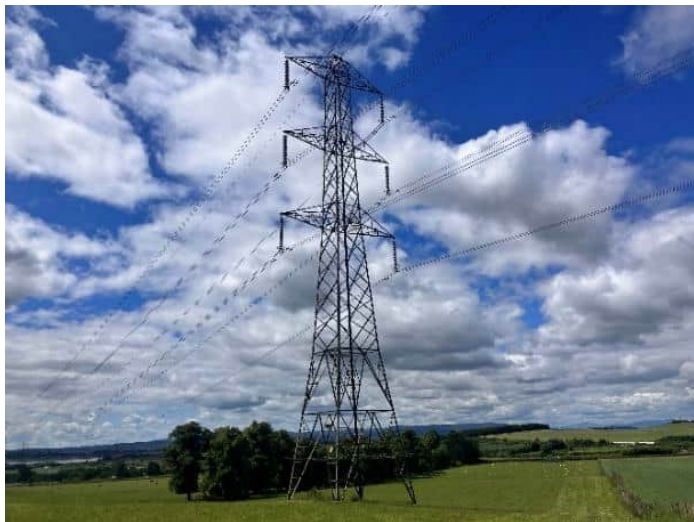
| XL009 | | <p><u>Access Track</u><br/>The access track is the same as XL008. From the paved road, the track turns north and crosses a poor semi-improved grassland field grazed by sheep.</p> | <p><b>Roosting Bats:</b> It is unknown if any tree felling or pruning is anticipated along the access track; however, if required, the removal or pruning of a tree may result in the disturbance, killing and injury of bats.</p> | <p><b>Avoid felling/pruning of tree/branches.</b> If not possible, then further bat surveys (e.g., aerial tree assessment, emergence surveys) should be undertaken.</p> | |
| | | <p><u>XL009</u><br/>The area surrounding the tower comprises predominantly poor semi-improved grassland, in addition to an arable crop (oat) to the north and a parcel of <b>mixed plantation woodland</b> to the east. The plantation is listed on the <b>AWI as long-established</b> and includes Scot's pine, fir, sycamore, and willow. Due to their age, several broadleaf trees in this woodland likely have features offering <b>bat roost potential</b>, however, a thorough ground-assessment was not possible due to leaf coverage. A <b>mammal push through</b> is located under the fence into the plantation (TN8).</p> | <p><b>Long-Established Plantation:</b> potential loss or damage of <b>woodland</b> habitat around base of tower. While it is unknown if tree felling or pruning is anticipated, impacts to trees can also include physical damage to root systems during the works.</p> | <p><b>Woodland retention where possible.</b> If not possible, replace the lost habitat. Implement best practice measures detailed in the report above.</p> | |

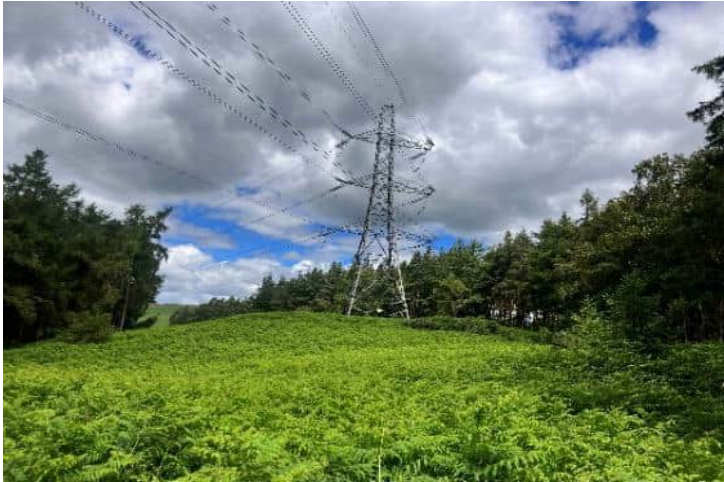
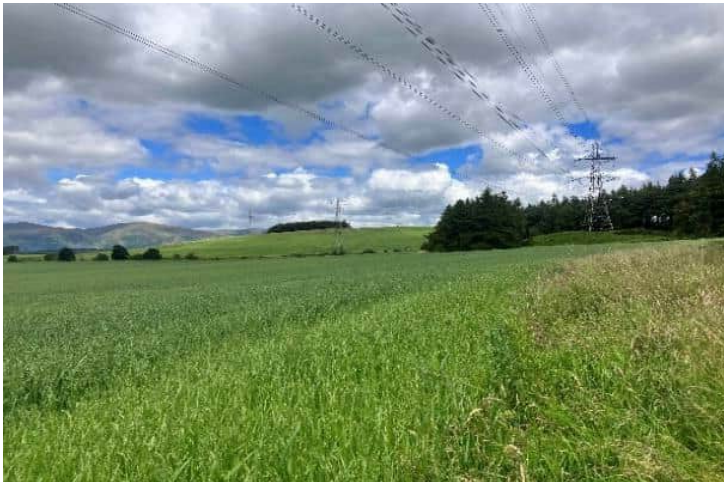
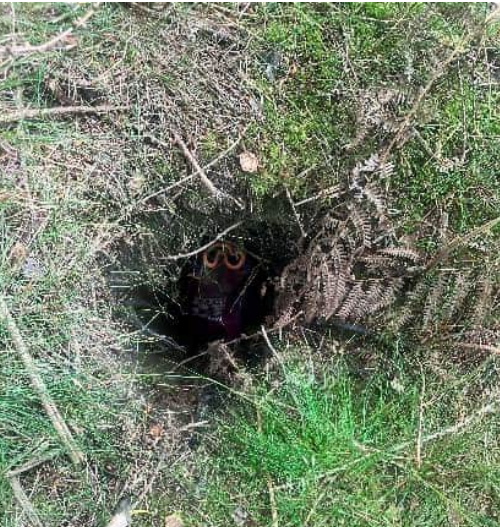
| | | | <p><b>Sett-Building Badger:</b> there is potential for holes to be excavated by badgers, especially within the dense bracken and plantation where a potential badger hole was identified.</p> | <p>Prior to any vegetation clearance/works to the tower and vehicular tracking, a <b>pre-works check</b> for badger signs, including any sett entrances, is advised. This should be undertaken by a qualified ecologist.</p> |
| | | | <p><b>Red Squirrel:</b> activities associated with the works carry a risk of short-term disturbance to red squirrel through increased noise, lighting and human presence. Any tree felling/pruning, if required, has the potential to damage or destroy a drey, or disturb/injure/kill a red squirrel.</p> | <p>Implementation of precautionary measures with respect to red squirrel as detailed in the report above. Prior to any tree felling/ pruning, a <b>pre-works check</b> for squirrel signs, including dreys, is advised. This should be undertaken by a qualified ecologist.</p> |

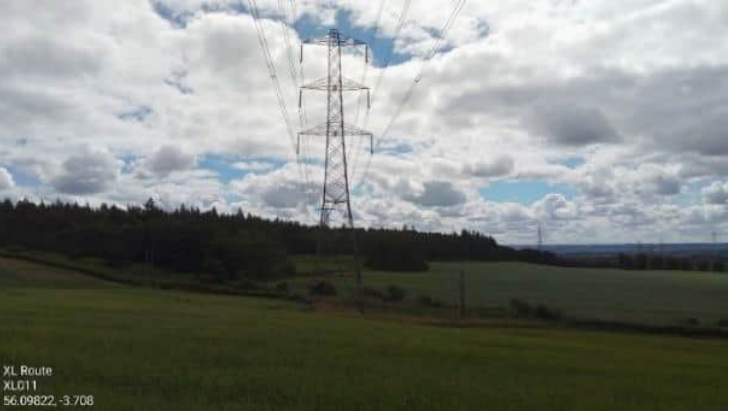
| | <p>XL Route<br/>XL011<br/>56.09822 -3.708</p> | <p>west and then crosses another gap in the hedgerow before entering an arable field (barley) towards the tower.</p> <p><u>XL011</u><br/>The area surrounding the tower comprises an arable field to the north, and continuous bracken, scattered hawthorn and elder scrub, semi-improved neutral grassland and tall ruderals to the south. Immediately southeast of the 50m buffer, there is a <b>long-established plantation</b> listed on the <b>AWI</b>.</p> <p>The grassland, hedgerow, bracken, and scrub provide habitat for <b>nesting birds, reptiles, commuting/foraging bats, and commuting/foraging/sett-building badger</b>.</p> | <p><b>Nesting Birds:</b> any potential vegetation clearance (grassland, hedgerow, bracken, scrub), and vehicle tracking have the potential to damage/destroy nests and kill/injure nesting birds. <b><u>Birds may also nest within the tower at any time.</u></b></p> <p><b>Commuting/Foraging Badger:</b> commuting/foraging badger may be present within the grassland, bracken, and scrub. Activities associated with the works carry a risk of short-term disturbance to badger through increased noise, vibrations, and human presence. There is potential for holes to be excavated by badgers.</p> <p><b>Commuting/Foraging Bats:</b> any potential removal of trees may result in a reduction in the availability of bat foraging and commuting habitat within the site and in the immediate vicinity. Any lighting associated with works has the potential to deter bats from using foraging and commuting habitats.</p> <p><b>Sett-Building Badger:</b> there is potential for holes to be excavated by badgers, especially within the patches of dense bracken and scrub.</p> | <p>Prior to any vegetation clearance/works to the tower and vehicular tracking, <b>a pre-works check for nesting birds will be required</b> by an ecologist, if the works will occur within nesting bird season (March to September).</p> <p>Implementation of precautionary measures with respect to commuting/ foraging badger detailed in the report above.</p> <p><b>Avoid/minimise any loss or fragmentation of foraging and commuting habitat.</b> Where this is not possible replace the lost habitat. Trees should remain dark to allow bats to commute.</p> <p>Prior to any vegetation clearance/works to the tower and vehicular tracking, <b>a pre-works check for badger signs, including any sett entrances, is advised.</b> This should be undertaken by a qualified ecologist.</p> |

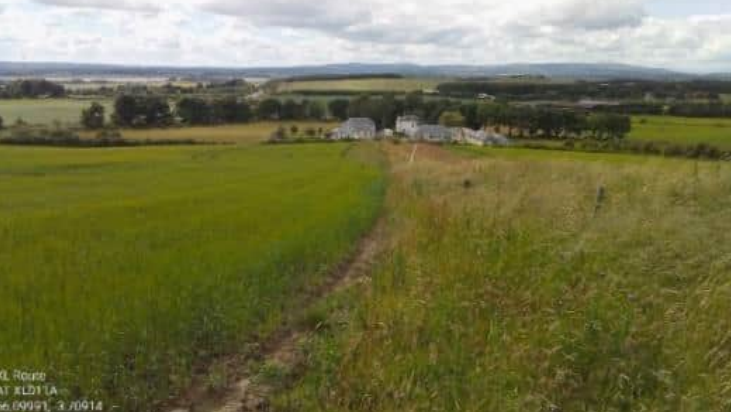
| XL011A | <p>XL Route<br/>AT XL011A<br/>56.09919 -3.70914</p> | <p><u>Access Track</u><br/>The first part of the access track is the same as XL011, before heading east through an <b>intact hawthorn and blackthorn hedgerow</b> and along the edge of an arable field (barely) and semi-improved neutral grassland field margin.</p> <p><u>XL011A</u><br/>The area surrounding the tower comprises an arable field to the south and north, a small patch of Scot's pine plantation to the east, and semi-improved neutral grassland with scattered <b>hawthorn scrub</b> around the base of the tower. <b>No bat roost potential was found within the plantation.</b></p> <p>The hedgerow, plantation, scrub, and tall grassland provide habitat for <b>nesting birds, reptiles, foraging/commuting bats, and foraging/commuting badgers</b>.</p> | <p><b>Priority Habitat Loss:</b> potential loss or damage of <b>hedgerow</b> along access track may result in the fragmentation of habitats in the area. Impacts to retained hedgerows may include physical damage to root systems during the works.</p> <p><b>Reptiles:</b> vegetation clearance and vehicle tracking risk causing harm or mortality to reptiles which may be present within the hedgerow, bracken, and scrub.</p> <p><b>Nesting Birds:</b> any potential vegetation clearance (grassland, hedgerow, plantation, scrub), and vehicle tracking have the potential to damage/destroy nests and kill/injure nesting birds. <b><u>Birds may also nest within the tower at any time.</u></b></p> <p><b>Commuting/Foraging Badger:</b> commuting/foraging badger may be present within the grassland, hedgerow, plantation and scrub. Activities associated with the works carry a risk of short-term disturbance to badger through increased noise, vibrations, and human presence. There is potential for holes to be excavated by badgers.</p> | <p><b>Hedgerow retention where possible.</b> If not possible, replace the lost habitat. Implement best practice measures detailed in the report above.</p> <p>Implementation of precautionary measures with respect to amphibians/ reptiles detailed in the report above.</p> <p>Prior to any vegetation clearance/works to the tower and vehicular tracking, <b>a pre-works check for nesting birds will be required</b> by an ecologist, if the works will occur within nesting bird season (March to September).</p> <p>Implementation of precautionary measures with respect to commuting/ foraging badger detailed in the report above.</p> |

| | | | | <b>Commuting/Foraging Bats:</b> any potential removal of trees may result in a reduction in the availability of bat foraging and commuting habitat within the site and in the immediate vicinity. Any lighting associated with works has the potential to deter bats from using foraging and commuting habitats. | <b>Avoid/minimise any loss or fragmentation of foraging and commuting habitat.</b><br>Where this is not possible replace the lost habitat. Trees should remain dark to allow bats to commute. |

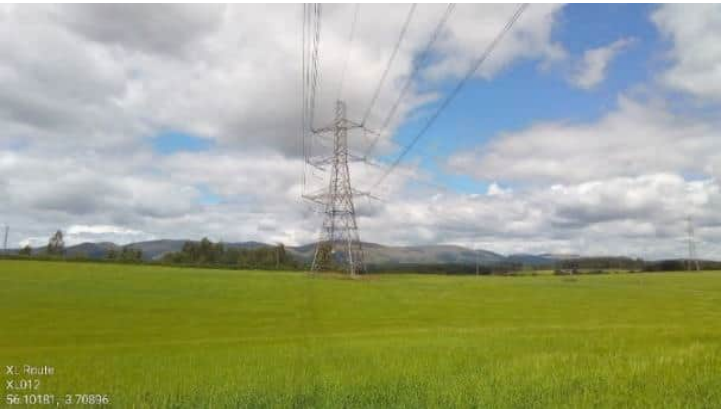
| XL012 | | <p><u>Access Track</u><br/>The access track to the tower passes along the edge of an arable field (barley) with a semi-improved neutral grassland field margin.</p> <p><u>XL012</u><br/>The area surrounding the tower comprises predominantly an arable field, with a small patch of continuous bracken and scattered hawthorn scrub to the north.</p> <p>The bracken, scrub, and grassland provide habitat for <b>nesting birds, reptiles, and commuting/foraging/ sett-building badger.</b></p> | | <b>Reptiles:</b> vegetation clearance and vehicle tracking risk causing harm or mortality to reptiles which may be present within the bracken and scrub. | Implementation of precautionary measures with respect to amphibians/ reptiles detailed in the report above. |
| | | | | <b>Nesting Birds:</b> any potential vegetation clearance (grassland, scrub, bracken), and vehicle tracking have the potential to damage/destroy nests and kill/injure nesting birds. <b><u>Birds may also nest within the tower at any time.</u></b> | Prior to any vegetation clearance/works to the tower and vehicular tracking, <b>a pre-works check for nesting birds will be required</b> by an ecologist, if the works will occur within nesting bird season (March to September). |
| | | | | <b>Commuting/Foraging Badger:</b> commuting/foraging badger may be present within the grassland, scrub or bracken. Activities associated with the works carry a risk of short-term disturbance to badger through increased noise, vibrations, and human presence. There is potential for holes to be excavated by badgers. | Implementation of precautionary measures with respect to commuting/ foraging badger detailed in the report above. |

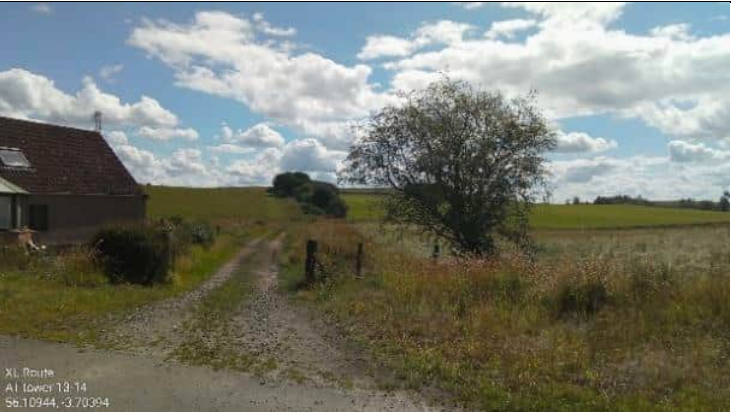
| XL013 | | <p><u>Access Track</u><br/>The access track to the tower starts from the Clackmannan (cycle) Way and follows a farm track south through three improved grassland fields. There is a culvert and <b>dry drainage ditch</b> under the track, however, this is <b>unsuitable for water vole</b> due to the lack of water and minimal banking for burrowing. <b>Otters</b> may commute within the ditch to/from the two nearby permanent ponds (Pond 1/2).</p> | | <b>Otters:</b> Activities associated with the works carry a risk of short-term disturbance to otter through increased noise, lighting and human presence. | No floodlighting and/or night work. Follow the precautionary measures with respect to otter as detailed in this report. |

| | | | | <b>Ditch:</b> Considering the proximity of the ditch to the access route, pollution/sediment run-off may impact this feature. | Works must follow pollution prevention measures detailed in this report. |

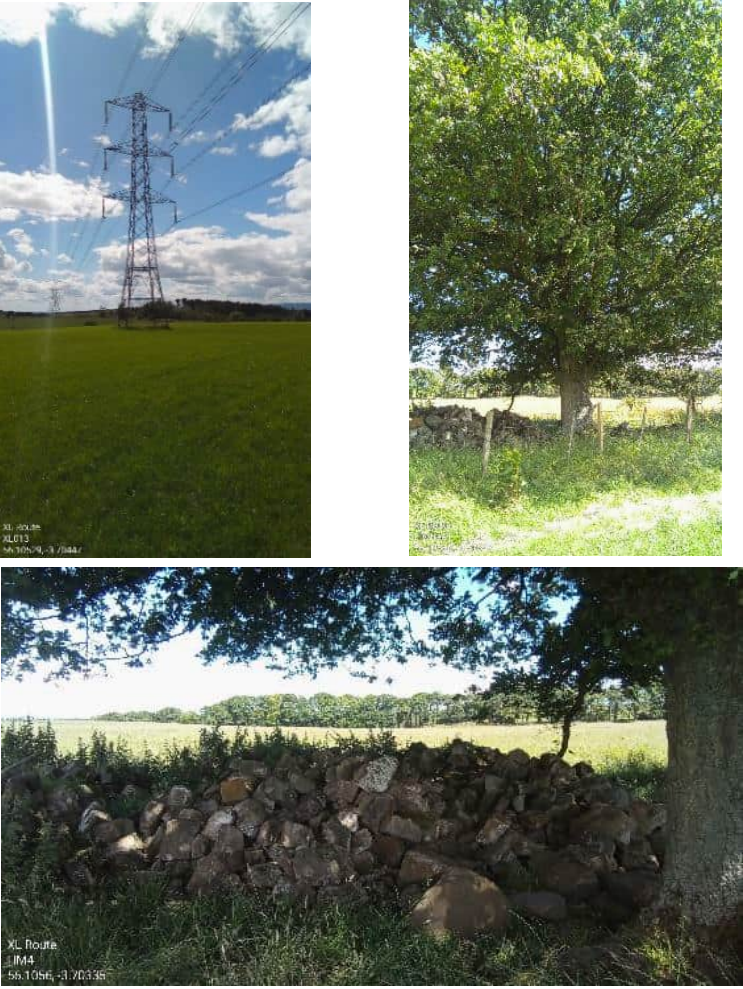
| | | | | <b>Habitat Pile:</b> any removal of the pile has the potential to kill/injure small mammals, amphibians and/or reptiles. | <b>Retain pile where possible.</b> If required, removal of the pile should be undertaken by hand with an ECoW present as there is a risk of individuals present at any time during the year. |

| | | <p>Between two fields, there is a large pile of stones (<b>habitat pile</b>; TN4) with potential for <b>small mammals, amphibians and reptiles</b>. Adjacent to this pile, there is a <b>mature oak tree</b> (T1) with a potential feature (small cavity) suitable for an <b>individual bat (PRF-I)</b>.</p> <p>Adjacent to the access track (just outside of the buffer), there is a <b>line of deciduous trees and scrub</b> with a depression separating two fields, providing habitat for <b>nesting birds, foraging/commuting bats, and foraging/commuting badgers</b>. The depression may also offer suitable habitat for <b>badger sett construction</b>; however, a dedicated search of this area was not conducted due to livestock presence.</p> <p><u>XL013</u><br/>The area surrounding the tower is entirely improved grassland comprised of perennial rye grass and white clover. Two <b>brown hares</b> were spotted within the field (TN5).</p> | <p><b>Roosting Bats:</b> It is not known whether any tree felling is anticipated; however, if required, the removal or pruning of a tree may result in the disturbance, killing and injury of bats.</p> <p><b>Commuting/Foraging Bats:</b> any potential removal of trees may result in a reduction in the availability of bat foraging and commuting habitat within the site and in the immediate vicinity. Any lighting associated with works has the potential to deter bats from using foraging and commuting habitats.</p> <p><b>Nesting Birds:</b> any potential vegetation clearance (grassland, trees, scrub), and vehicle tracking have the potential to damage/destroy nests and kill/injure nesting birds. <b>Birds may also nest within the tower at any time.</b></p> <p><b>Commuting/Foraging Badger:</b> commuting/foraging badger may be present within the grassland, trees and scrub. Activities associated with the works carry a risk of short-term disturbance to badger through increased noise, vibrations, and human presence. There is potential for holes to be excavated by badgers.</p> <p><b>Sett-Building Badger:</b> there is potential for holes to be excavated by badgers, especially along the tree-lined depression.</p> <p><b>Small mammals:</b> vegetation clearance and vehicle tracking risk causing harm or mortality to brown hares.</p> | <p><b>Avoid felling/pruning of tree/branches.</b> If not possible, then further bat surveys (e.g., aerial tree assessment, emergence surveys) should be undertaken.</p> <p><b>Avoid/minimise any loss or fragmentation of foraging and commuting habitat.</b> Where this is not possible replace the lost habitat. Trees should remain dark to allow bats to commute.</p> <p>Prior to any vegetation clearance/works to the tower and vehicular tracking, <b>a pre-works check for nesting birds will be required</b> by an ecologist, if the works will occur within nesting bird season (March to September).</p> <p>Implementation of precautionary measures with respect to commuting/ foraging badger detailed in the report above.</p> <p>Prior to any vegetation clearance/works to the tower and vehicular tracking, <b>a pre-works check for badger signs, including any sett entrances, is advised.</b> This should be undertaken by a qualified ecologist.</p> <p>Implementation of precautionary measures with respect to small mammals as detailed in the report above.</p> |

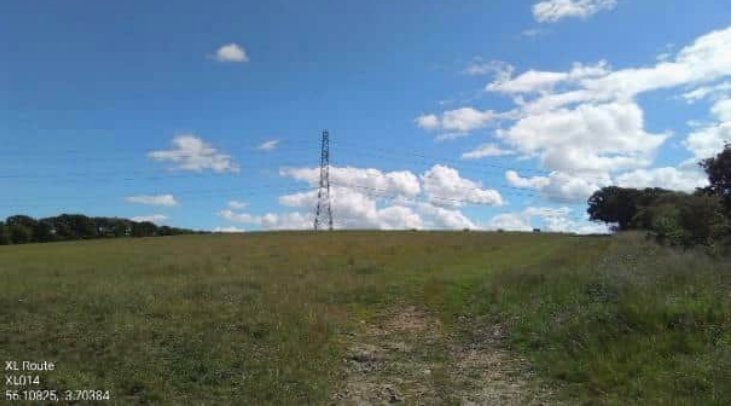
| XL014 | | <p><u>Access Track</u><br/>The access track to the tower is the same as described in XL013.</p> <p><u>XL014</u><br/>The area surrounding the tower is an improved grassland field with livestock grazing.</p> | <p><b>Please refer to the constraints listed under XL013</b></p> | <p><b>Please refer to mitigation measures listed under XL013</b></p> |

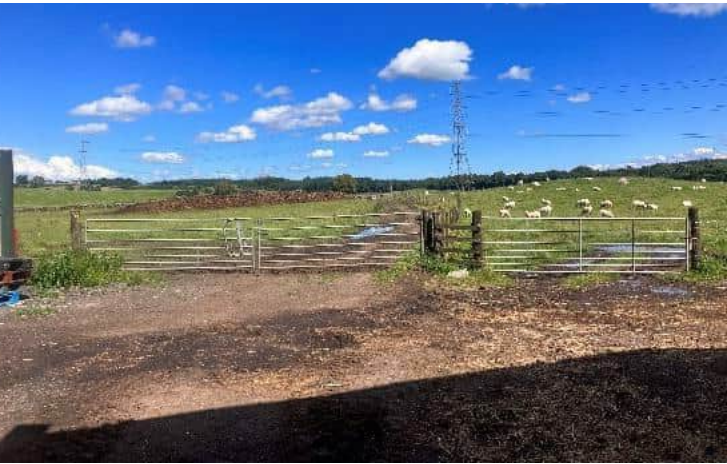
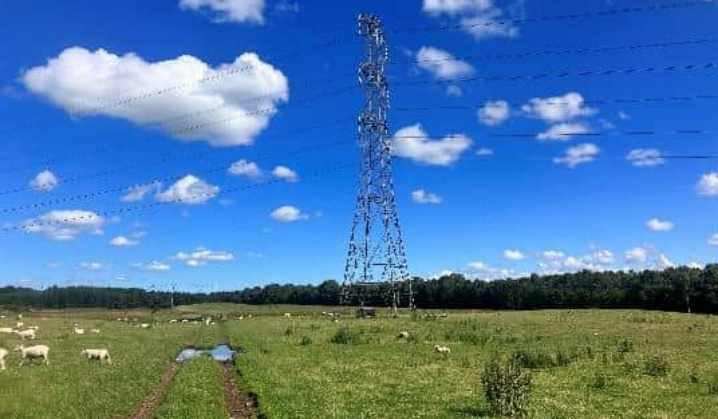
| | <br><br><br><small>XL Route<br/>HM POND 1<br/>56.10841, -3.70023</small> | <p><u>XL015</u><br/>The area surrounding the tower comprises improved grassland grazed by sheep. <b>Two manmade agricultural ponds</b> (Pond 1 &amp; 2) are located approx. 125m southwest of the tower. Both ponds have an HSI score of <b>0.63</b>, indicating <b>average potential for great crested newt</b>. Other species including <b>amphibians</b> and <b>otters</b> could also be using these ponds.</p> <p>The scrub/trees and grassland provide habitat for <b>nesting birds, foraging/commuting bats, and foraging/commuting badgers</b>. The enclosed farm buildings also offer suitable habitat for <b>nesting birds</b> including <b>barn owl</b>.</p> | | ecologist, if the works will occur within nesting bird season (March to September). |

| | | | <b>Commuting/Foraging Badger:</b> commuting/foraging badger may be present within the grassland, scrub and trees. Activities associated with the works carry a risk of short-term disturbance to badger through increased noise, vibrations, and human presence. There is potential for holes to be excavated by badgers. | Implementation of precautionary measures with respect to commuting/ foraging badger detailed in the report above. |

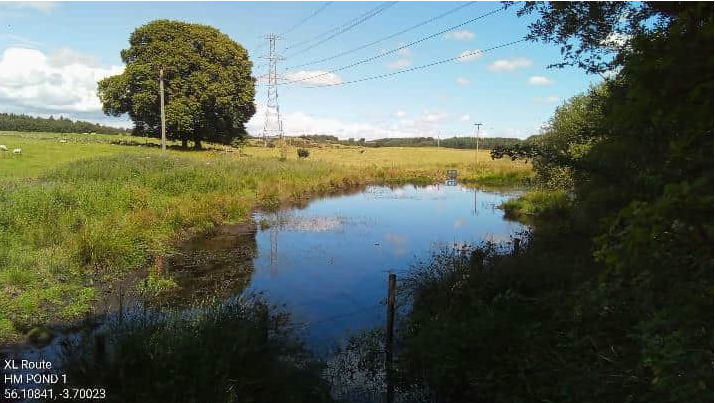
| | | | <b>Permanent Ponds (Priority Habitat) &amp; potential Great Crested Newt:</b> considering the distance of the two ponds to the working area and access routes, disturbance/impacts are considered low. However, pollution/sediment run-off may still degrade the aquatic habitat. Any vegetation clearance and vehicle movements have the potential to kill and injure individual newts, if present. | Works must follow the pollution prevention measures and precautionary measures with respect to great crested newt as detailed in the report above. |

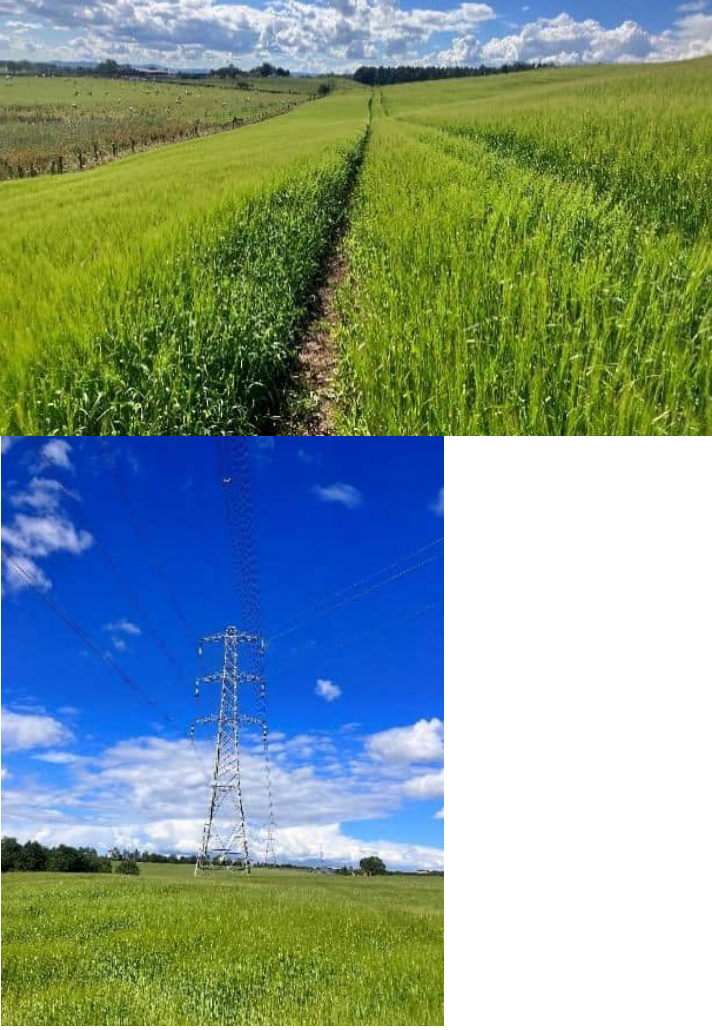
| | | <p><b>XL016</b><br/>The area surrounding the tower comprises an arable field (barley). A large permanent <b>pond</b> (Pond 8) is located approx. 110m north of the tower and has a HSI score of 0.60 indicating <b>average potential</b> for <b>great crested newt</b>. Other species including <b>amphibians</b> and <b>otters</b> could also be using this pond.</p> | <p><b>Nesting Birds:</b> any potential vegetation clearance (grassland), and vehicle tracking have the potential to damage/destroy nests and kill/injure nesting birds. <b><u>Birds may also nest within the tower at any time.</u></b></p> <p><b>Commuting/Foraging Badger:</b> commuting/foraging badger may be present within the grassland. Activities associated with the works carry a risk of short-term disturbance to badger through increased noise, vibrations, and human presence. There is potential for holes to be excavated by badgers.</p> <p><b>Permanent Ponds (Priority Habitat) &amp; potential Great Crested Newt:</b> considering the distance of the pond to the working area and access routes, disturbance/impacts are considered low. However, pollution/sediment run-of could degrade the aquatic habitat. Any vegetation clearance and vehicle movements have the potential to kill and injure individual newts, if present.</p> <p><b>Otters:</b> activities associated with the works carry a risk of short-term disturbance to otter through increased noise, lighting and human presence.</p> | <p>Prior to any vegetation clearance/works to the tower and vehicular tracking, <b>a pre-works check for nesting birds will be required</b> by an ecologist, if the works will occur within nesting bird season (March to September).</p> <p>Implementation of precautionary measures with respect to commuting/ foraging badger detailed in the report above.</p> <p>Works must follow the pollution prevention measures and precautionary measures with respect to great crested newt as detailed in the report above.</p> <p>Follow the precautionary measures with respect to otter as detailed in this report.</p> |

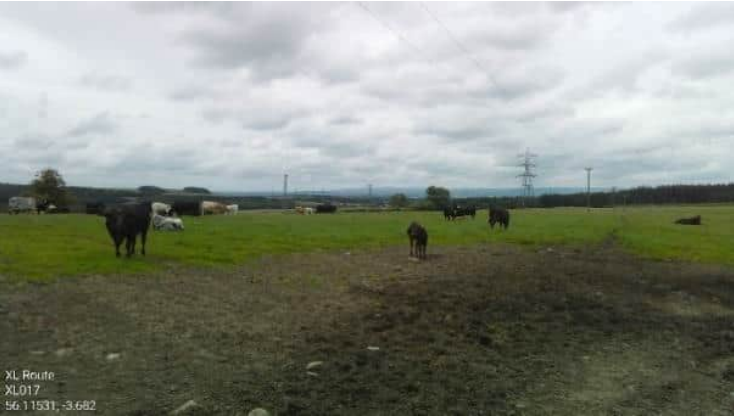
| XL017 | | <p><b>Access Track</b><br/>The access track for XL017 – 019 follows a gravel road to Hazleyshaw Farm, with semi-improved grassland on the verges and improved fields on both sides. The south side is lined with <b>immature oak, rowan, prunus sp., hawthorn and ash trees</b>. The access track to the tower is adjacent to a <b>hawthorn hedgerow with scattered trees</b> including immature birch and two mature deciduous trees. The mature trees may have <b>bat roosting potential</b>; however, they were not inspected due to livestock obstructing access (TN13). The hedgerow and trees provide habitat for <b>nesting birds, foraging and commuting bats</b>, and <b>foraging and commuting badger</b>.</p> <p><b>XL017</b><br/>The area surrounding the tower is an improved grassland field with cows grazing and an arable crop and farm building to the south.</p> | <p><b>Commuting/Foraging Bats:</b> any potential removal of trees may result in a reduction in the availability of bat foraging and commuting habitat within the site and in the immediate vicinity. Any lighting associated with works has the potential to deter bats from using foraging and commuting habitats.</p> <p><b>Priority Habitat Loss:</b> potential loss or damage of <b>hedgerow</b> around base of tower and along access track may result in the fragmentation of habitats in the area. Impacts to retained hedgerows may include physical damage to root systems during the works.</p> <p><b>Nesting Birds:</b> any potential vegetation clearance (grassland, trees, hedgerow), and vehicle tracking have the potential to damage/destroy nests and kill/injure nesting birds. <b><u>Birds may also nest within the tower at any time.</u></b></p> <p><b>Commuting/Foraging Badger:</b> commuting/foraging badger may be present within the grassland, trees and hedgerow. Activities associated with the works carry a risk of short-term disturbance to badger through increased noise, vibrations, and human presence. There is potential for holes to be excavated by badgers.</p> | <p><b>Avoid/minimise any loss or fragmentation of foraging and commuting habitat.</b> Where this is not possible replace the lost habitat. Trees should remain dark to allow bats to commute.</p> <p><b>Hedgerow retention where possible.</b> If not possible, replace the lost habitat. Implement best practice measures detailed in the report above.</p> <p>Prior to any vegetation clearance/works to the tower and vehicular tracking, <b>a pre-works check for nesting birds will be required</b> by an ecologist, if the works will occur within nesting bird season (March to September).</p> <p>Implementation of precautionary measures with respect to commuting/ foraging badger detailed in the report above.</p> |

| | | | <b>Roosting Bats:</b> It is unknown whether tree felling or pruning is anticipated; however, if required, the removal or pruning of a tree may result in the disturbance, killing and injury of bats. | <b>Avoid felling/pruning of tree/branches.</b> If not possible, then further bat surveys (e.g., aerial tree assessment, emergence surveys) should be undertaken. |

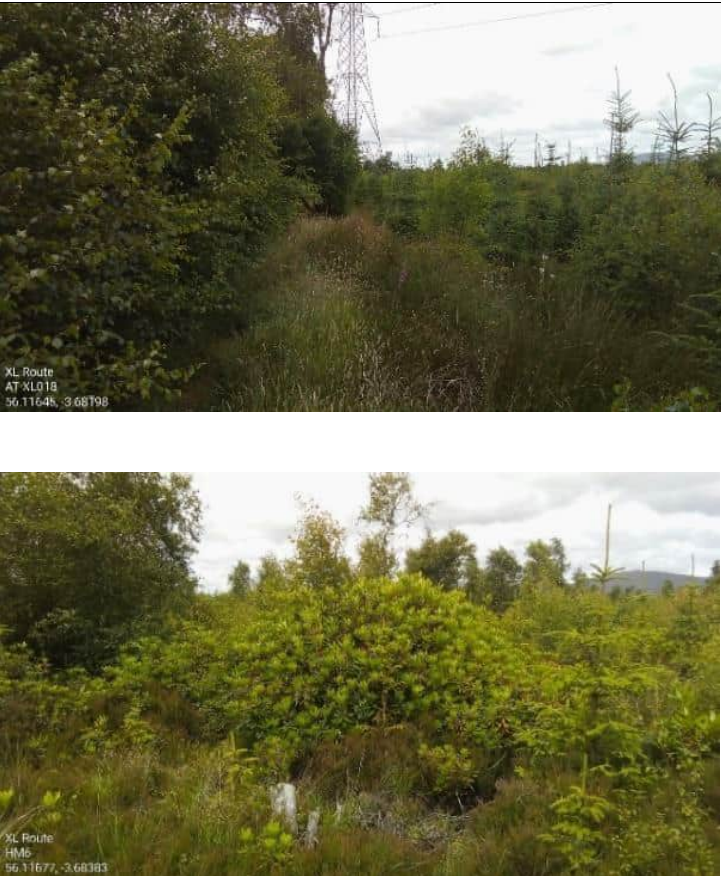
| XL018 | | <p><u>Access Track</u><br/>The start of the access track is the same as in XL017 and then passes through an improved grassland field grazed by cattle. It then crosses a dry drainage ditch and into an area of young plantation with dominant Sitka spruce and birch regeneration. The ditch is <b>unsuitable for water vole</b> due to the lack of water and shading from scrub.</p> <p><u>XL018</u><br/>The area surrounding the tower comprises an improved grassland field, strip of birch <b>scrub</b> and <b>dry ditch</b> to the south, and <b>young Sitka spruce plantation</b> with birch regeneration to the north. The plantation is listed on the <b>AWI as long-established</b>. No features suitable for roosting bats was observed. There are several scattered <b>brash piles</b> with high potential for <b>small mammals, amphibians and reptiles</b>. The ground flora comprises dominant common heather, and frequent soft rush and Molinia, indicating that the original habitat before planting may have been <b>degraded bog</b> or <b>wet dwarf shrub heath (priority habitats)</b>. Several drainage channels are present, infilled almost entirely with <b>Sphagnum spp.</b> Directly underneath the tower, there is a patch of <b>marshy grassland (potential GWDTE)</b>.</p> <p>These habitats provide habitat for <b>nesting birds, foraging/commuting bats, foraging/commuting badgers, and reptiles/amphibians</b>.</p> <p>A stand of <b>rhododendron</b> is present in the plantation (TN6).</p> | <b>Reptiles/Amphibians:</b> vegetation clearance and vehicle tracking risk causing harm or mortality to reptiles/amphibians which may be present within the scrub and young plantation. | Implementation of precautionary measures with respect to amphibians/ reptiles detailed in the report above. |

| | | | <b>Priority Habitat Loss:</b> potential loss or further damage to marshy grassland, modified bog or wet heath habitats. Considering the nature of the works, pollution and physical damage may impact these habitats. | Works must follow the pollution prevention measures detailed in this report. |

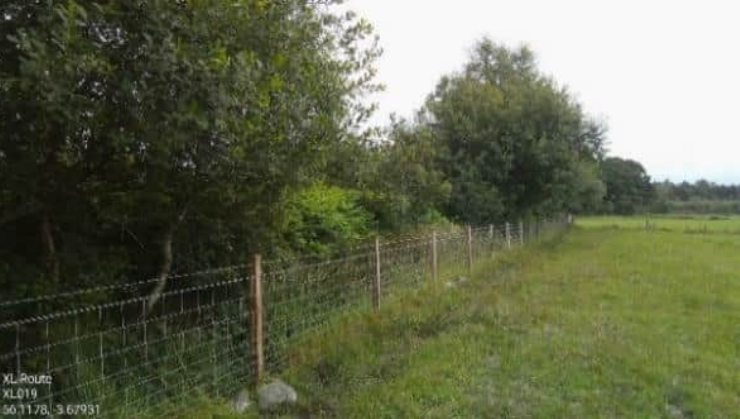
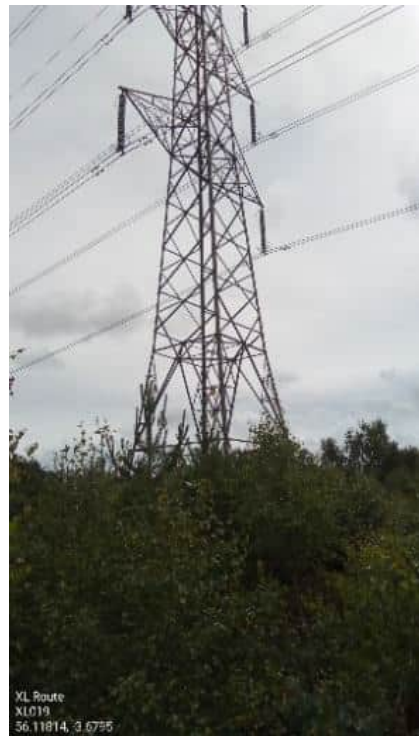
| XL019 | <div></div> <div></div> | <p><u>Access Track</u><br/>The access track passes through an improved grassland field grazed by cows. On the west side there is a dried, overgrown <b>drainage ditch</b> and a line of semi-mature birch trees (<b>no bat roost potential observed</b>), providing habitat for <b>nesting birds, commuting/foraging bats</b> and <b>commuting/foraging badger</b>. The ditch is unsuitable for <b>water vole</b> due to the lack of water and shading from scrub.</p> <p><u>XL019</u><br/>The habitats surrounding the tower are the same as XL018, in addition to a patch of dense bracken and semi-natural mixed woodland. Between the young plantation stands, there is a ride of marshy grassland covered in Sitka spruce, larch, lodgepole pine, birch and willow regeneration. Like XL018, the plantation is listed on the <b>AWI as long-established</b>, and the ground flora may have originally been <b>degraded bog or wet dwarf shrub heath (priority habitats)</b>.</p> <p>These areas provide habitat for <b>nesting birds, foraging/commuting bats, foraging/commuting badgers, and reptiles/amphibians</b>.</p> | Please refer to the constraints listed under XL018 | Please refer to mitigation measures listed under XL018 |

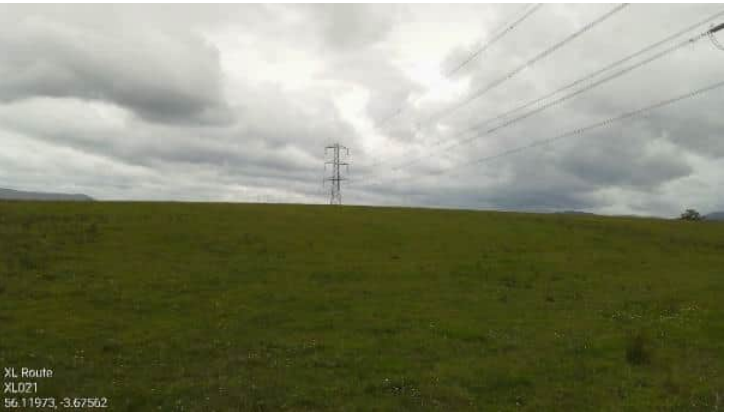
| XL021 | | <p><u>Access Track</u><br/>The access track passes through an improved grassland field.</p> <p><u>XL021</u><br/>The area surrounding the tower comprises entirely an improved grassland field.</p> <p>The short grassland provides habitat for <b>foraging/commuting badgers and nesting birds.</b></p> | <p><b>Nesting Birds:</b> any potential vegetation clearance (grassland), and vehicle tracking have the potential to damage/destroy nests and kill/injure nesting birds. <b><u>Birds may also nest within the tower at any time.</u></b></p> | <p>Prior to any vegetation clearance/works to the tower and vehicular tracking, <b>a pre-works check for nesting birds will be required</b> by an ecologist, if the works will occur within nesting bird season (March to September).</p> |

| | | | <p><b>Commuting/Foraging Badger:</b> commuting/foraging badger may be present within the grassland. Activities associated with the works carry a risk of short-term disturbance to badger through increased noise, vibrations, and human presence. There is potential for holes to be excavated by badgers.</p> | <p>Implementation of precautionary measures with respect to commuting/ foraging badger detailed in the report above.</p> |
