# **ECU – LWUP XL Route Refurbishment**

## **Ecological Walkover**

| <b>Document:</b> | <b>BOWS23.097 ECU – LWUP XL Route Ecological Walkover Report</b> | | | |

- 1.1 Bowland Ecology Ltd. was commissioned by Scottish Power Energy Networks (SPEN) to undertake an ecological walkover of the XL overhead line (OHL) running between the former Kincardine Power Station (NS923885) and the transmission license boundary at Blairingone (NS981966). This pertains to scheduled reconductoring works along the route, including the replacement of existing conductors between XL001A to XL006, the replacement of existing conductors between XL007 to XL031 (excluding XL006 to XL007), the replacement of existing downloads and associated fittings at Kincardine substation and the replacement and/or upgrade of damaged / corroded tower steelwork where required between XL001A-XL006 and XL007-XL031. The commencement of works is scheduled for Autumn 2024.

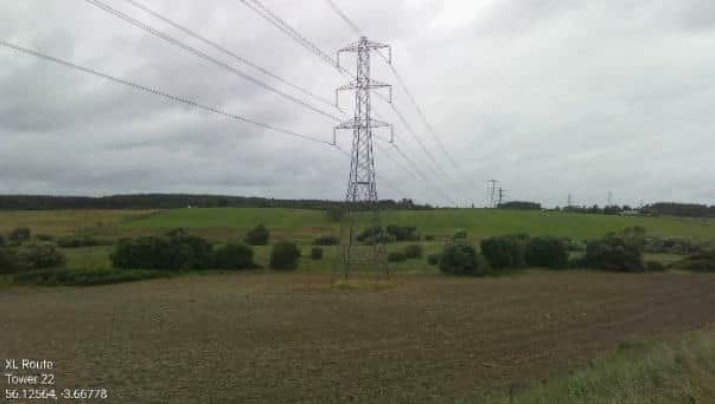
| | <p>XL Route<br/>Tower 22<br/>56.12564, -3.66778</p> <p>XL Route<br/>HM pond 5<br/>56.12559, -3.67221</p> <p>XL Route<br/>HM pond 6<br/>56.12582, -3.67219</p> | <p>vegetation restricting access (TN14). Other species including <b>amphibians</b> and <b>otters</b> may also be using the ponds.</p> <p>Either side of the track, there are patches of semi-improved neutral grassland and semi-mature, <b>semi-natural mixed broadleaved woodland</b> including willow, birch, and alder trees (<b>no bat roost potential observed</b>).</p> <p><u>XL022</u><br/>The area surrounding the tower comprises predominantly an arable field (bare soil), with small patches of semi-improved <b>neutral grassland</b> and scattered willow scrub to the south.</p> <p>The woodland and scrub provide habitat for <b>nesting birds, foraging/commuting bats, and foraging/commuting badgers</b>. Part of the woodland strip is on a slope which may also offer suitable habitat for <b>badger sett construction</b> (TN16).</p> | <p><b>Otters:</b> activities associated with the works carry a risk of short-term disturbance to otter through increased noise, lighting and human presence.</p> <p><b>Commuting/Foraging Bats:</b> any potential removal of trees or hedgerow may result in a reduction in the availability of bat foraging and commuting habitat within the site and in the immediate vicinity. Any lighting associated with works has the potential to deter bats from using foraging and commuting habitats.</p> <p><b>Priority Habitat Loss:</b> potential loss or damage of <b>woodland</b> habitat along access track. While it is unknown if tree felling or pruning is anticipated, impacts to trees can also include physical damage to root systems during the works.</p> <p><b>Nesting Birds:</b> any potential vegetation clearance (grassland, woodland, scrub), and vehicle tracking have the potential to damage/destroy nests and kill/injure nesting birds. <b><u>Birds may also nest within the tower at any time.</u></b></p> <p><b>Commuting/Foraging Badger:</b> commuting/foraging badger may be present within the grassland, woodland and scrub. Activities associated with the works carry a risk of short-term disturbance to badger through increased noise, vibrations, and human presence. There is potential for holes to be excavated by badgers.</p> <p><b>Sett-Building Badger:</b> there is potential for holes to be excavated by badgers, especially along the sloped wooded bank.</p> | <p>Follow the precautionary measures with respect to otter as detailed in this report.</p> <p><b>Avoid/minimise any loss or fragmentation of foraging and commuting habitat.</b> Where this is not possible replace the lost habitat. Trees should remain dark to allow bats to commute.</p> <p><b>Woodland retention where possible.</b> If not possible, replace the lost habitat. Implement best practice measures detailed in the report above.</p> <p>Prior to any vegetation clearance/works to the tower and vehicular tracking, <b>a pre-works check for nesting birds will be required</b> by an ecologist, if the works will occur within nesting bird season (March to September).</p> <p>Implementation of precautionary measures with respect to commuting/ foraging badger detailed in the report above.</p> <p>Prior to any vegetation clearance/works to the tower and vehicular tracking, <b>a pre-works check</b> for badger signs, including any sett entrances, is advised. This should be undertaken by a qualified ecologist.</p> |

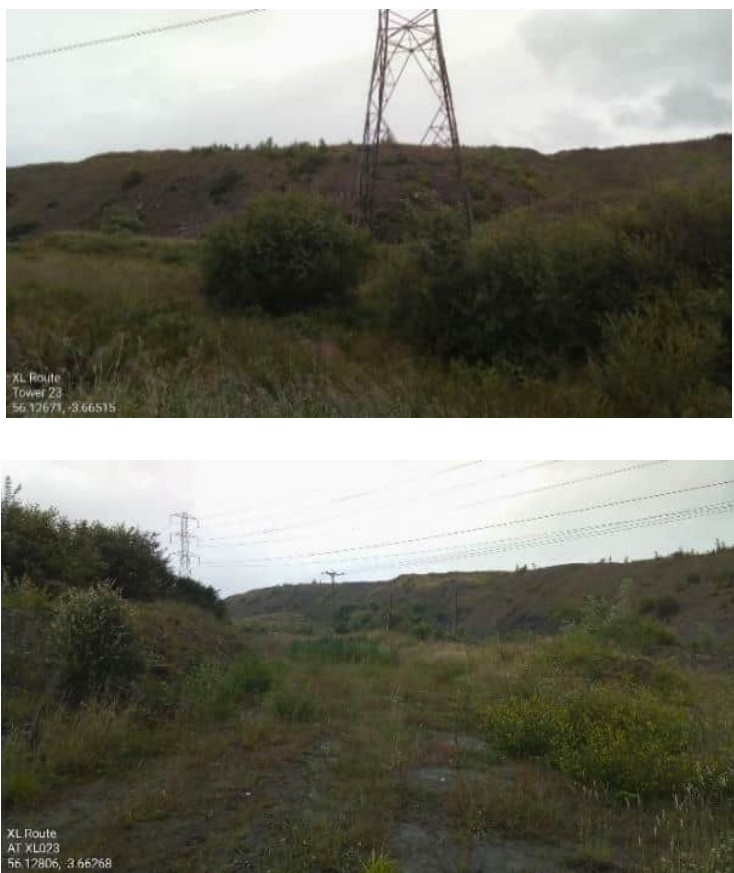
| | <p>XL Route<br/>Tower 23<br/>56.12671, -3.66515</p> <p>XL Route<br/>AT XL023<br/>56.12806, -3.66268</p> | <p>scattered willow <b>scrub</b> and steep sparsely vegetated ground/soil from quarry excavations. The steep slope is south facing which provide suitable basking habitat for <b>reptiles</b> (TN17).</p> <p>The grassland and scrub mosaic provide habitat for <b>nesting birds, foraging/commuting bats, foraging/commuting badgers, and reptiles/amphibians</b>. A steep bank to the south of the buffer also offers suitable habitat for <b>badger sett construction</b>.</p> | <p><b>Reptiles and Amphibians:</b> vegetation clearance and vehicle tracking risk causing harm or mortality to reptiles and amphibians which may be present within the scrub, grassland, or sparsely vegetated ground.</p> | <p>Implementation of precautionary measures with respect to amphibians/ reptiles detailed in the report above.</p> |

| | | | <p><b>Nesting Birds:</b> any potential vegetation clearance (grassland, scrub), and vehicle tracking have the potential to damage/destroy nests and kill/injure nesting birds. <b>Birds may also nest within the tower at any time.</b></p> | <p>Prior to any vegetation clearance/works to the tower and vehicular tracking, <b>a pre-works check for nesting birds will be required</b> by an ecologist, if the works will occur within nesting bird season (March to September).</p> |

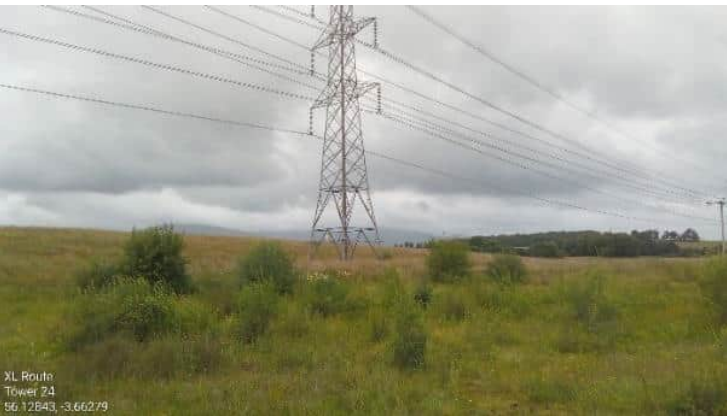
| XL024 | <p>XL Route<br/>Tower 24<br/>56.12843, -3.66279</p> | <p><u>Access Track</u><br/>Part of the same quarry complex as XL022-25A. From the paved road, the route follows a wide gravel road used by quarry vehicles. <b>Mixed scrub</b> including gorse, broom, birch and willow line both sides of this road.</p> <p><u>XL024</u><br/>The area surrounding the tower comprises predominantly <b>marshy grassland (potential priority habitat and GWDTE)</b> with small parcels of scattered birch and willow <b>scrub</b>.</p> <p>The scrub and marshy grassland provide habitat for <b>nesting birds, foraging/commuting badgers, and amphibians</b>.</p> | <p><b>Priority Habitat Loss:</b> potential loss or damage to <b>marshy grassland</b>, habitat. Considering the nature of the works, pollution and physical damage may impact this habitat.</p> | <p>Works must follow the pollution prevention measures detailed in this report.</p> |

| | | | <p><b>Potential GWDTEs:</b> there is a risk of pollution of groundwater from leaks or spills from vehicles or equipment. Any vehicle/plant movement could damage vegetation within the working areas and along vehicular tracks.</p> | <p>Works must follow pollution prevention and other precautionary measures with respect to GWDTE areas detailed in the report above.</p> |

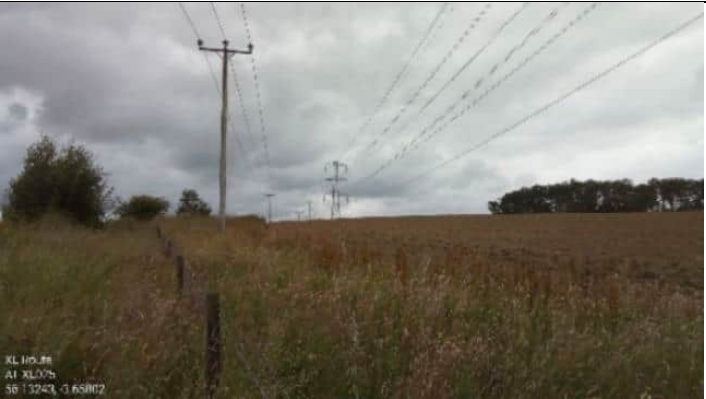
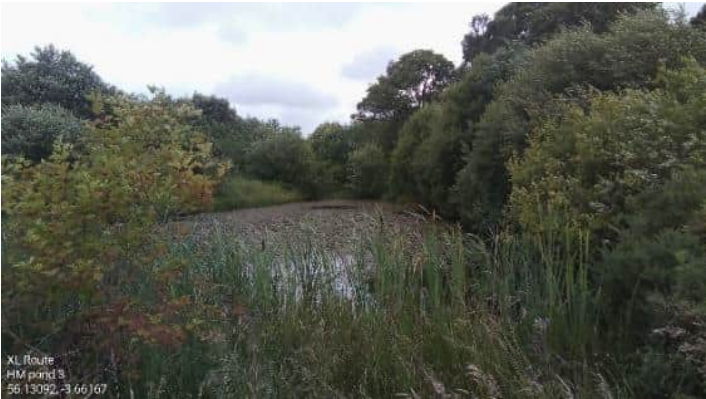
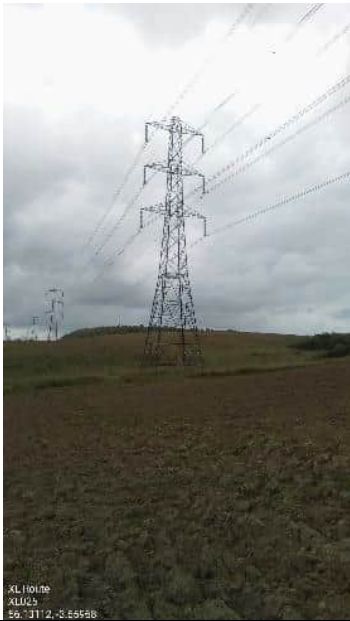
| XL025 | | <p><u>Access Track</u><br/>Part of the same quarry complex as XL022-25A. The access route starts out the same as XL025A. It then passes around the edge of an arable crop (bare ground) with a strip of semi-improved neutral grassland and some patches of <b>marshy grassland</b> along the fence line to the east.</p> <p><u>XL025</u><br/>The area surrounding the tower comprises predominantly <b>marshy grassland (potential priority habitat and GWDTE)</b> with an arable field (bare ground) to the northeast and scattered willow <b>scrub</b> to the east. A <b>permanent pond</b> (Pond 3) is found 70m west of the tower. This pond has an HSI score of 0.76, indicating <b>good potential for great crested newt</b>. Other species including <b>amphibians</b> and <b>otters</b> could be using this pond and the surrounding marshy grassland.</p> | Please refer to the constraints listed under XL025A. | Please refer to mitigation measures listed under XL025A |
| | | | <p><b>Priority Habitat Loss:</b> potential loss or damage to <b>marshy grassland</b>, habitat. Considering the nature of the works, pollution and physical damage may impact this habitat.</p> | Works must follow the pollution prevention measures detailed in this report. |
| | | | <p><b>Potential GWDTEs:</b> there is a risk of pollution of groundwater from leaks or spills from vehicles or equipment. Any vehicle/plant movement could damage vegetation within the working areas and along vehicular tracks.</p> | Works must follow pollution prevention and other precautionary measures with respect to GWDTE areas detailed in the report above. |

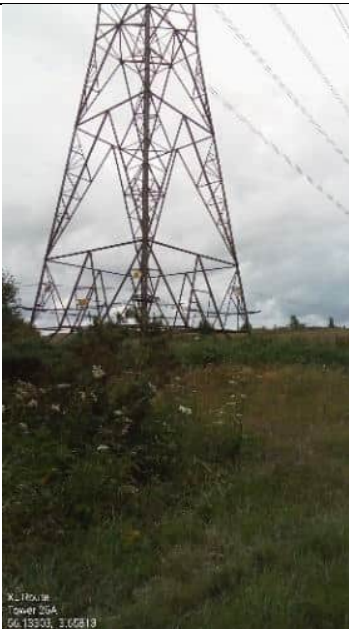
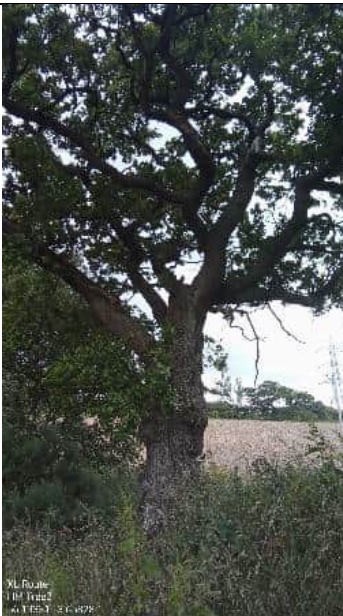
| XL025A | <br><small>XL Route<br/>Tower 25A<br/>56.13303, 3.02819</small> | <br><small>XL Route<br/>1st Tree<br/>56.13303, 3.02819</small> | <p><u>Access Track</u><br/>Part of the same quarry complex as XL022-25. From the paved road, the route follows an overgrown gravel track around the edge of an arable crop (bare soil). Adjacent to the road, there is a strip of <b>semi-natural broadleaved woodland</b> with oak, ash, and birch trees (<b>potential priority habitat but no bat roost potential observed</b>). A <b>wet ditch</b> and thick gorse <b>scrub</b> line the track to the north, and semi-improved grassland lines the south. The ditch was inaccessible due to the scrub; however, it is likely <b>unsuitable for water vole</b> due to high levels of shading. <b>Otters</b> may commute within the ditch to/from the nearby quarry reservoirs. Close to the tower buffer, one <b>mature oak tree</b> has a cracked limb and torn branch offering <b>bat roost suitability for multiple bats (BRP-M); T2</b>, and a <b>second mature oak tree</b> has a torn branch offering <b>bat roost suitability for individual bats (BRP-I; T3)</b>.</p> | <p><b>Priority Habitat Loss:</b> potential loss or damage of <b>woodland</b> habitat near start of access track. While it is unknown if tree felling or pruning is anticipated, impacts to trees can also include physical damage to root systems during the works.</p> | <p><b>Woodland retention where possible.</b> If not possible, replace the lost habitat. Implement best practice measures detailed in the report above.</p> |

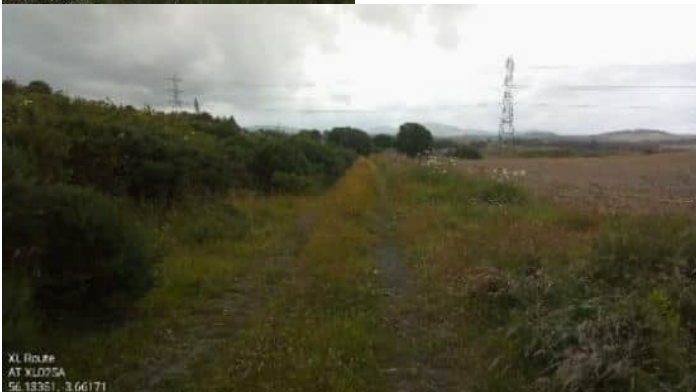
| | <br><small>XL Route<br/>AT XL025A<br/>56.13381, 3.06171</small> | <p><u>XL025A</u><br/>The area surrounding the tower comprises an arable crop (bare ground), semi-improved neutral grassland, a strip of willow <b>scrub</b> lining another <b>wet ditch</b>, and two <b>mature oak trees (T2/T3)</b>. Two stands of <b>Japanese knotweed</b> are present to the southeast of the tower (TN7). A large <b>reservoir</b> (Pond 9) is located 100m southeast of the tower. This reservoir has a HSI score of 0.51, indicating <b>below average potential for great crested newt</b>.</p> | <p><b>Roosting Bats:</b> It is unknown if any tree felling or pruning is anticipated; however, if required, the removal or pruning of a tree may result in the disturbance, killing and injury of bats.</p> | <p><b>Avoid felling/pruning of tree/branches.</b> If not possible, then further bat surveys (e.g., aerial tree assessment, emergence surveys) should be undertaken.</p> | |

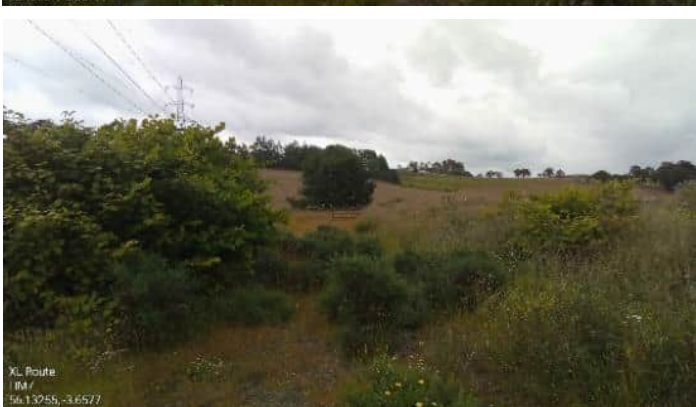
| | <br><small>XL Route<br/>1st Tree<br/>56.13265, 3.06577</small> | <p>The woodland, grassland, scrub, and trees provide habitat for <b>nesting birds, foraging/commuting bats, and foraging/commuting badgers</b>.</p> | <p><b>Ditch:</b> considering the proximity of the ditch to the access route, <b>pollution/sediment run-off may impact this feature</b>.</p> <p><b>Otters:</b> activities associated with the works carry a risk of short-term disturbance to otter through increased noise, lighting and human presence.</p> | <p>Works must follow pollution prevention measures detailed in this report.</p> <p>No floodlighting and/or night work. Follow the precautionary measures with respect to otter as detailed in this report.</p> | |

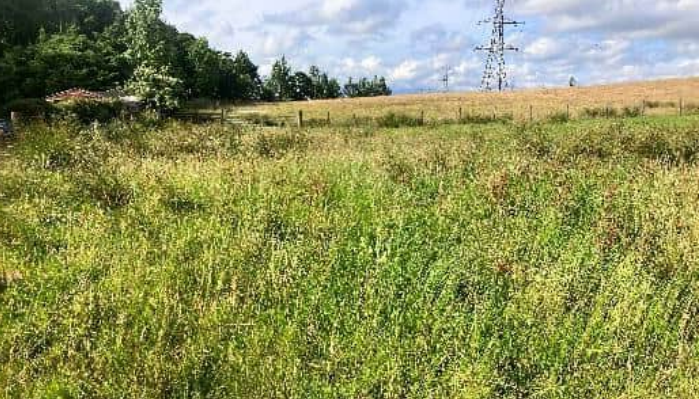
| XL026 | <br> | <p><u>Access Track</u><br/>The access track crosses two semi-improved grassland fields, one grazed by sheep.</p> <p><u>XL026</u><br/>The area around the tower comprises predominantly semi-improved neutral grassland, with a paved road lined with tall ruderals, bramble/hawthorn <b>scrub</b> and scattered oak saplings. South of the paved road, there is a line of <b>semi-mature aspen and young oak trees (no bat roost potential)</b>.</p> <p>The grassland, scrub and trees provide habitat for <b>nesting birds, foraging/commuting bats, and foraging/commuting badgers</b>.</p> | <p><b>Commuting/Foraging Bats:</b> any potential removal of scrub/trees may result in a reduction in the availability of bat foraging and commuting habitat within the site and in the immediate vicinity. Any lighting associated with works has the potential to deter bats from using foraging and commuting habitats.</p> | <p>Avoid/minimise any loss or fragmentation of foraging and commuting habitat. Where this is not possible replace the lost habitat. Trees should remain dark to allow bats to commute.</p> |

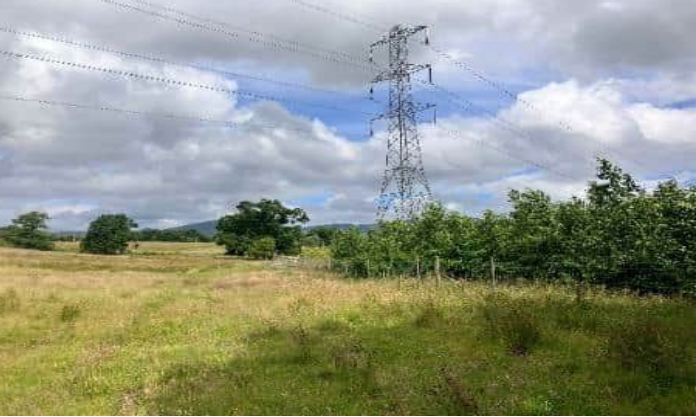
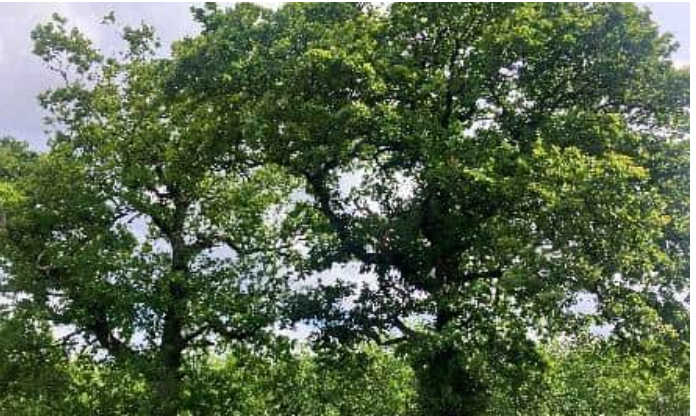
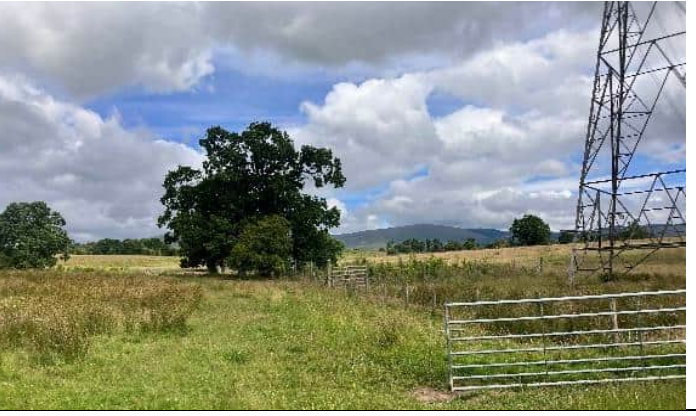
| | | <p><b>roost potential for multiple bats (BRP-M)</b> and are found adjacent to the track (T4/5/6).</p> <p><u>XL027</u><br/>The area surrounding the tower comprises semi-improved neutral grassland and two fenced-off areas of young broadleaved plantation. To the southeast, the plantation is alder and to the northwest the plantation is beech and birch. These areas provide habitat for <b>nesting birds, commuting/foraging bats, and foraging/commuting badgers</b>.</p> <p>Along the fence line, <b>three mature oak trees</b> with features including split limbs and lifted bark, offer <b>bat roost potential for multiple bats (BRP-M)</b> (T7/8/9).</p> <p>Underneath the tower, there are some rocky boulders offering refugia for <b>small mammals, amphibians, and reptiles</b> (TN18).</p> | <p><b>Habitat Pile:</b> any removal of the boulders has the potential to kill/injure small mammals, amphibians and/or reptiles.</p> | <p><b>Retain boulders where possible.</b> If required, removal of the boulders should be undertaken by hand with an ECoW present as there is a risk of individuals present at any time during the year.</p> |

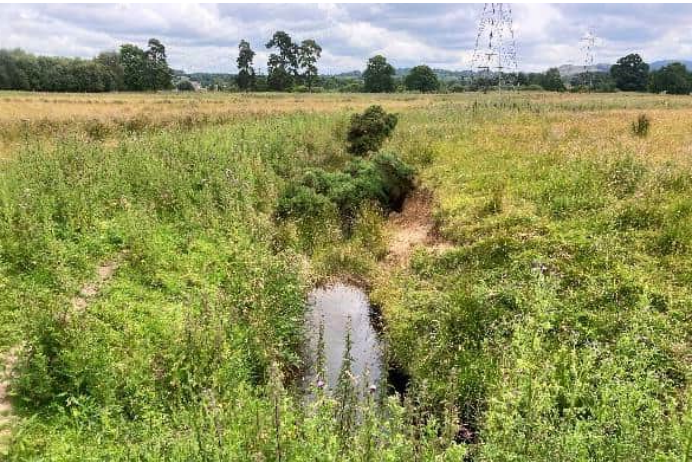
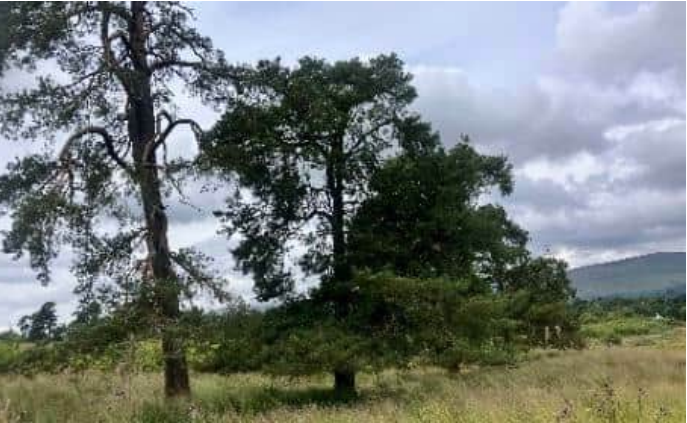
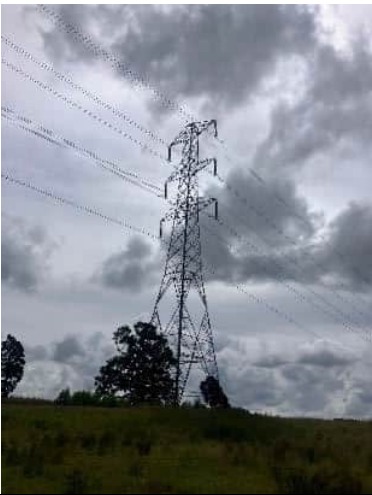
| | | <p>species including <b>amphibians</b> and <b>otter</b> may also be using the ditches.</p> <p><u>XL029</u><br/>The area surrounding the tower comprises semi-improved neutral grassland to the north and a strip of semi-improved neutral grassland and mixed broadleaf plantation to the south. The plantation to the southeast comprises birch and oak saplings, while to plantation to the west comprises silver birch (approx. 2m tall) with <b>scattered mature oak</b> and occasional Scot's pine. The plantations were not accessible due to deer fencing; however, they provide habitat for <b>nesting birds, foraging/commuting bats, and foraging/commuting badgers</b>. The mature trees may have features suitable for <b>roosting bats</b>.</p> | <p><b>Commuting/Foraging Bats:</b> any potential removal of trees may result in a reduction in the availability of bat foraging and commuting habitat within the site and in the immediate vicinity. Any lighting associated with works has the potential to deter bats from using foraging and commuting habitats.</p> <p><b>Nesting Birds:</b> any potential vegetation clearance (grassland, plantation), and vehicle tracking have the potential to damage/destroy nests and kill/injure nesting birds. <b><u>Birds may also nest within the tower at any time.</u></b></p> <p><b>Commuting/Foraging Badger:</b> commuting/foraging badger may be present within the grassland and plantation. Activities associated with the works carry a risk of short-term disturbance to badger through increased noise, vibrations, and human presence. There is potential for holes to be excavated by badgers.</p> <p><b>Roosting Bats:</b> It is not known whether any tree felling is anticipated; however, if required, the removal or pruning of a tree may result in the disturbance, killing and injury of bats.</p> | <p>Avoid/minimise any loss or fragmentation of foraging and commuting habitat. Where this is not possible replace the lost habitat. Trees should remain dark to allow bats to commute.</p> <p>Prior to any vegetation clearance/works to the tower and vehicular tracking, <b>a pre-works check for nesting birds will be required</b> by an ecologist, if the works will occur within nesting bird season (March to September).</p> <p>Implementation of precautionary measures with respect to commuting/ foraging badger detailed in the report above.</p> <p>Avoid felling/pruning of tree/branches. If not possible, then further bat surveys (e.g., aerial tree assessment, emergence surveys) should be undertaken.</p> |

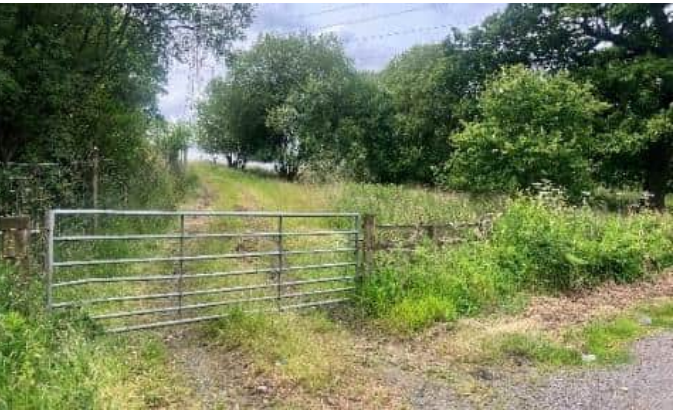
| XL030 | | <p><u>Access Track</u><br/>From the paved road, the access track to the tower is lined by tall ruderals. It follows an existing hardcore/stone track within semi-improved neutral grassland, with fenced goat willow and birch and scattered mature oak (<b>no bat roost potential observed</b>).</p> <p><u>XL030</u><br/>The area around the tower comprises entirely semi-improved neutral grassland. Dead tree stumps placed under tower could provide <b>refugia</b></p> | <p><b>Commuting/Foraging Bats:</b> any potential removal of trees may result in a reduction in the availability of bat foraging and commuting habitat within the site and in the immediate vicinity. Any lighting associated with works has the potential to deter bats from using foraging and commuting habitats.</p> <p><b>Nesting Birds:</b> any potential vegetation clearance (trees, ruderals, hedgerow, scrub, and grassland), and vehicle tracking have the potential to damage/destroy nests and kill/injure nesting birds. <b><u>Birds may also nest within the tower at any time.</u></b></p> | <p>Avoid/minimise any loss or fragmentation of foraging and commuting habitat. Where this is not possible replace the lost habitat. Trees should remain dark to allow bats to commute.</p> <p>Prior to any tree vegetation clearance (i.e. tree removal) or works to the tower and vehicular tracking, <b>a pre-works check for nesting birds will be required</b> by an ecologist, if the works will occur within nesting bird season (March to September).</p> |

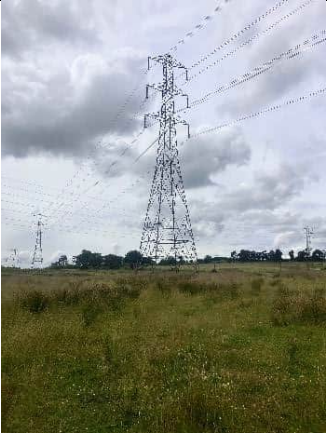
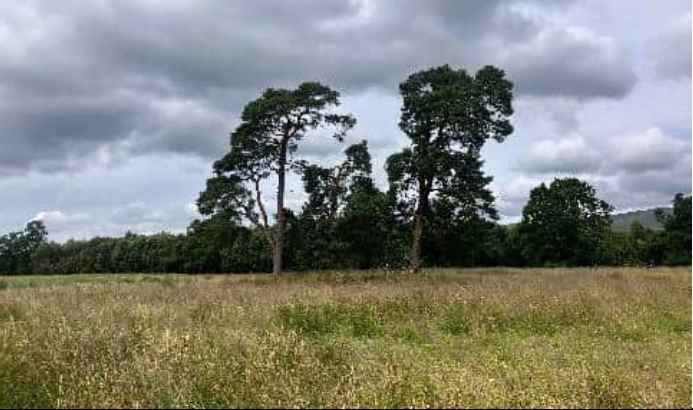
| | | <p><b>for small mammals, reptiles or amphibians.</b> On the edge of the 50m buffer, there are three Scot's pine trees with <b>bird's nest</b> present (TN15).</p> <p>The woods, scrub, and ruderals provide habitat for <b>nesting birds, foraging/commuting bats, and foraging/commuting badgers.</b></p> | <p><b>Nesting Birds:</b> any potential vegetation clearance (grassland, woodland, scrub), and vehicle tracking have the potential to damage/destroy nests and kill/injure nesting birds. <b><u>Birds may also nest within the tower at any time.</u></b></p> <p><b>Commuting/Foraging Badger:</b> commuting/foraging badger may be present within the grassland, woodland, scrub. Activities associated with the works carry a risk of short-term disturbance to badger through increased noise, vibrations, and human presence. There is potential for holes to be excavated by badgers.</p> <p><b>Habitat Pile:</b> any removal of the tree stumps has the potential to kill/injure small mammals, amphibians and/or reptiles.</p> | <p>Prior to any vegetation clearance/works to the tower and vehicular tracking, <b>a pre-works check for nesting birds will be required</b> by an ecologist, if the works will occur within nesting bird season (March to September).</p> <p>Implementation of precautionary measures with respect to commuting/ foraging badger detailed in the report above.</p> <p><b>Retain stumps where possible.</b> If required, the removal of the pile should be undertaken by hand and supervised by an ECoW as there is a risk of individuals present at any time during the year.</p> |

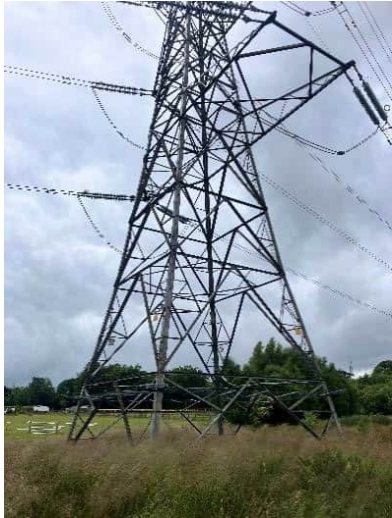
| XL031 | | <p><b>Access Track</b><br/>The access track follows a paved B-road with tall ruderals and willow scrub verges. Towards the bend, the ground drops to a large area of <b>marshy grassland (potential priority habitat and GWDTE)</b>. The road crosses over a bridge with a <b>wet ditch</b> beneath. A tall intact hawthorn hedgerow is present to the east of the road. The track turns down residential/equestrian property drive with poor semi-improved neutral grassland paddocks on both sides.</p> <p><b>XL031</b><br/>The area surrounding the tower comprises poor semi-improved grassland fields grazed by horses to the east and west of the tower, in addition to tall, semi-improved neutral grassland with areas of tall ruderal and a localised nutrient rich area where garden waste is being dumped around the base of the tower (TN19). This piled heap offers suitable refugia habitat for <b>small mammals, reptiles and amphibians</b>. Two dry <b>ditches</b> run within the buffer; however, they are both <b>unsuitable for water vole</b> due to the lack of water. To the southeast and north of the tower, there is a willow and birch plantation. The plantation and grassland offer suitable habitat for <b>nesting birds, foraging/commuting bats, and foraging/commuting badgers.</b></p> | <p><b>Priority Habitat Loss:</b> potential loss or damage to marshy grassland. Considering the nature of the works, pollution and physical damage may impact these habitats. Potential loss or damage of hedgerow along access track may result in the fragmentation of habitats in the area. Impacts to retained hedgerows may include physical damage to root systems during the works.</p> <p><b>Potential GWDTEs:</b> there is a risk of pollution of groundwater from leaks or spills from vehicles or equipment. Any vehicle/plant movement could damage vegetation within the working areas and along vehicular tracks.</p> <p><b>Nesting Birds:</b> any potential vegetation clearance (grassland, plantation), and vehicle tracking have the potential to damage/destroy nests and kill/injure nesting birds. <b><u>Birds may also nest within the tower at any time.</u></b></p> <p><b>Commuting/Foraging Badger:</b> commuting/foraging badger may be present within the grassland and plantation. Activities associated with the works carry a risk of short-term disturbance to badger through increased noise, vibrations, and human presence. There is potential for holes to be excavated by badgers.</p> <p><b>Habitat pile:</b> any removal of the pile has the potential to kill/injure small mammals, amphibians and/or reptiles.</p> | <p>Works must follow the pollution prevention measures detailed in this report. Hedgerow retention where possible. If not possible, replace the lost habitat. Implement best practice measures detailed in the report above</p> <p>Works must follow pollution prevention and other precautionary measures with respect to GWDTE areas detailed in the report above.</p> <p>Prior to any vegetation clearance/works to the tower and vehicular tracking, <b>a pre-works check for nesting birds will be required</b> by an ecologist, if the works will occur within nesting bird season (March to September).</p> <p>Implementation of precautionary measures with respect to commuting/ foraging badger detailed in the report above.</p> <p><b>Retain pile where possible.</b> If required, removal of the pile should be undertaken by hand with an ECoW present as there is a risk of individuals present at any time during the year.</p> |

| | | | <p><b>Ditch:</b> considering the proximity of the ditch to the access route, pollution/sediment run-off may impact this feature.</p> <p><b>Commuting/Foraging Bats:</b> any potential removal of trees may result in a reduction in the availability of bat foraging and commuting habitat within the site and in the immediate vicinity. Any lighting associated with works has the potential to deter bats from using foraging and commuting habitats.</p> | <p>Works must follow pollution prevention measures detailed in this report.</p> <p>Avoid/minimise any loss or fragmentation of foraging and commuting habitat. Where this is not possible replace the lost habitat. Trees should remain dark to allow bats to commute.</p> |

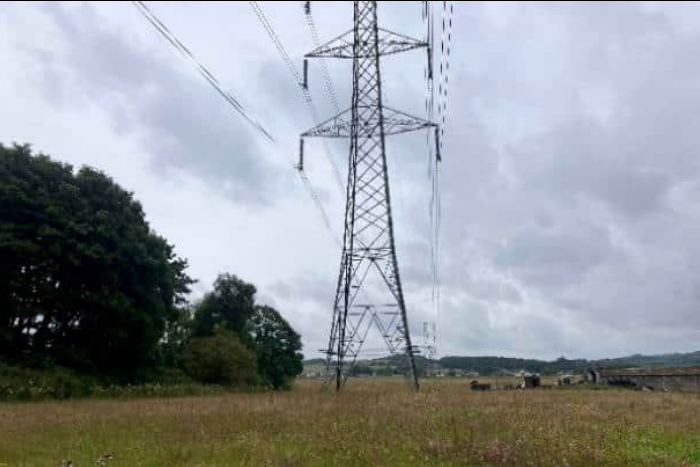
| XL032 | | <p><u>Access Track</u><br/><b>No access route marked on plans.</b></p> <p><u>XL032</u><br/>The area surrounding the tower comprises predominantly semi-improved neutral grassland, managed as a hay field. Northwest of the tower, there is a residential garden that comprises ornamental leylandii hedges and <b>mature sycamore, oak and birch trees</b>. Considering their age, some of these trees likely have features offering <b>bat roost potential</b>, however, a thorough ground search was not conducted as access to this area was not possible (TN20). These trees are part of a larger plantation that is listed on the <b>AWI as long-established</b>.</p> <p>The hedgerows and trees also provide habitat for <b>nesting birds, foraging and commuting bats, and foraging and commuting badger</b>.</p> | <p><b>Roosting Bats:</b> It is unknown whether tree felling or pruning is anticipated; however, if required, the removal or pruning of a tree may result in the disturbance, killing and injury of bats.</p> <p><b>Long-Established Plantation:</b> potential loss or damage of <b>woodland</b> habitat north of tower. While it is unknown if tree felling or pruning is anticipated, impacts to trees can also include physical damage to root systems during the works.</p> <p><b>Nesting Birds:</b> any potential vegetation clearance (grassland, hedgerow, trees), and vehicle tracking have the potential to damage/destroy nests and kill/injure nesting birds. <b><u>Birds may also nest within the tower at any time.</u></b></p> <p><b>Commuting/Foraging Badger:</b> commuting/foraging badger may be present within the grassland, hedgerow, and trees. Activities associated with the works carry a risk of short-term disturbance to badger through increased noise, vibrations, and human presence. There is potential for holes to be excavated by badgers.</p> <p><b>Commuting/Foraging Bats:</b> any potential removal of trees or hedgerow may result in a reduction in the availability of bat foraging and commuting habitat within the site and in the immediate vicinity. Any lighting associated with works has the potential to deter bats from using foraging and commuting habitats.</p> | <p>Avoid felling/pruning of tree/branches. If not possible, then further bat surveys (e.g., aerial tree assessment, emergence surveys) should be undertaken.</p> <p>Woodland retention where possible. If not possible, replace the lost habitat. Implement best practice measures detailed in the report above.</p> <p>Prior to any vegetation clearance/works to the tower and vehicular tracking, <b>a pre-works check for nesting birds will be required</b> by an ecologist, if the works will occur within nesting bird season (March to September).</p> <p>Implementation of precautionary measures with respect to commuting/ foraging badger detailed in the report above.</p> <p>Avoid/minimise any loss or fragmentation of foraging and commuting habitat. Where this is not possible replace the lost habitat. Trees should remain dark to allow bats to commute.</p> |

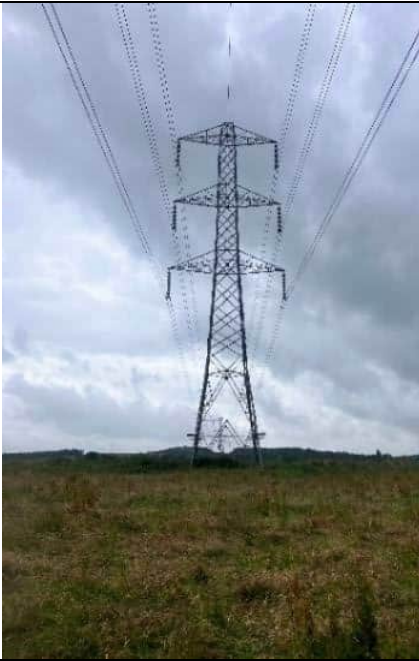
| | | | | <p><b>Sett-Building Badger:</b><br/>there is potential for holes to be excavated by badgers, especially along the vegetated slope close to the tower.</p> | <p>Prior to any vegetation clearance/works to the tower and vehicular tracking, <b>a pre-works check</b> for badger signs, including any sett entrances, is advised. This should be undertaken by a qualified ecologist.</p> |

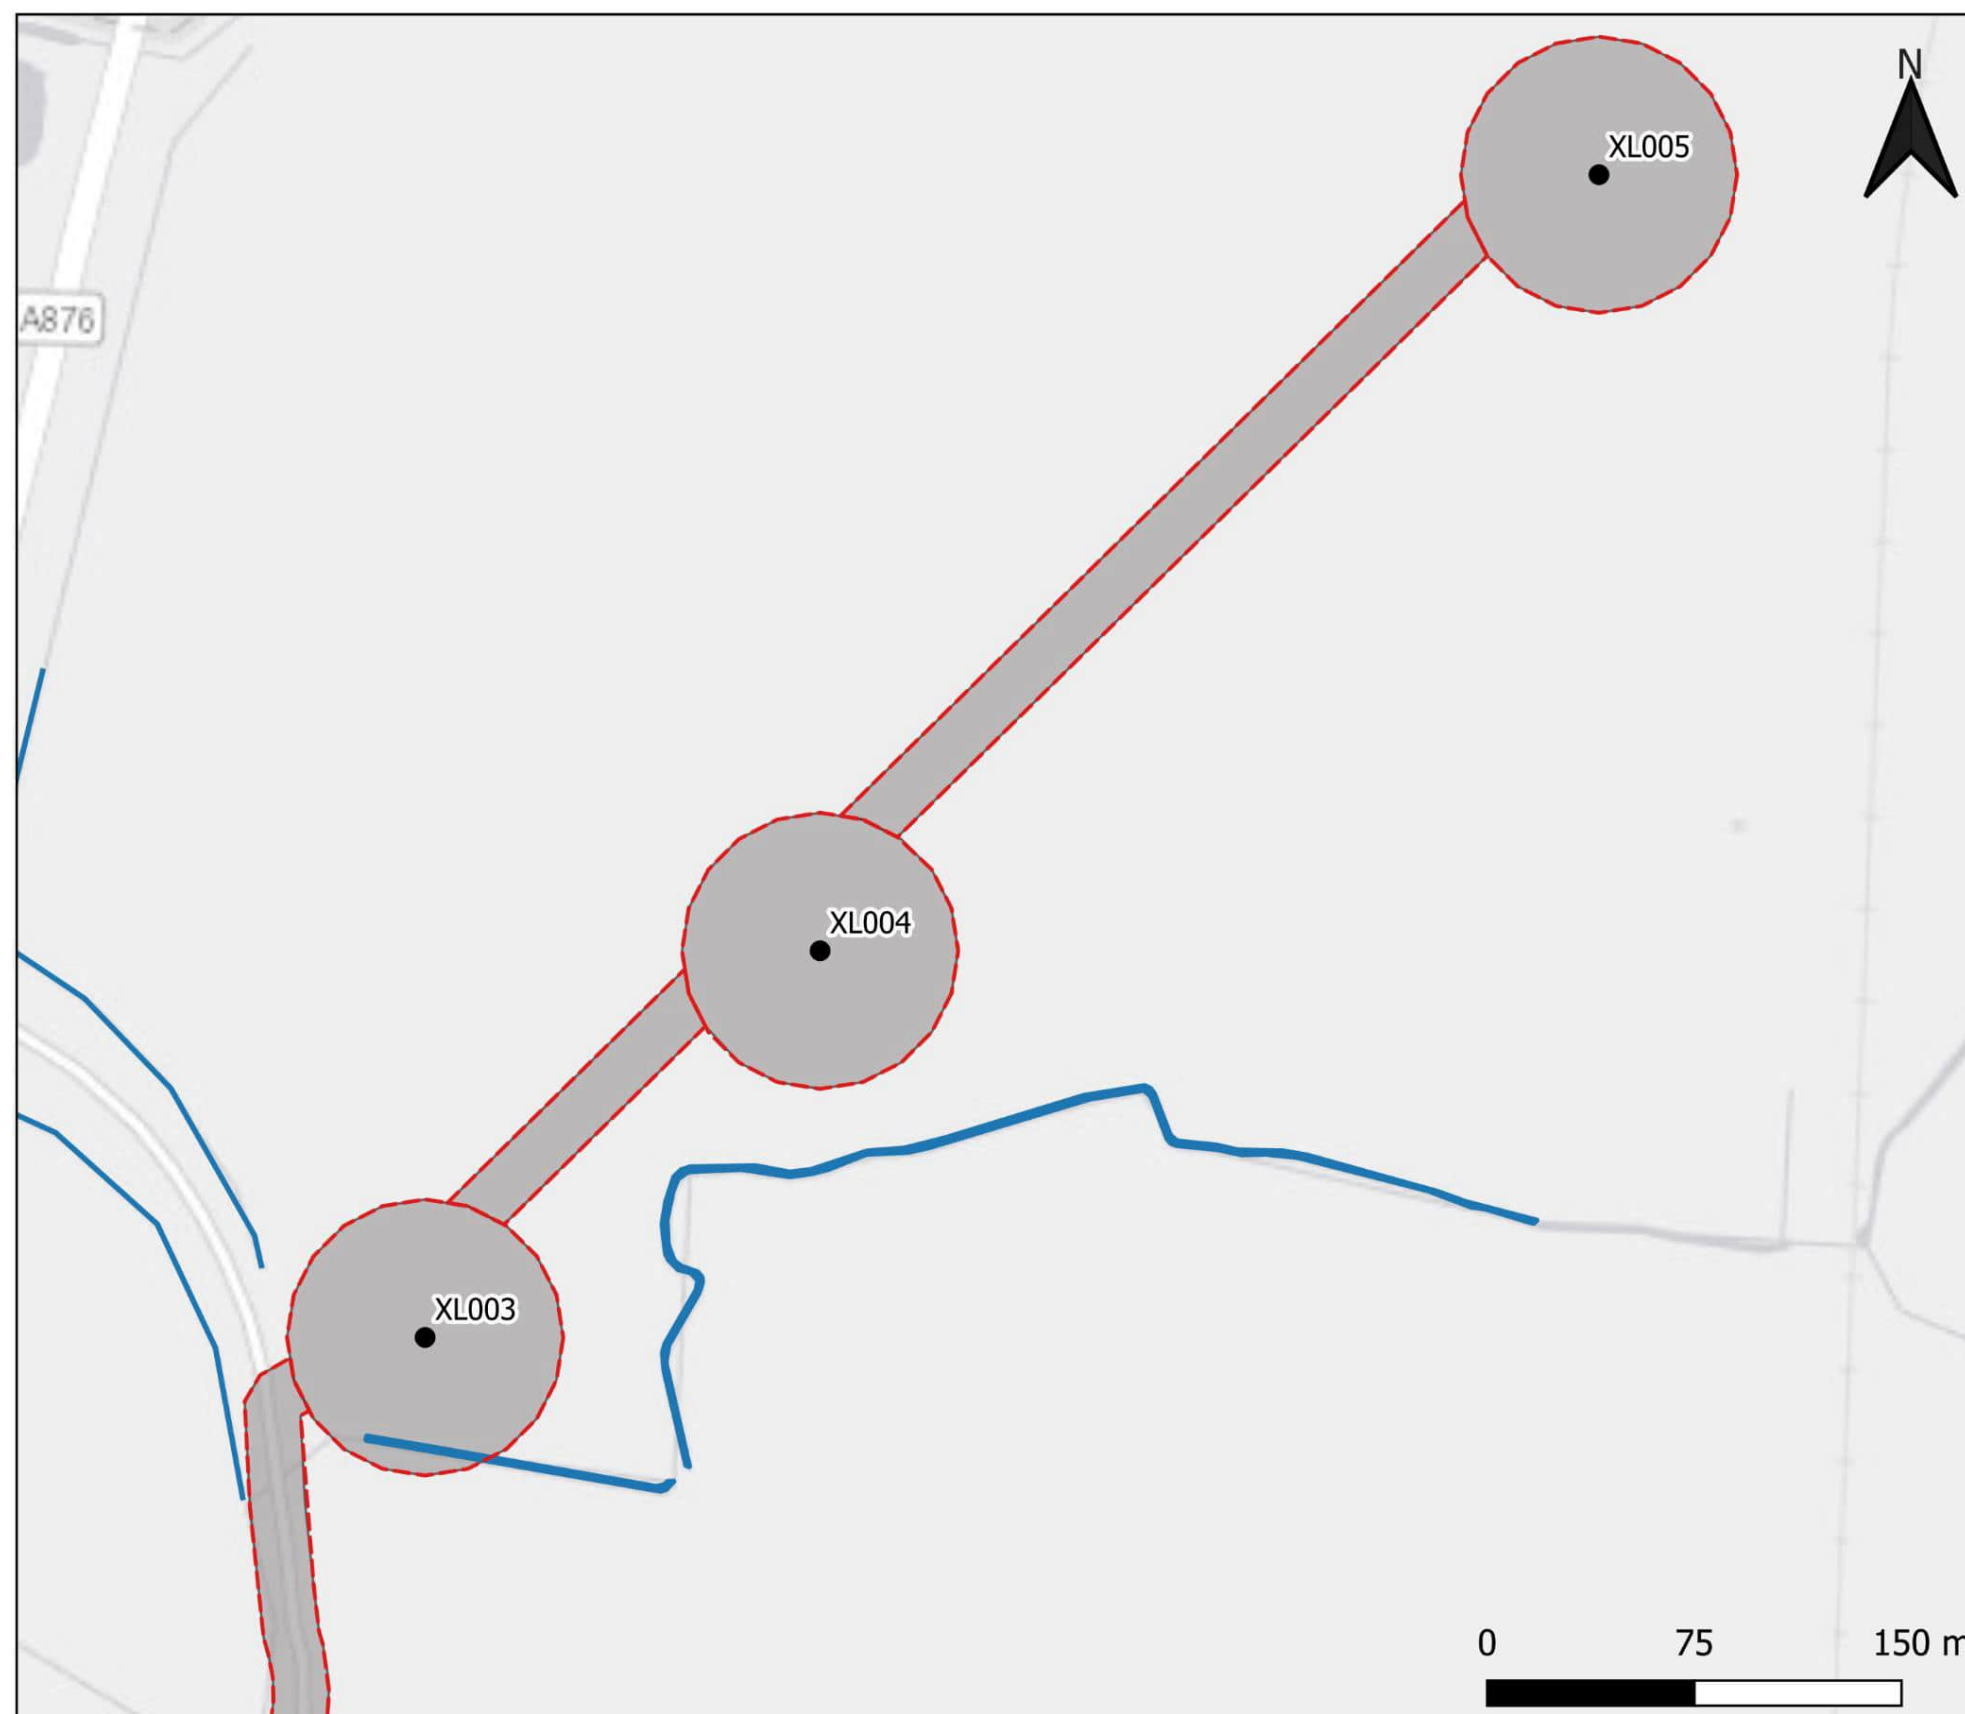
# BOWS23.097 XL Route Ecological Constraints Plan

- XL Towers
- ▭ Survey Area
- Target Notes
- Phase 1 Habitats
- Not Accessed Land
- Watercourse/ Drainage Ditches

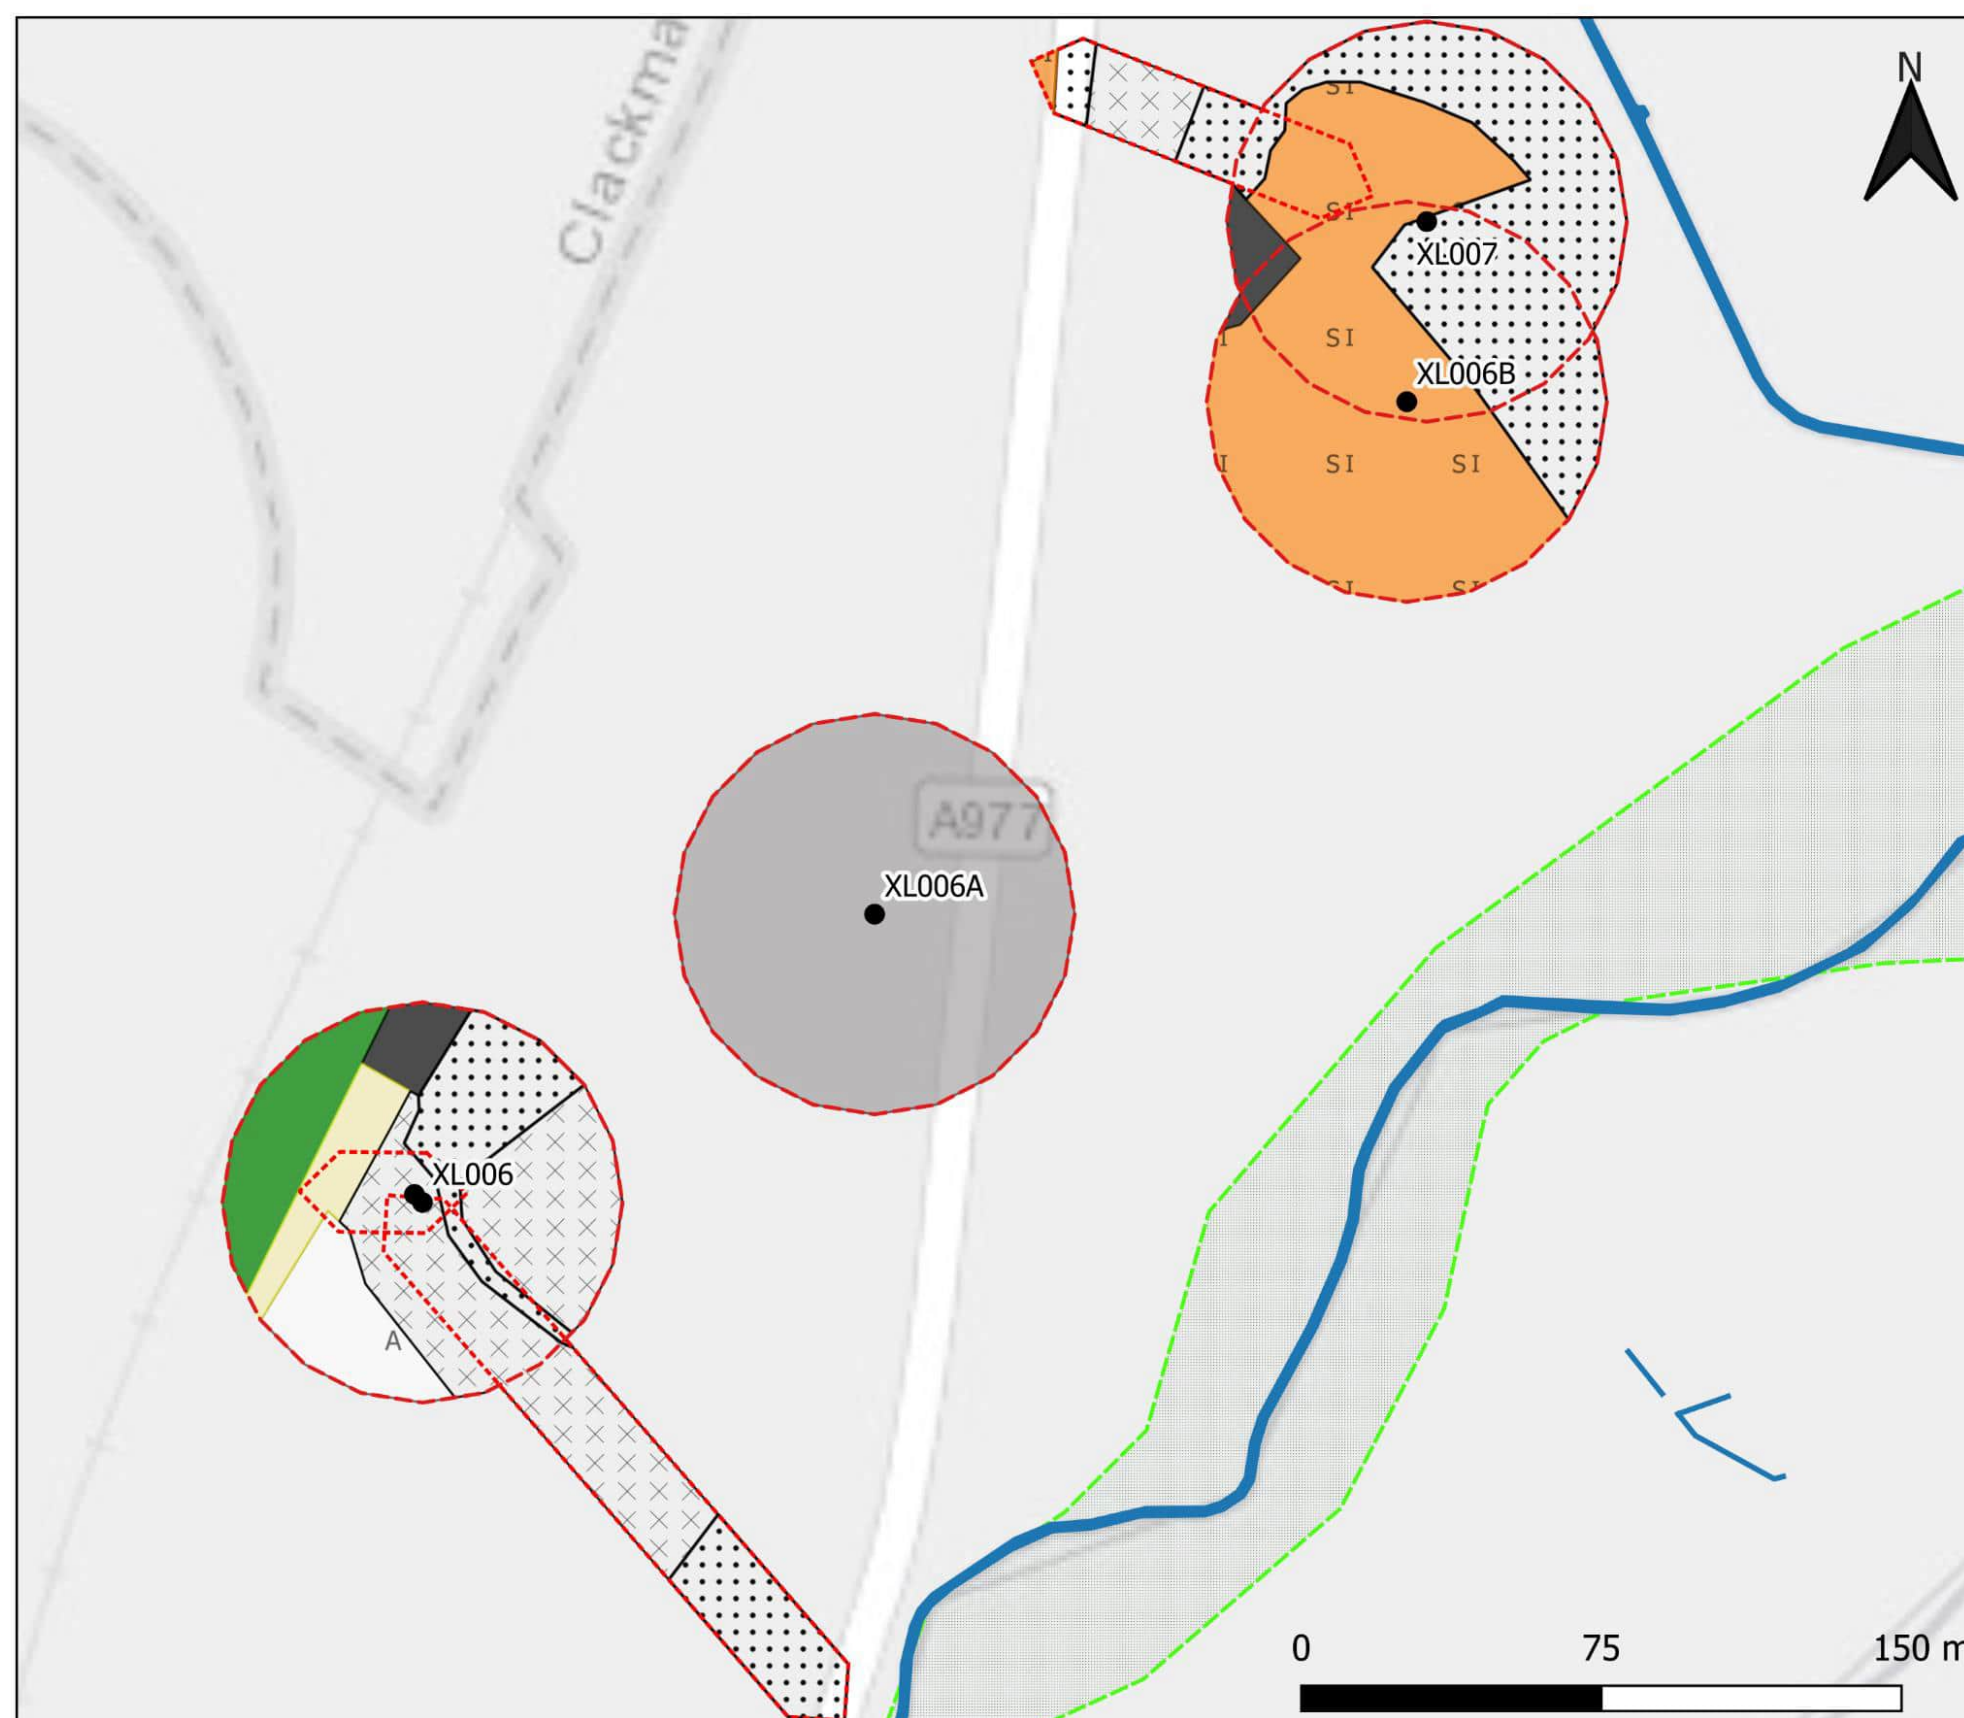
# BOWS23.097 XL Route Ecological Constraints Plan

- Broadleaved woodland  
- semi-natural
- Semi-improved neutral  
grassland
- Poor semi-improved  
grassland
- ▭ Arable Crop
- ▭ Disturbed land -  
ephemeral/short  
perennial
- Built-up areas
- ▭ Bare ground
- Not Accessed Land
- ▭ Acient Woodland  
Inventory Areas
