# **ECU – LWUP XL Route Refurbishment**

## **Ecological Walkover**

| <b>Document:</b> | <b>BOWS23.097 ECU – LWUP XL Route Ecological Walkover Report</b> | | | |

- 1.1 Bowland Ecology Ltd. was commissioned by Scottish Power Energy Networks (SPEN) to undertake an ecological walkover of the XL overhead line (OHL) running between the former Kincardine Power Station (NS923885) and the transmission license boundary at Blairingone (NS981966). This pertains to scheduled reconductoring works along the route, including the replacement of existing conductors between XL001A to XL006, the replacement of existing conductors between XL007 to XL031 (excluding XL006 to XL007), the replacement of existing downloads and associated fittings at Kincardine substation and the replacement and/or upgrade of damaged / corroded tower steelwork where required between XL001A-XL006 and XL007-XL031. The commencement of works is scheduled for Autumn 2024.

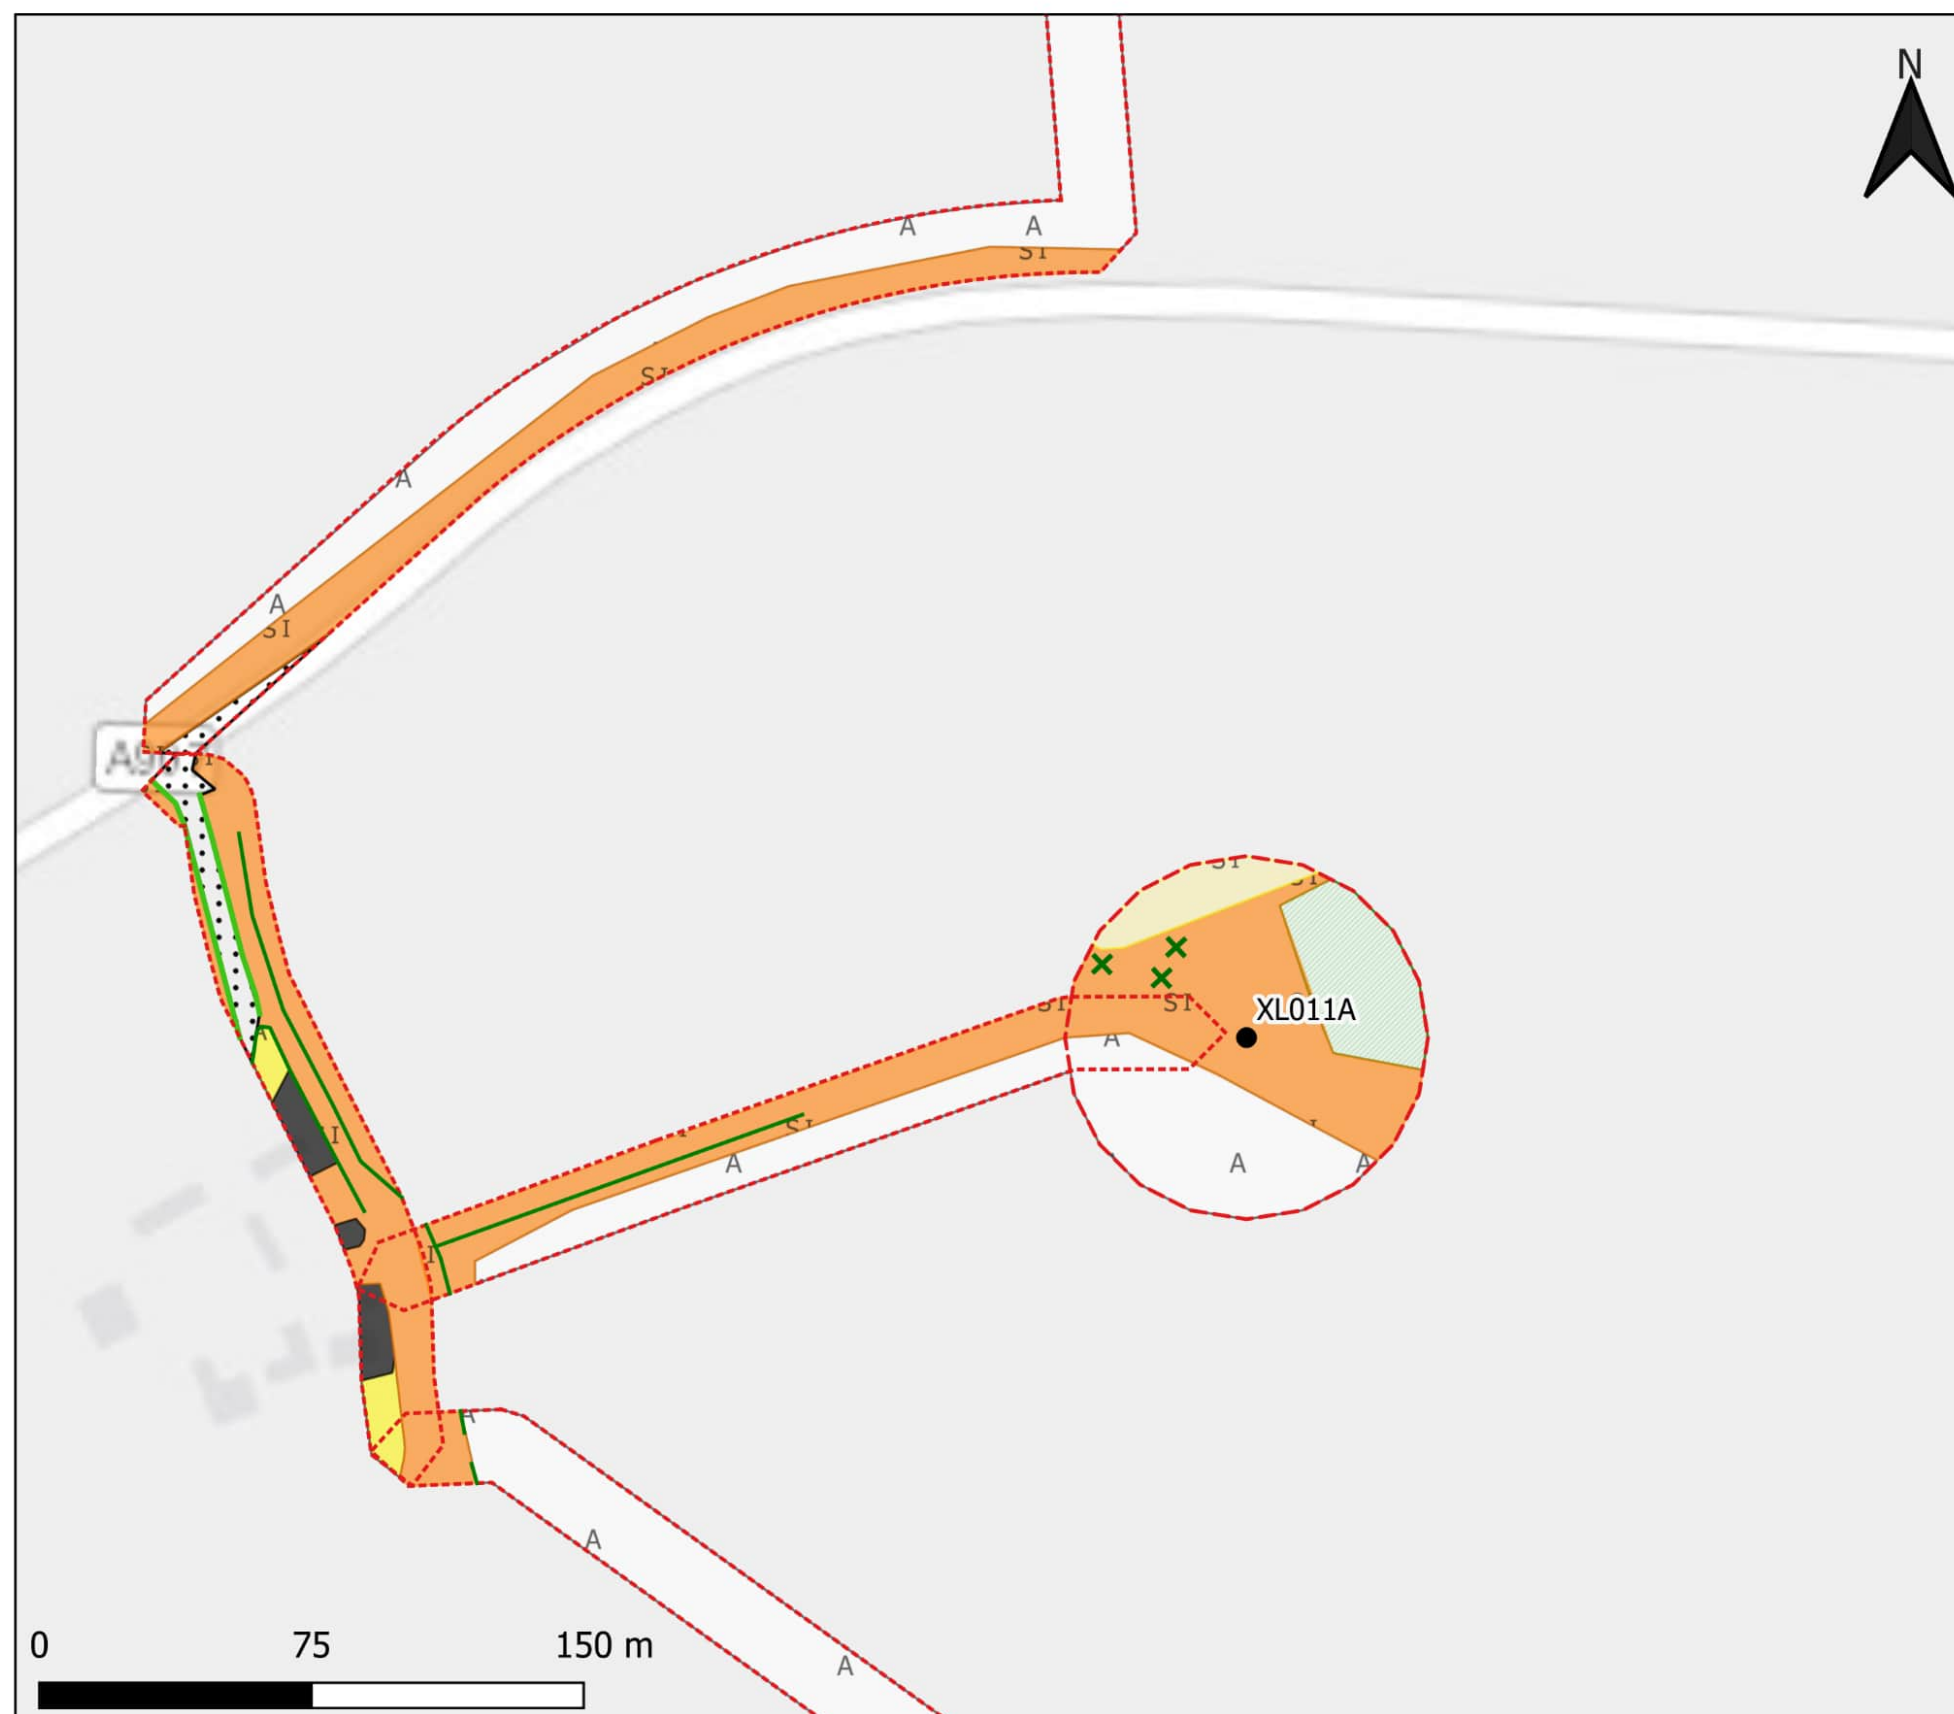
## BOWS23.097 XL Route Ecological Constraints Plan

- Intact hedge  
- species-poor
- Line of Trees
