Appendix 9.3

Non-designated Assets Baseline and Assessment and Plates

Appendix 9.3 Non-designated assets baseline and assessment and plates

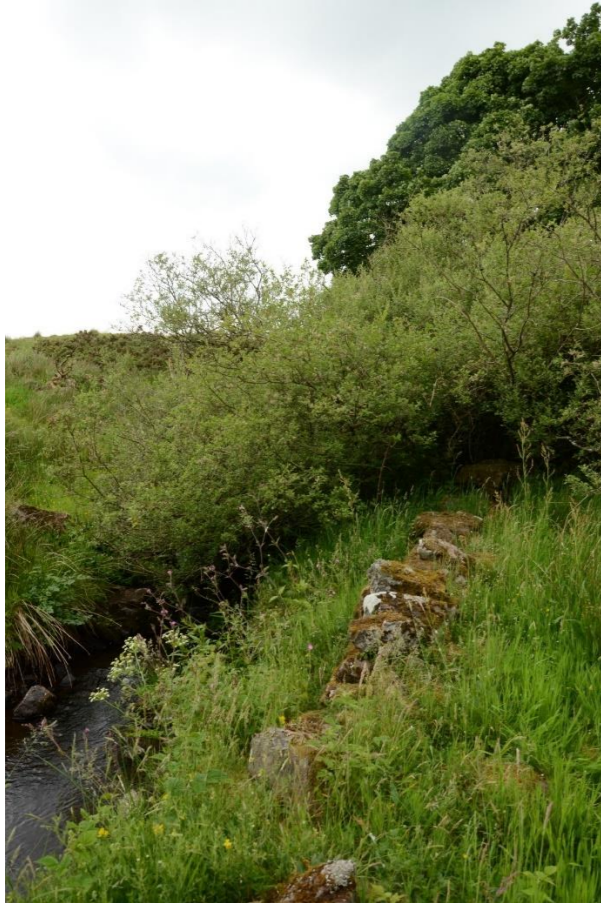
Plate 9. 1: Remains of a wall associated with Barscube Mill

Asset name	Asset reference	Description	Value	Sensitivity to physical change	Magnitude of change	Significance of effect	Mitigation	Residual effect
Site of Barscube Mill	WoSAS ref: 42306	Site of a former corn mill depicted on the 1863 OS 6-inch map and annotated as a ruin, indicating a medieval or early modern date for its use. The mill is located along a waterway at the bottom of Barscube Hill. Although largely overgrown some stonework, including truncated walls, were observed during the site walkover, along with slight earthworks. See plate 9.1 at end of this appendix	Low Derived from its intrinsic characteristics which have the potential to inform our understanding of medieval or early modern industry and technology and the patterns and distribution of such sites.	High	Low Micrositing of OHL no.97 could result in localised damage to the site of Barscube Mill as a result of truncation. Good practice measures should prevent damage to buried remains as a result of vehicular movement but there remains the potential for damage to above ground walls/ earthworks. However, the hillside location of this asset means that it is unlikely to be suitable for micrositing of the OHL or access, making any interaction highly unlikely.	None It is assumed that no effects would arise due to the hillside location of the asset making it inappropriate for micrositing	N/A	None

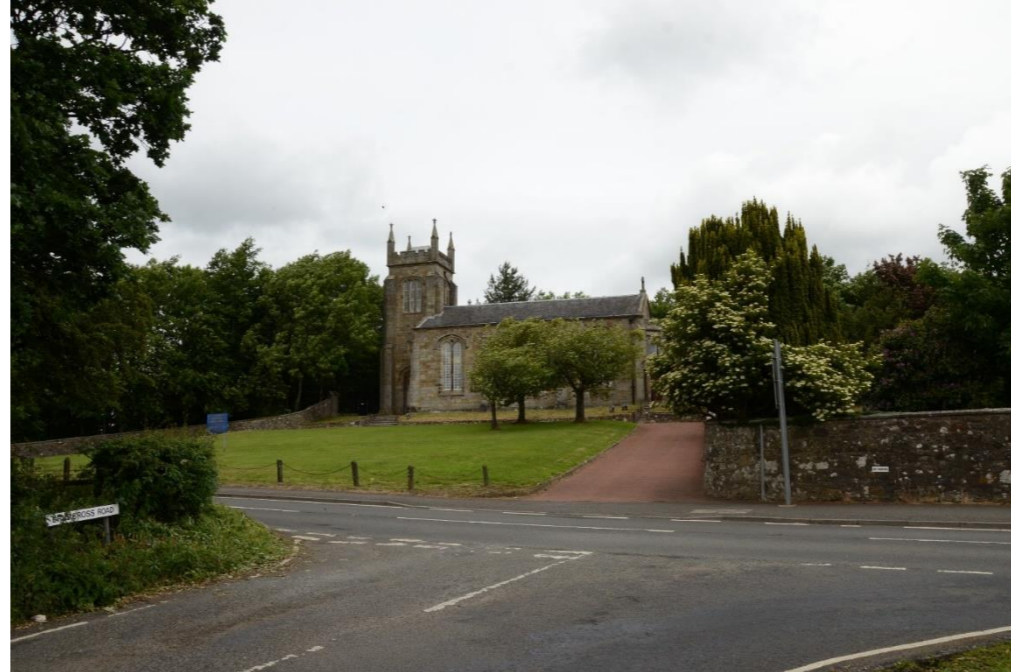
Plate 9. 2 Old Erskine Church (Bishopton Parish Church) facing north

Asset name	Asset reference	Description	Value	Sensitivity (to setting change only)	Magnitude of change	Significance of effect (also residual significance of effect)
Old Erskine Church (Bishopton Parish Church) and cemetery	WOA19 and WoSAS 7896	<p>Bishopton Parish Church lies on a knoll to the north-east of the village, in an area that remains largely undeveloped. The Abbey of Paisley founded a church on the site, on the pilgrimage route to Iona, in the twelfth century; however, the current building was constructed between 1813 and 1815. Built to designs by the Glaswegian mason and architect David Hamiltoni (1768 – 1843) the building comprises a hall church with a square tower at the west end. A lawn cemetery lies to the east of the church – over the site of the original church building - and beyond that is the former manse - now a category C listed building – that has been extended for use as a nursing home.</p> <p>See plate 9.2 at the end of this appendix</p>	<p>Low</p> <p>This asset has a low cultural value, derived from a combination of its architectural and historical interest as a well-preserved example of a Scottish post-reformation church designed by a prominent local architect.</p>	<p>Low</p> <p>In terms of setting, the cemetery and lawns contribute to the special interest of the building and its legibility. The church also has an important functional and historical relationship with the Manse, although the ability to appreciate this relationship has been diminished by the increased boundary separation between the two and the built additions to the manse.</p> <p>There is a large commercial/ industrial complex to the rear of the church, but it is screened by an extant woodland shelter belt from Erskine Park. There is also a large tarmac surfaced carpark on the opposite side of the B815, which runs past the church. Otherwise, the setting remains largely undeveloped and allows for its appreciation as a rural parish church.</p>	<p>Negligible</p> <p>The New 132kV OHL will effectively replace the Existing 132kV OHL, running approximately 660m to the south of the church, roughly in line with the M8. Consequently, they will only be perceived from the church and cemetery and not in conjunction with it. As such, there is no risk of any change to the legibility of the relationship between the church, its cemetery and the manse.</p> <p>Views from the church are cross wide-open agricultural land with some intervening trees, and built development (1 Kirkton Cottages), as well as existing OHL. These existing OHL are closer and will be more prominent in the views than the New 132kV OHL.</p>	<p>None</p> <p>The New 132kV will make a barely perceptible material change to the rural character of the landscape and will not affect the legibility of Old Bishopton Church as a rural parish church or any of the Church's key functional and historical relationships.</p>

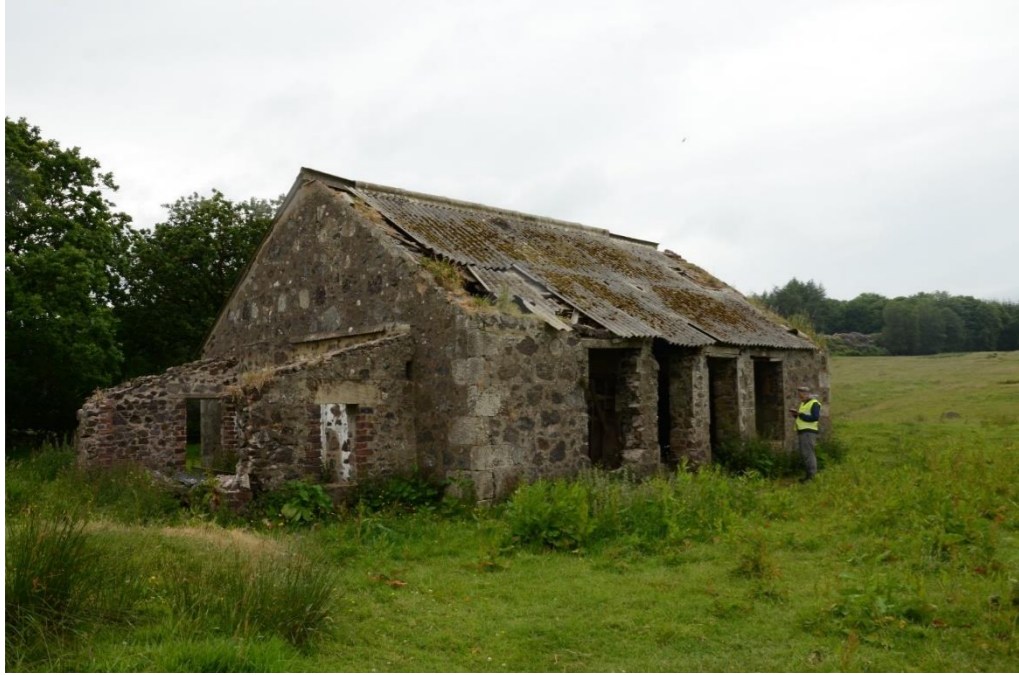
Plate 9. 3 Derelict house in Park Erskine

Park Erskine derelict house	WOA10	During the site walkover a roofed but semi-derelict house of late 19th century date was identified in Park Erskine. Constructed in uncoursed rubble with a corrugated roof, it comprised two bays with front hall and a later brick and stone lean-to to the southern gable; missing door and window joinery, but internal stud walls and lath with some extant plaster remains. Partially extant cast-iron kitchen range and two fireplaces to both gables noted on field inspection. Review of historic maps suggests that the building replaced a larger structure, also named Park Erskine and depicted on the first edition of the Ordnance Survey 25-inch map (Renfrewshire, Sheet VII.3, 1858, surveyed 1857), along with a small sub-rectangular possible garden enclosure to the northeast, built into the adjacent field boundaries and partially lined with trees. By the time of the second edition (25-inch, Renfrewshire, Sheet VII.3, revised 1895-97, published 1897), the larger structure has gone and been replaced by a smaller roofed structure within the putative garden	Low Derived from its intrinsic ability to evidence local vernacular and contribute to the understanding of settlement patterns.	High	Negligible This asset lies in working area and location ILA of pole no.82. However, for health and safety, as well as practicality reasons it is assumed that this asset will be avoided during the construction of the New 132kV OHL.	None No effect is anticipated.	N/A	Park Erskine derelict house

Park Erskine derelict house	WOA10	<p>During the site walkover a roofed but semi-derelict house of late 19th century date was identified in Park Erskine. Constructed in uncoursed rubble with a corrugated roof, it comprised two bays with front hall and a later brick and</p>	<p>Low</p> <p>This asset has a low cultural value derived from its intrinsic ability to evidence local vernacular</p>	<p>Low</p>	<p>Negligible</p> <p>The New 132kV OHL will pass approximately 50m south of this asset.</p>	<p>None</p> <p>The small material change to the rural setting of the asset will be of negligible effect as the</p>

<p>stone lean-to to the southern gable; missing door and window joinery, but internal stud walls and lath with some extant plaster remains. Partially extant cast-iron kitchen range and two fireplaces to both gables noted on field inspection.</p> <p>Review of historic maps suggests that the building replaced a larger structure, also named Park Erskine and depicted on the first edition of the Ordnance Survey 25-inch map (Renfrewshire, Sheet VII.3, 1858, surveyed 1857), along with a small sub-rectangular possible garden enclosure to the northeast, built into the adjacent field boundaries and partially lined with trees. By the time of the second edition (25-inch, Renfrewshire, Sheet VII.3, revised 1895-97, published 1897), the larger structure has gone and been replaced by a smaller roofed structure within the putative garden enclosure – the position occupied by the extant building noted on site.</p> <p>See plate 9.2 at the end of this appendix</p>	and contribute to the understanding of settlement patterns.	The agricultural setting of the asset contributes to the legibility of the building as a rural dwelling.	<p>Their introduction will result in a very slight change to the rural character of the landscape and setting of the asset, as the Existing 132kV do not interact with its setting.</p> <p>The New 132kV OHL will be experienced in conjunction with, and from, the asset.</p>	asset will retain its intrinsic characteristics and continue to be understood as a rural dwelling.

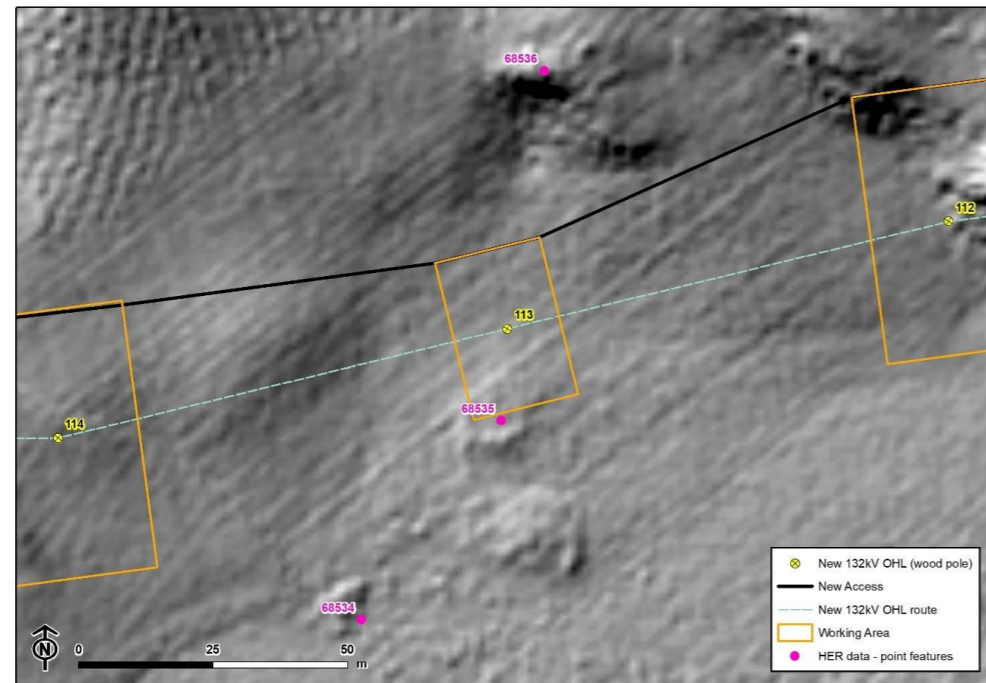
Plate 9. 4: Dargavel Burn hut circle (WoSAS ref: 68535)

Dargavel Burn hut circle(?)	WoSAS ref: 68535	A sub oval area of stone with a low bank along the south side, interpreted as a possible stone hut. Covered by moss and stone and is prominent from the remainder of the long grass covering the field. Measures 10m by 6m by 0.5m high. Visible on LiDAR data. See figure 9.2 at the end of this appendix	Uncertain (but has the potential to be of medium to high value) Hut circles are not common in the area and this possible example - it has only been identified via Lidar as a circular feature - may have potential to enhance our understanding of prehistoric settlement and agriculture through its intrinsic characteristics.	Potential physical effect lies within the working area of New 132kV OHL no.113	None - Minor The working area should be adjusted to avoid this asset and LGP vehicles and matting should be used to avoid compression/ truncation to any potentially associated archaeological deposits in the wider area of the earthworks. There is the potential for the excavation of the OHL pole to truncate previously unknown archaeological deposits in the vicinity	Minor Truncation of previously unknown associated deposits will likely result in a Minor effect	A watching brief may be required during the excavation of OHL no. 115 due to proximity to the possible hut circle	None (barely perceptible)

Dargavel Burn hut circle(?)	WoSAS ref: 68535	A sub oval area of stone with a low bank along the south side, interpreted as a possible stone hut. Covered by moss and stone and is prominent from the remainder of the long grass covering the field. Measures 10m by 6m by 0.5m high. Visible on LiDAR data..See figure 9.2 at the end of this appendix	Uncertain (but has the potential to be medium to high value) Hut circles are not common in the area and this possible example - it has only been identified via Lidar as a circular feature - may have good potential to enhance our understanding of prehistoric settlement and agriculture through its intrinsic characteristics.	None The setting of this asset comprises agricultural land with woodland to the south. This setting does not appear to contribute to its heritage value, which is derived mainly from its intrinsic characteristics.	None There will be no change to the heritage value of this asset as its setting does not contribute to that value.	None There is no effect.

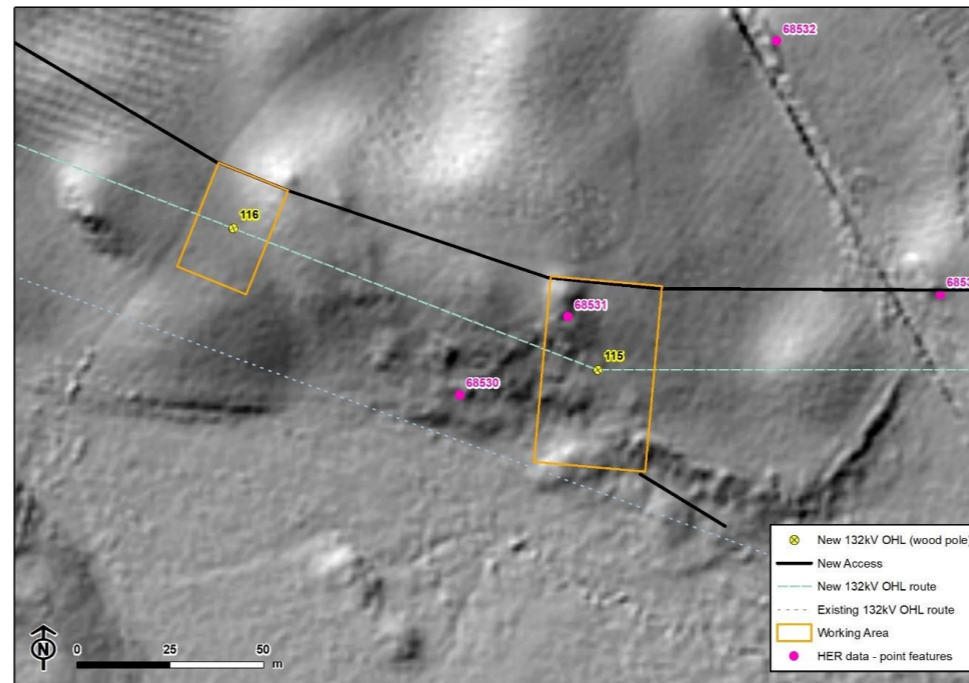
Plate 9. 5: Knockmountain settlement/ buildings (WoSAS ref: 6853)

Asset name	Asset reference	Description	Value	Interaction with EDM Project	Magnitude of change	Significance of effect	Mitigation	Residual significance of effect
					of, and associated with, the possible hut circle.			
Knockmountain settlement/ building	WoSAS ref: 68530	This asset comprises an unclassified and undated building/ settlement site, for which the HER has no further information. It is located to the southeast of Knockmountain in a valley. Review of LiDAR data suggests that the asset is a rectangular shaped building, which must pre-date the mid-19th century as it is not shown on any historic OS mapping. See figure 9.3 at the end of this appendix	Uncertain This undated building/ asset would inform our understanding of local settlement and land use through its intrinsic characteristics.	Potential physical effect extends into the working area of New 132kV OHL no. 115	Low No harm should arise to the asset as a result of vehicular movement as the working area should be adjusted to avoid the asset; and/ or LGP vehicles and matting will be used. There is the risk of truncation of archaeological deposits as a result of excavations for the erection of the OHL pole. This may lead to a slight change in the cultural significance of this asset.	Minor Excavations for the OHL pole may lead to a slight change in the cultural significance of this asset.	A watching brief may be required during ground intrusive works	None (barely perceptible)

Knockmountain settlement/ building	WoSAS ref: 68530	This asset comprises an unclassified and undated building/ settlement site, for which the HER has no further information. It is located to the southeast of Knockmountain in a valley near two field clearance cairns (WOA8 and WoSas ref: 68531), as well as two settlement sites: to the southwest a ruinous homestead of unknown date (Canmore: 42401), and, to the east, a possible prehistoric hut circle (WoSas ref: 68535). See figure 9.3 at the end of this appendix Review of LiDAR data suggests that the asset is a rectangular shaped building, which must pre-date the mid-19th century as it is not shown on any historic OS mapping.	Uncertain This undated building/ asset will inform our understanding of local settlement and land use through its intrinsic characteristics.	Uncertain The contribution that setting makes to the heritage value of this asset is uncertain as its heritage value is not fully understood. However, it is likely to be an agricultural settlement and, if broadly contemporary, with the surrounding fieldscape the two may be functionally/ historically related. If this is the case, then the asset would be of low sensitivity to setting change given that its value is largely archaeological.	Negligible The Existing 132kV OHL are located approximately 15m south of this asset. The New 132kV OHL will be routed approximately 20m north of the asset. Therefore, the experiential change to the legibility of the asset will be barely perceptible.	None Given the uncertain value of this asset and the barely perceptible change to its setting the value of this effect is None.
