Kendoon to Tongland 132kV Reinforcement Project

Appendix 9.6 Peat Landslide Hazard and Risk Assessment

June 2020

Client	SPEN
Document Number	19-LUC-004-01v02
Author(s)	Andy Mills, Director
Approved by	David Rushton, Director
Version	02
Date	25/06/2020

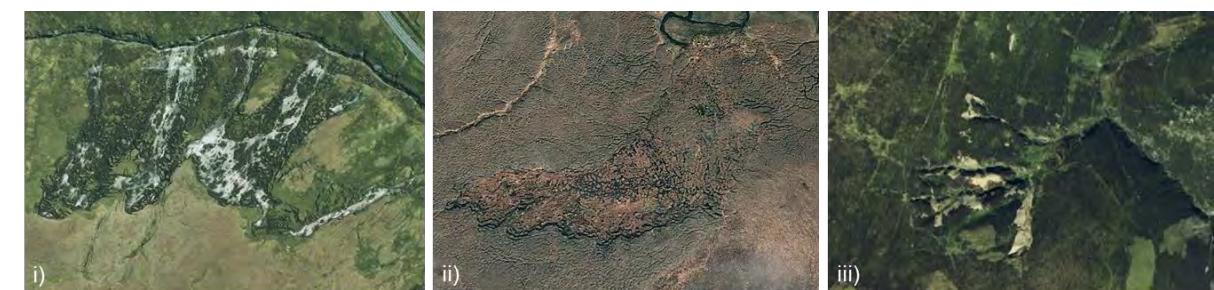
Plate 1: Characteristics landslide types in UK uplands: i) multiple peat slides with displaced slabs and exposed substrate, ii) retrogressive bog burst with peat retained within the failed area, iii) multiple peaty soil slides in a headwater area with displacement of thin soils exposing substrate (all images are at a similar scale and approximately 400m in width)

3.2.3 For the purposes of this assessment, landslide classification is simplified and split into three main types, typical examples of which are shown in **Plate 1**. Dimensions, slope angles and peat depths are drawn from charts presented in Evans and Warburton (2007). The term “peat slide” is used to refer to large-scale (typically less than 10,000 of cubic metres) landslides in which failure initiates as large rafts of material which subsequently break down into smaller blocks and slurry. Peat slides occur ‘top-down’ from the point of initiation on a slope in thinner peats (between 0.5 m and 1.5 m) and on moderate slope angles (typically 5-15°).

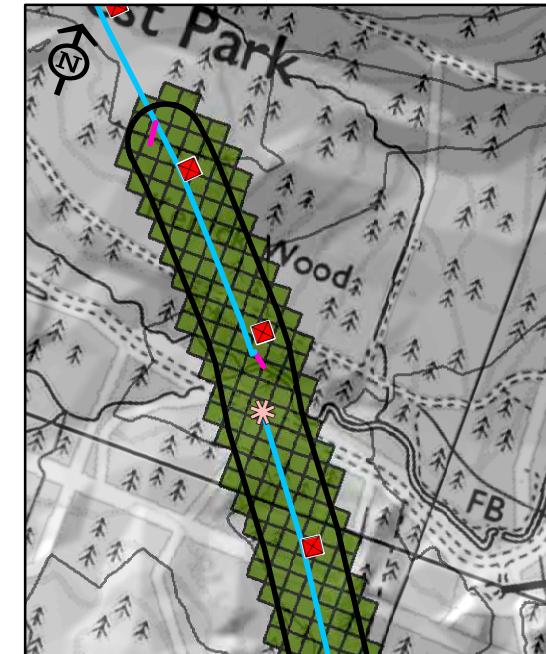
**Appendix 9.6
Figure 7: Factor of Safety
Results (Limit Equilibrium)**

The outputs of the drained analysis (effective stress) are shown for the less conservative combination in **Figure 7** ('Factor of Safety Results (Limit Equilibrium)'). The more conservative combination, not shown, suggests that a considerable proportion of the site is either unstable ($F < 1$) or of marginal stability ($F < 1.4$) which is not consistent with site observations nor with the stability of peat in general – peat landslides are very rare occurrences given the wide distribution of peat soils in England, Scotland and Wales. The less conservative combination therefore results in more credible results, with only the steepest valley sideslopes showing marginal stability ($F < 1.4$).

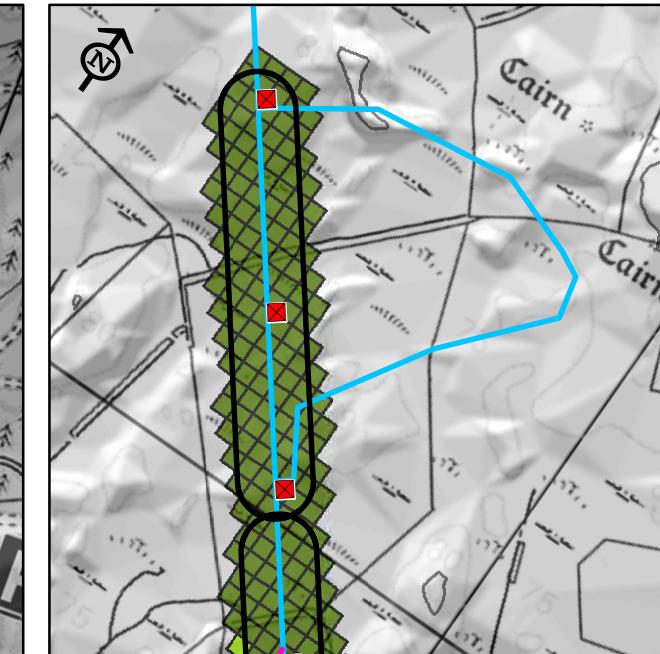
■	≤ 1.0	Unstable
■	$> 1.0 \text{ to } 1.4$	Marginally Stable
■	$> 1.4 \text{ to } 2.0$	
■	$> 2.0 \text{ to } 3.0$	Stable
■	> 3.0	
		No results

- 4.2.4 Where the driving forces exceed the shear strength (i.e. where the bottom half of the equation is larger than the top), F is < 1, indicating instability. A factor of safety between 1 and 1.4 is normally taken in engineering to indicate marginal stability (providing an allowance for variability in the strength of the soil, depth to failure, etc). Slopes with a factor of safety greater than 1.4 are generally considered to be stable.
