# LV Engine

LVDC Trial Site

LVDC Protection Strategy Summary

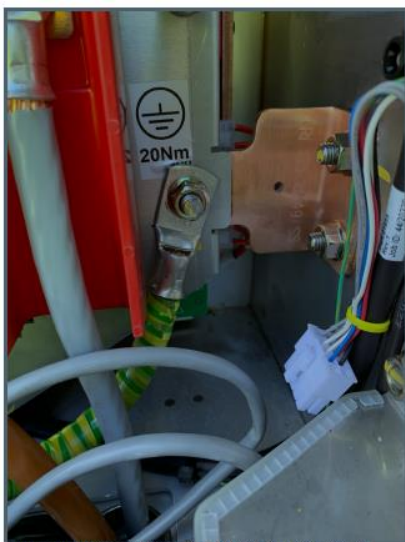
**Figure 4 – CPC connection to earth terminal**

- 1- One core of the 3-core cable is allocated as a CPC and connected to the earth bar in the substation at one end and to the earth terminal at the EV charger at the other end, Figure 4.
- 2- The armour of the 3-core cable is earthed at the substation end and also connected to the EV charger chassis from the other end, see Figure 5.

The earth connection to the EV charger is provided by two circuit protective conductors (CPCs) from the substation:
