LV ENGINE

LV Engine Solution Integration and Regression Testing

Report Title : LV Engine Deliverable #4 – Integration Testing

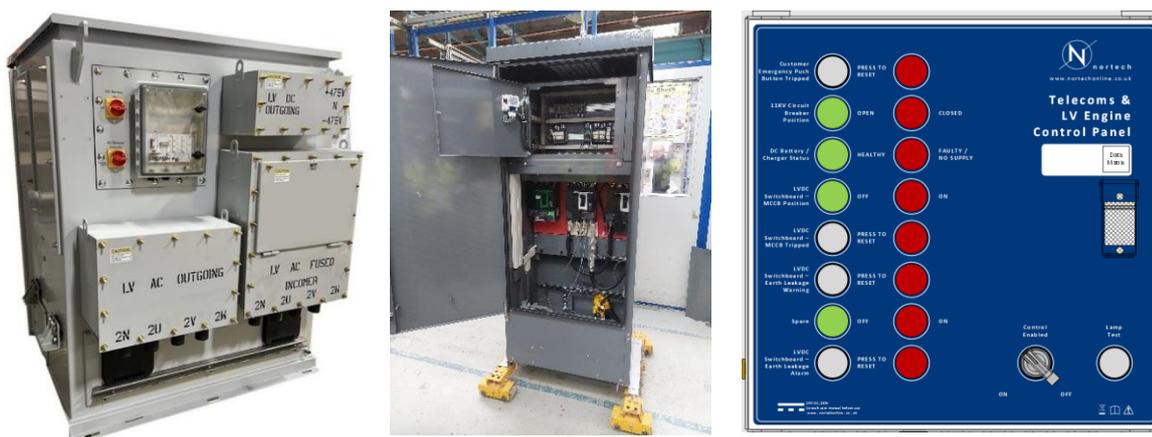
Figure 1 – UPFC (left) and LVDC distribution board (middle), LCS (Right)

Additionally, the switchboard houses protection and isolation equipment. The LVDC distribution board is fitted with disconnectors, Moulded Case Circuit Breakers (MCCB) and under-voltage release relays. Furthermore, an earth leakage protection relay is installed in the distribution board measuring current through the earth-neutral link. The Bender RCMB301 earth leakage protection relay has been selected to deliver this function. The suitability of this relay has been confirmed previously following tests carried out PNDC [2]. See Figure 1 for the general arrangement of the LV Switchboard.

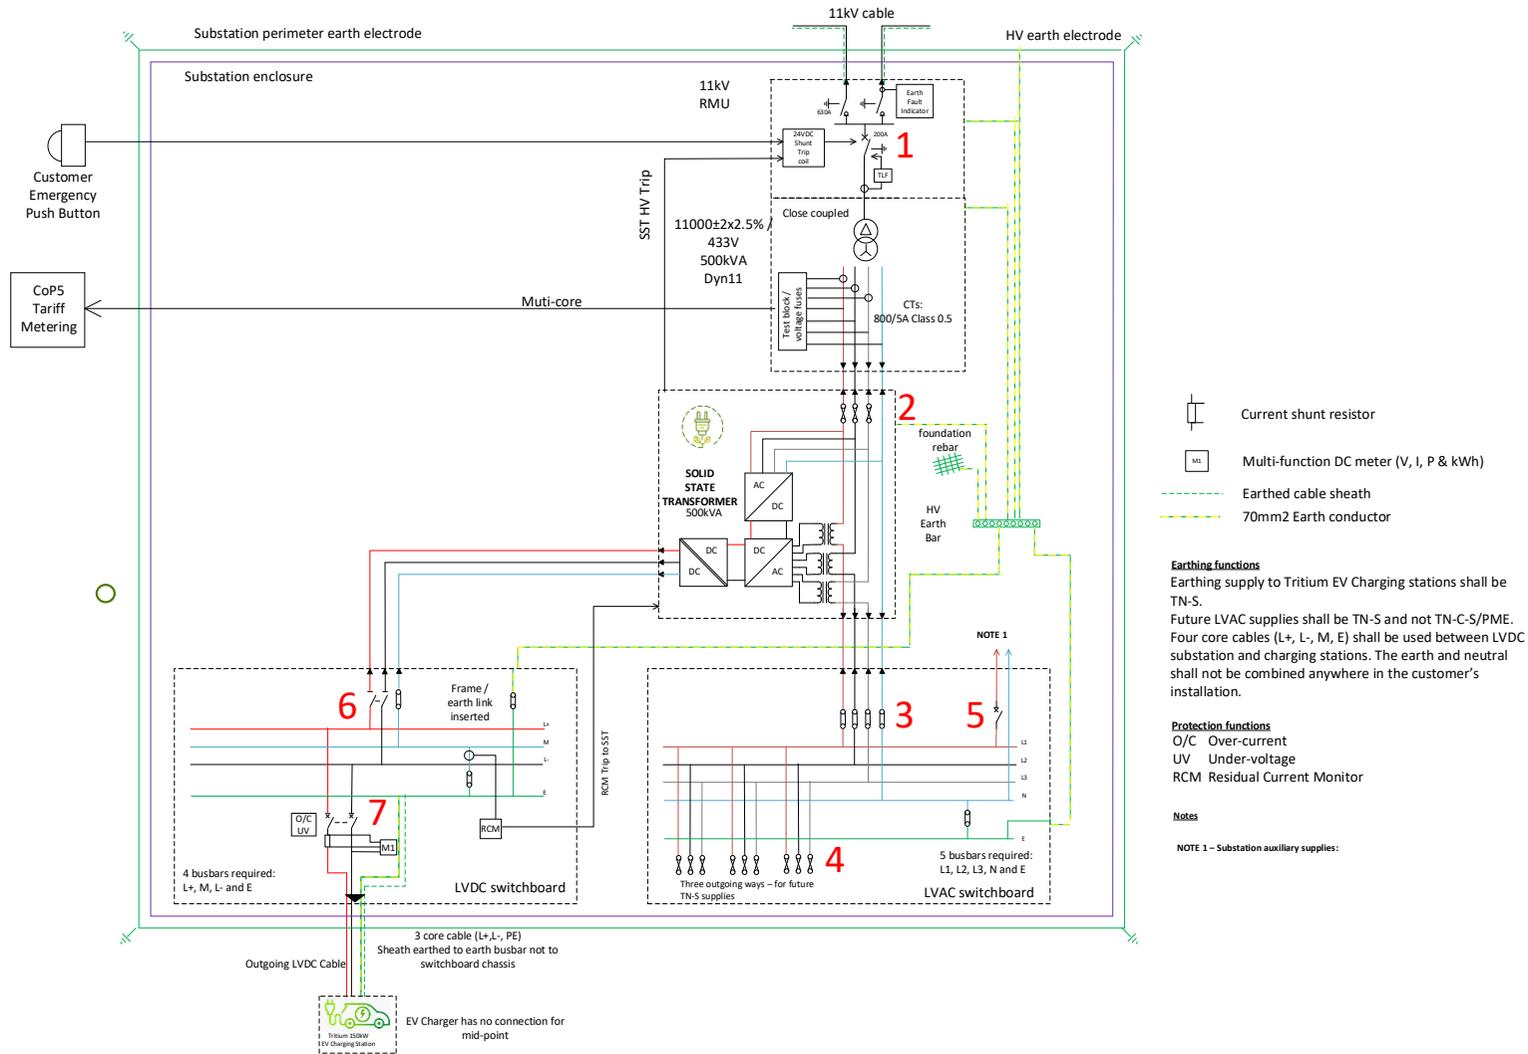
Figure 2 – Trial network diagram illustrating the key hardware and interconnections [2].

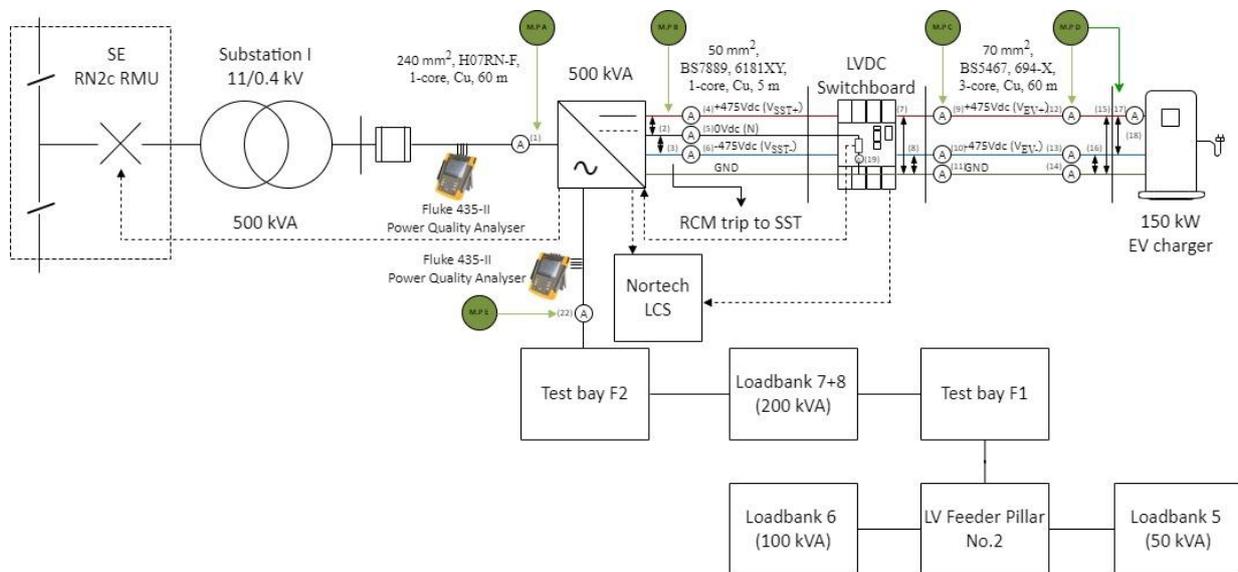
Figure 3 – Test circuit employed for AC and DC testing on the LV Engine equipment

An LVDC switchboard was installed between the UPFC and the DC EV charger. The switchboard is used to distribute the DC power to the downstream DC loads and provides protection functionality. The LVDC switchboard is fitted with disconnectors, an MCCB, under-voltage release relays and an earth leakage protection relay.

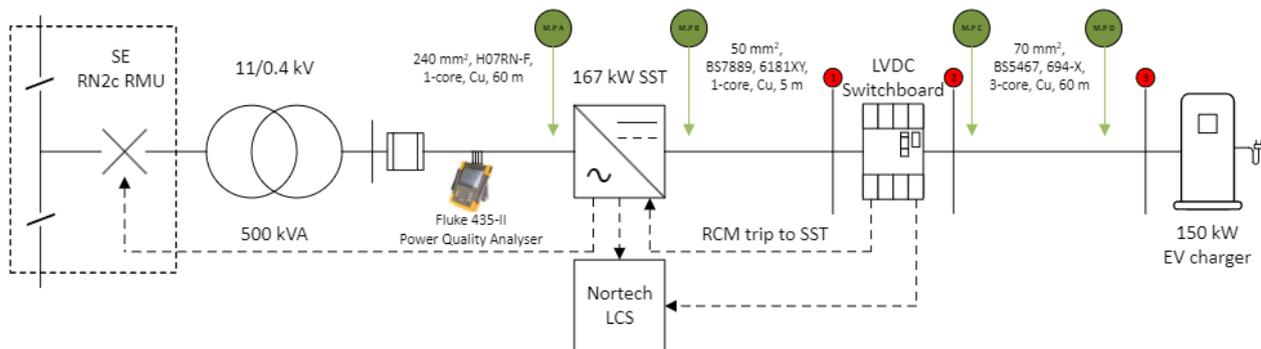
Figure 6 – Simplified test circuit with measurement points (M.P) and fault locations (red numbered circles).

The PNDC measurement setup will record voltage and current data during the applied fault conditions. Figure 6 details the general test circuit, where the specific measurement points (MP) will be and fault locations (red numbered points).

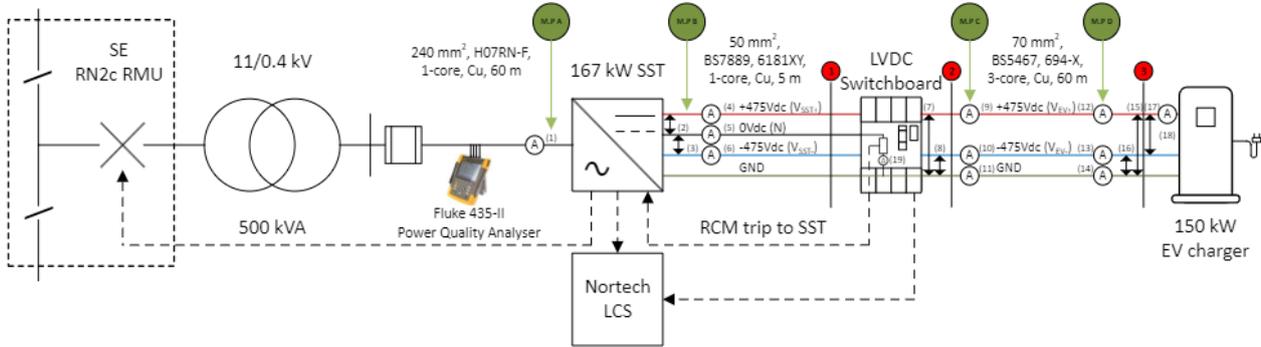
Figure 7 – Annotated test diagram with measurements. Measurement names and sensors are given in Table 3.

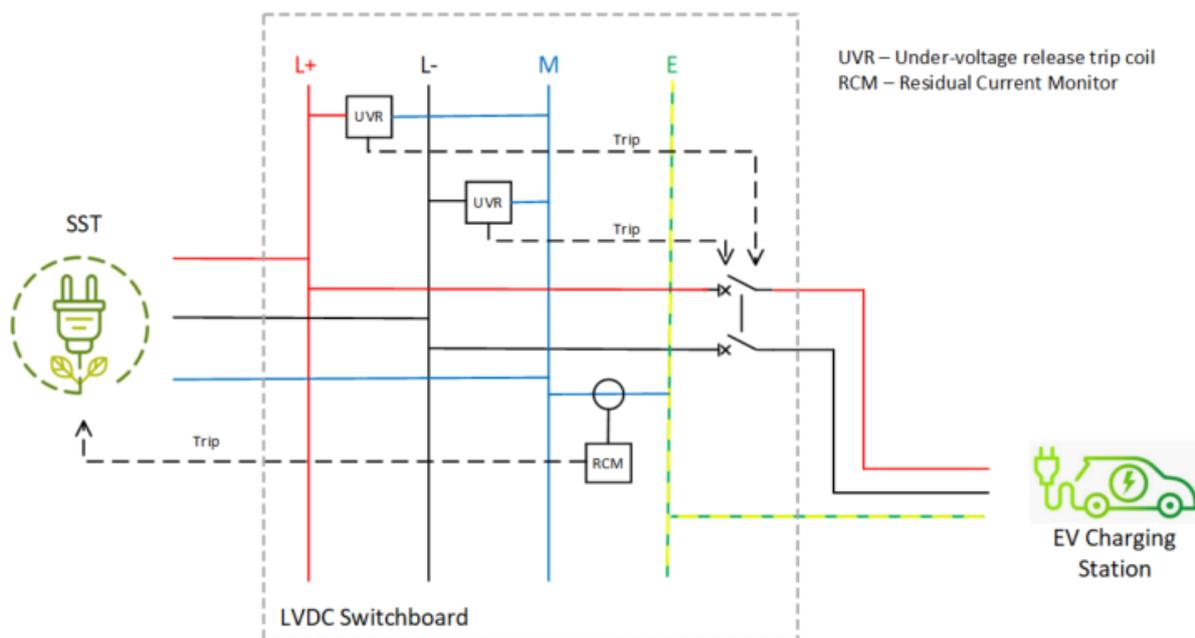
Figure 8 – LVDC Switchboard protection arrangement

The LVDC switchboard contains a MCCB, a DC Residual Current Monitor (RCM) and two under-voltage release coils. The LVDC switchboard supplies the customer's EV charger via four single core cables, which carry the supply positive, negative, neutral and earth. One under-voltage relay is connected between the positive pole and the mid-point, and the other under-voltage relay is connected between the negative pole and the mid-point. When either pole voltage falls below a given threshold, the MCCB is tripped. The EV charger does not have a mid-point input, so the system mid-point goes no further than the LVDC switchboard. The DC RCM measures the current between the mid-point and earth, and any current flowing above a given threshold sends a trip signal to the UPFC. This is shown diagrammatically in Figure 8.

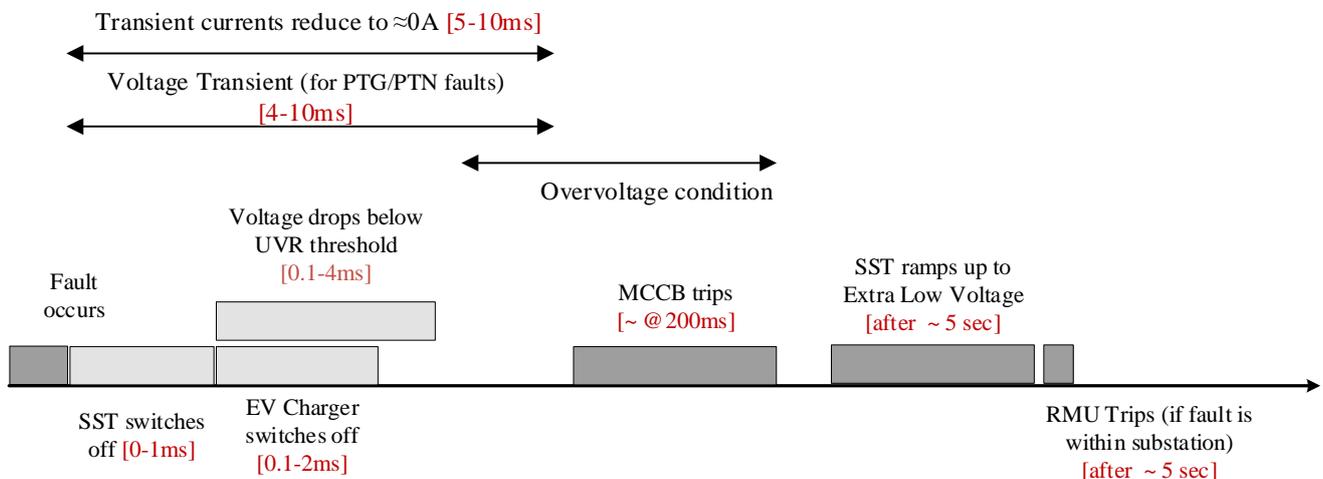
Figure 9 – Time sequence of various events from fault inception.

Figure 9 shows the expected time sequence of various events when any LVDC fault occurs between UPFC LVDC terminal and EV charger.

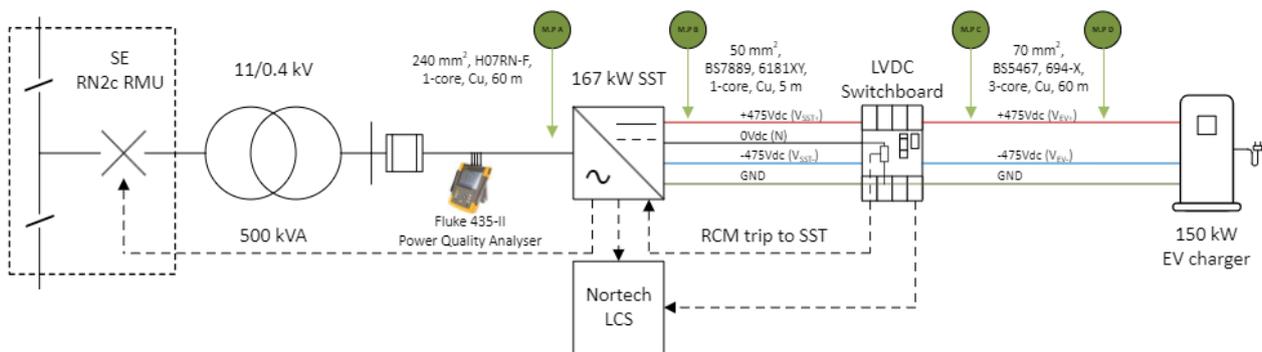
Figure 10 – Test arrangement for functional testing.

Initial functional testing of the UPFC to verify overall operation and facilitate any test setup debugging. Figure 10 shows the circuit diagram for the functional testing. The control/communications will be setup to ensure normal operation. In the functional test, an EV with a CHAdeMO/CCS2 charging port will be connected to the Tritium EV charger which will provide the DC load on the UPFC/LVDC switchboard. The PNDC measurement system will be operational throughout and data will be collected to show start-up, operation and shutdown procedures. This may enable correlations between the UPFC/LVDC switchboard measured quantities and the PNDC measurement apparatus.

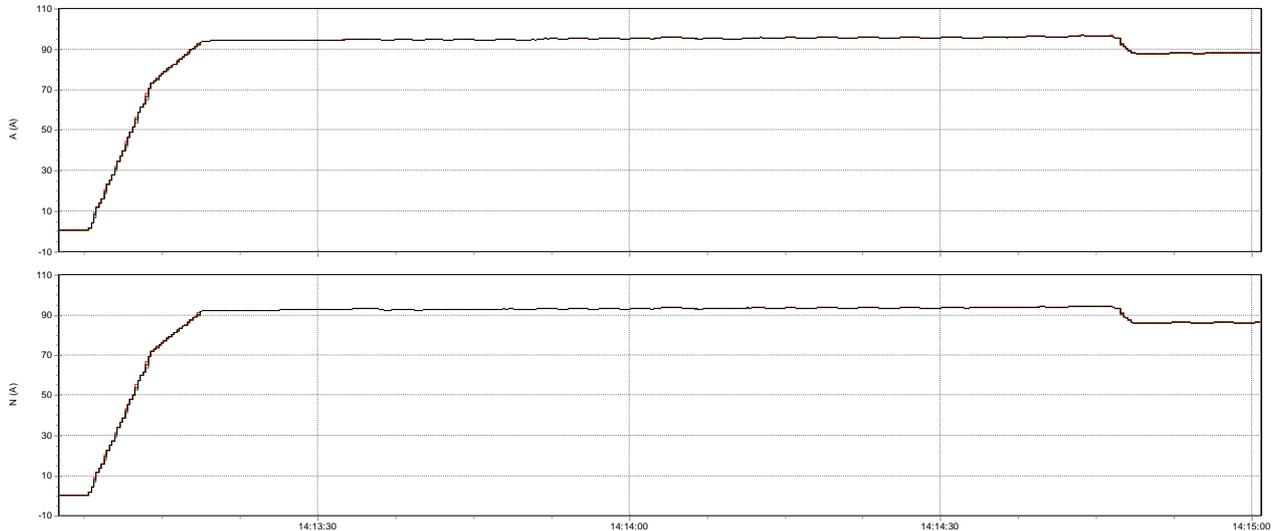
Figure 12 – Current on positive pole (A) and negative pole (N) at the start of Nissan leaf and Hyundai Kona charging session.

The Nissan Leaf and Hyundai Kona were charged simultaneously over a number of charging sessions. The simultaneous start of a charge session is shown in Figure 12 with the DC current demand on the positive and negative poles.

The trace shows several minutes charging at 95 A, then a drop in current below 90 A. This drop was a tapering of the charge rate of the Kona. The trace in Figure 13 shows the current on the positive pole whilst the Nissan leaf and Hyundai Kona were charged. At 12:14, the charge rate of the Kona dropped at 12:20 the Kona was disconnected. At 12:27 the Nissan leaf was taken off charge and at 12:29 the Kona was reconnected. There were no abnormal responses observed from the UPFC whilst the loading and charge sessions were varied.

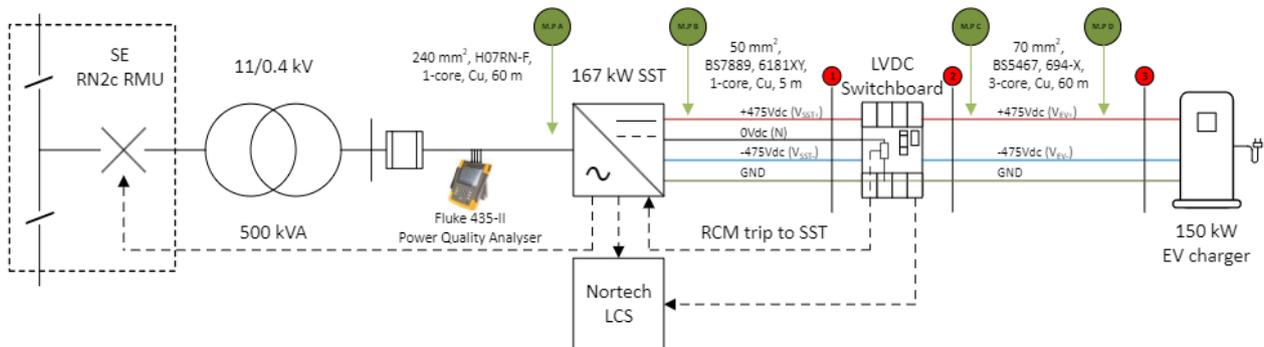
Figure 15 – Fault locations on the DC side of the test circuit.

The one fault configuration that has a difference in setup is the resistive pole to ground faults. The 10 Ω (6 kW rated) Cressall resistor will be included in the fault path to emulate a fault of higher resistance. Each fault configuration will be applied at the three fault locations as detailed in Figure 15.

Pole to pole faults were applied at the three locations shown in Figure 15. An example of the current profile recorded at the output terminals of the LVDC switchboard during pole-to-pole faults is detailed in Figure 16.

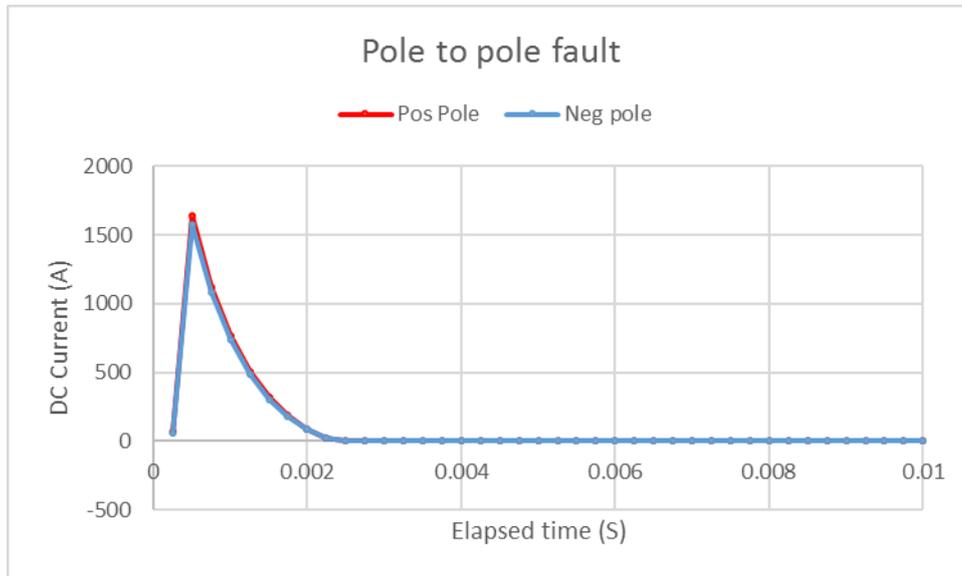
Figure 16 – Pole to pole fault current profile [FB_meas84]

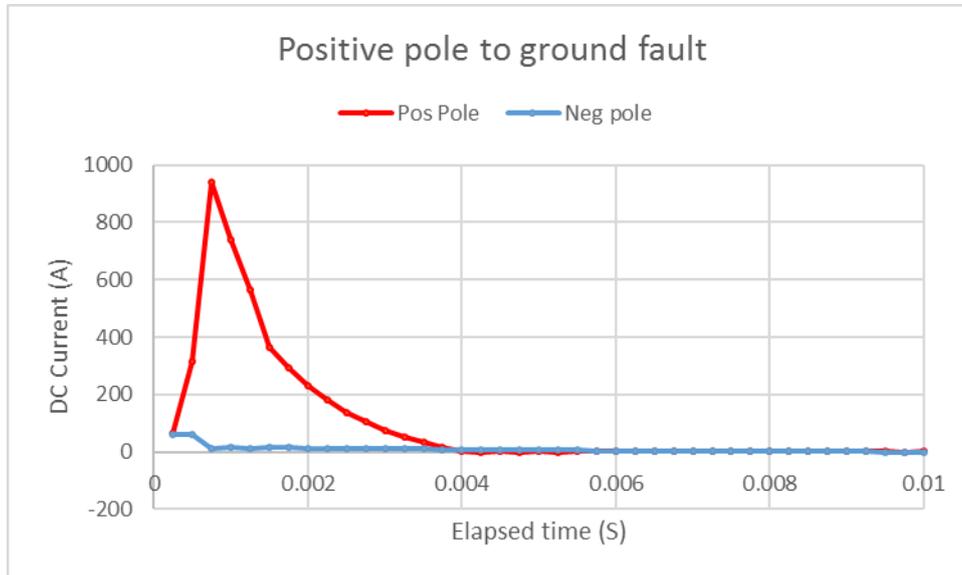
Figure 17 – Positive pole (red trace) to ground fault [FB_meas85_ifault]

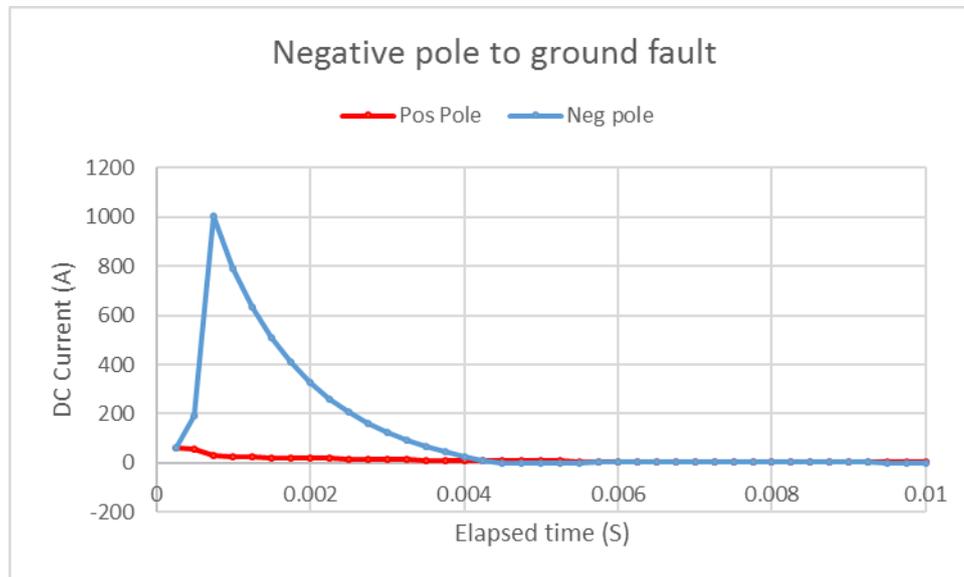
Figure 18 – Negative pole (blue trace) to ground fault [FB_meas86_ifault]

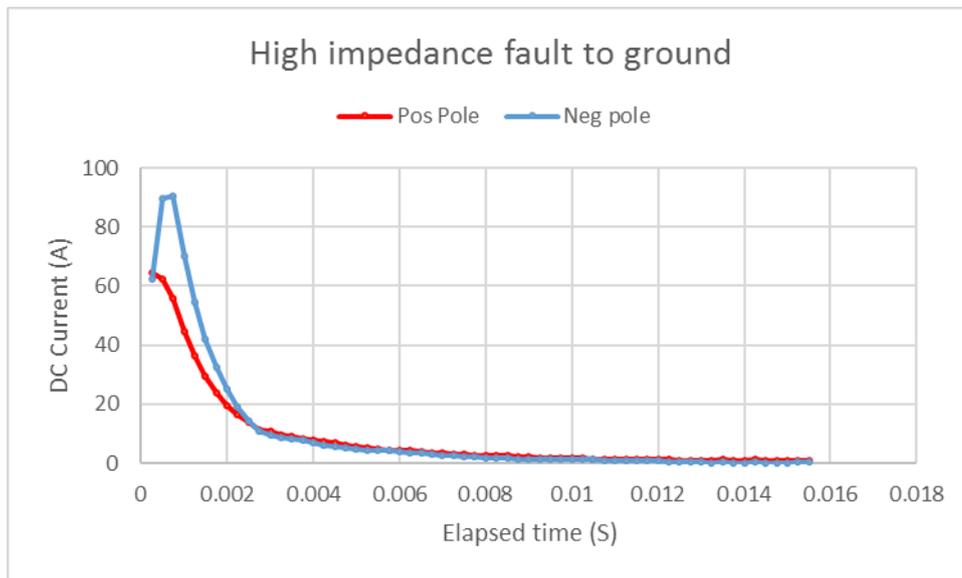
Figure 19 – High impedance fault to ground

current flowing to earth, under these fault conditions. An example of the current profile for a negative pole to ground high impedance fault is shown in Figure 19.

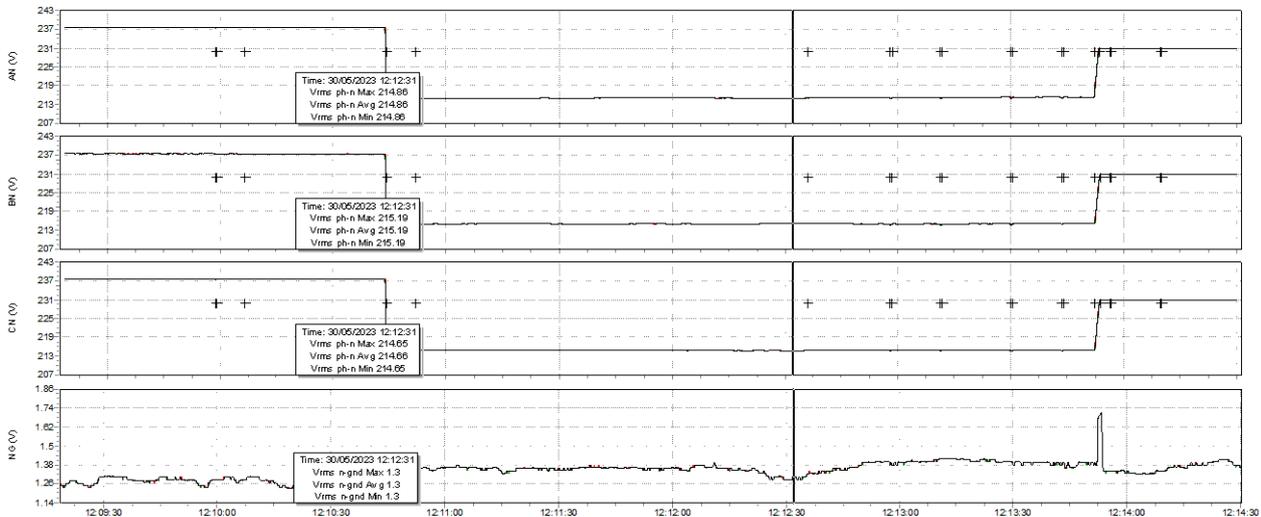
Figure 20 – 215 V output on the UPFC AC output [FC_meas63]

An additional test performed during the test programme was to request a setpoint of 215 V. Initially the setpoint was 238 V, then the setpoint was changed to 215 V (12:10:44) and finally a setpoint of 231 (12:13:53) was selected by the operator. The voltage output from the UPFC (Fluke C) is detailed in Figure 20.

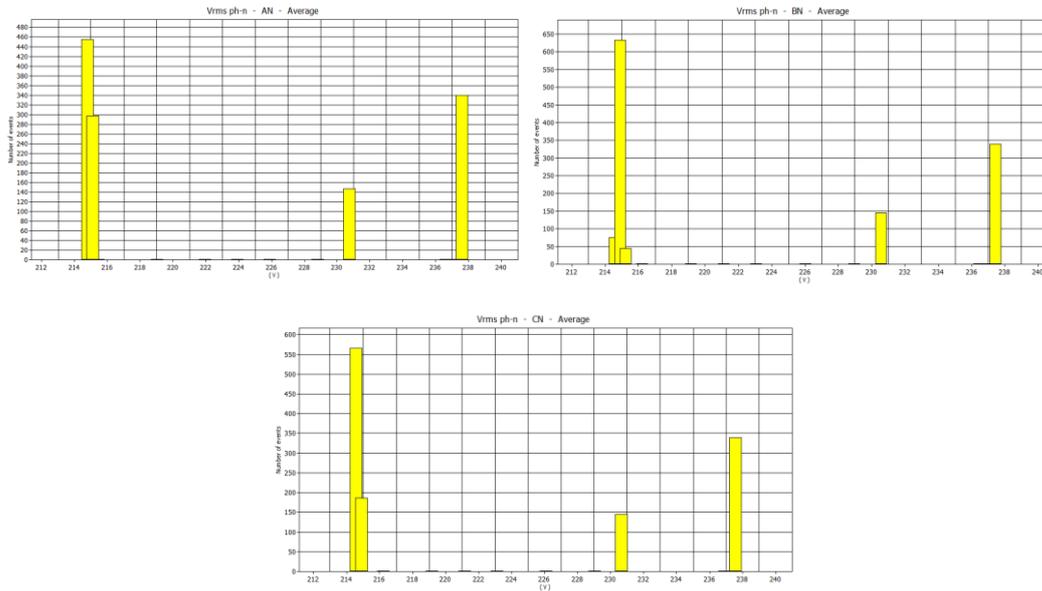
Figure 21 – Phase to neutral voltage distributions

In order to study the control of the UPFC AC output, the distribution of the three phase to neutral voltages was investigated. Figure 21 shows the number of events recorded over the phase voltage range of interest.

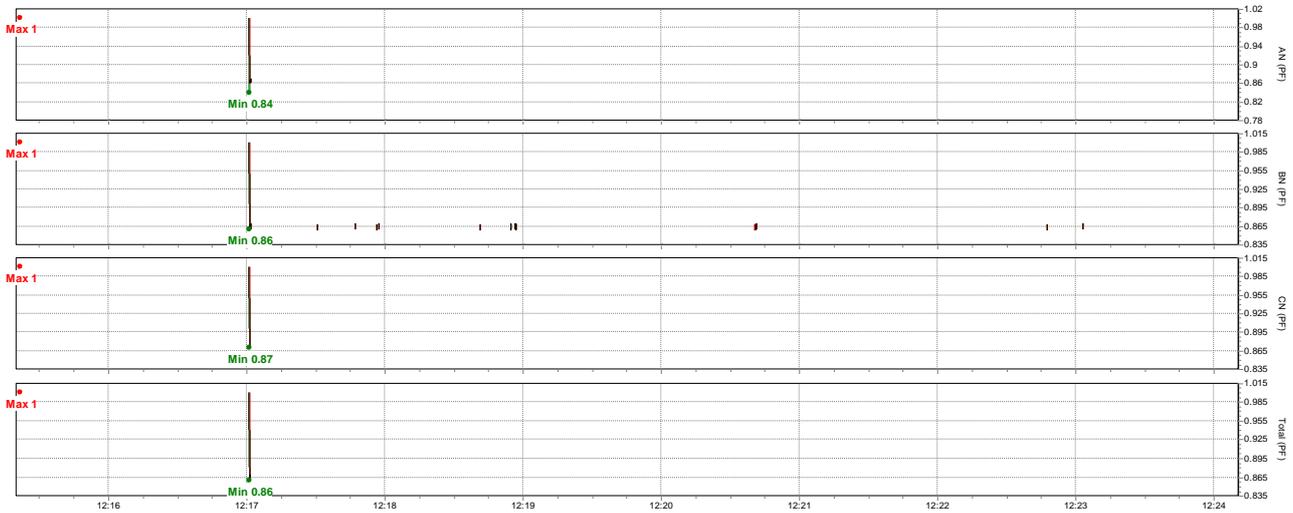
Figure 22 – Power factor at UPFC AC output terminals [FC_meas64]

The reactive power compensation of the UPFC was demonstrated by the Grid Bridge representative. The UPFC used alternative operating mode, whereby the capacitor bank inside the unit was used for power factor correction. The PNDC load bank was set as a balanced 96.6 kVA load with a lagging power factor of 0.84 (Figure 22).

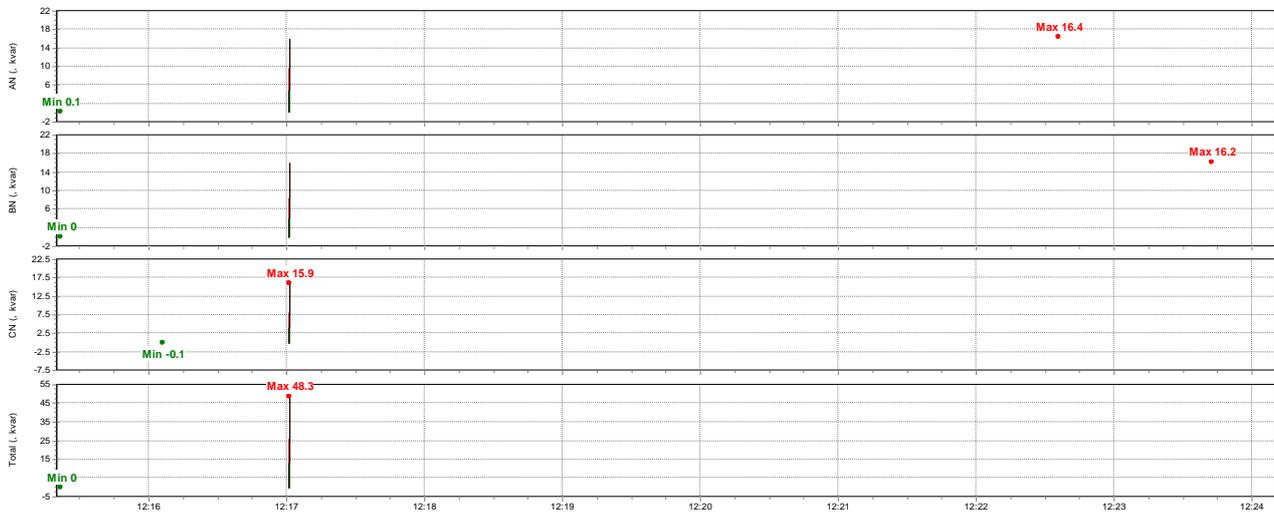
Figure 23 – Reactive power compensation [FC_meas64_kvar]

At 12:17:03, 45 kVAR of reactive power was requested on the UPFC control, this was recorded as 48.3 kVAR on the Fluke power quality analyser. The reactive power consumed by the UPFC is illustrated in Figure 23.

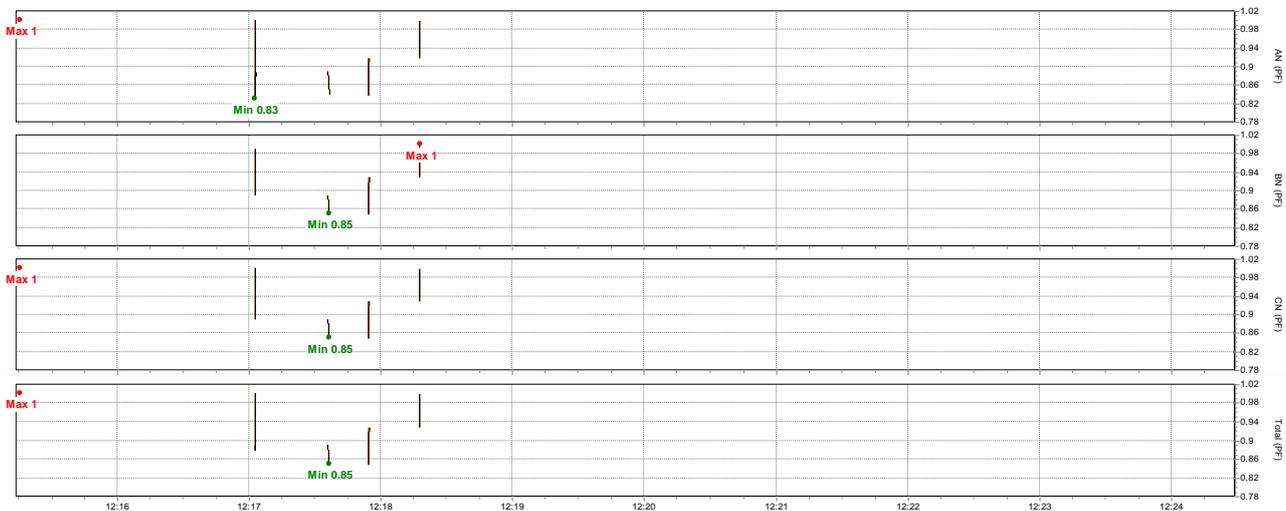
Figure 24 – Reactive power compensation and power factor at UPFC input terminals [FA_meas63]

The reactive power compensation is shown across the AC input terminal of the UPFC (Figure 24) with the power factor returning to 1 at 12:18:18 despite the load still being 85 kW with a lagging power factor of 0.84.

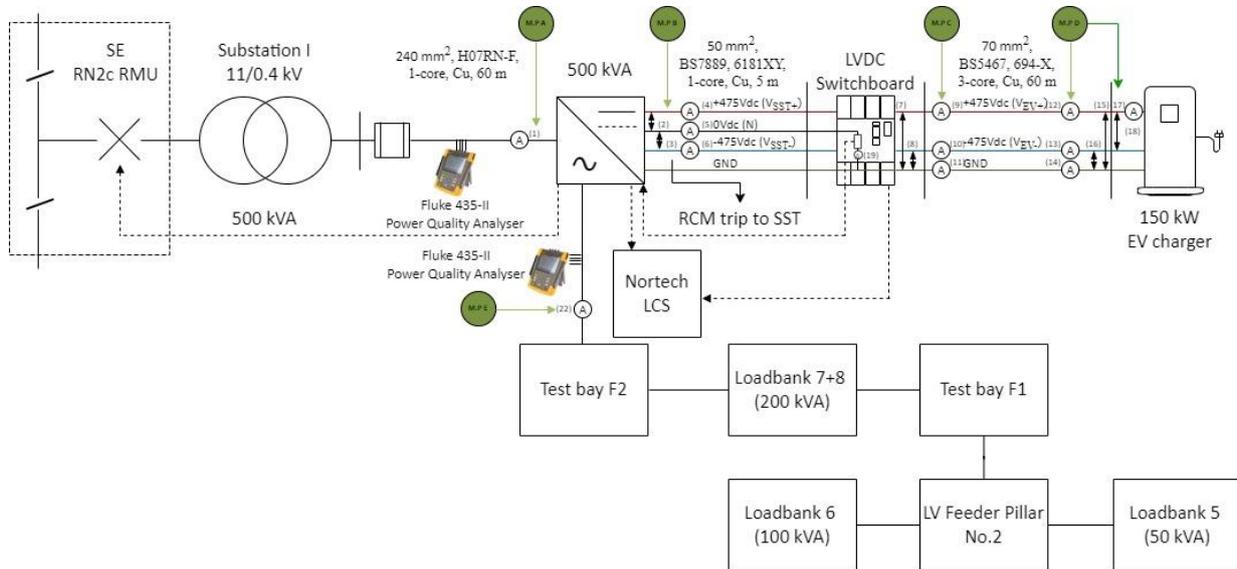
Figure 25 – SPEN-030 test setup with AC load

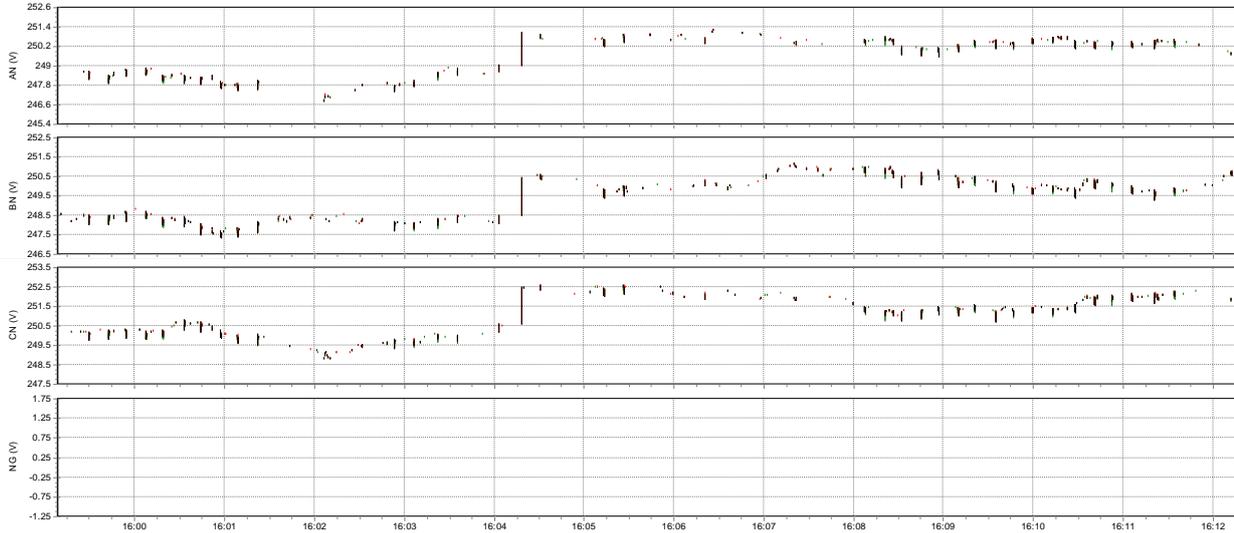
Figure 26 – Voltage at the input of the UPFC (regulation mode) [FA_meas53]

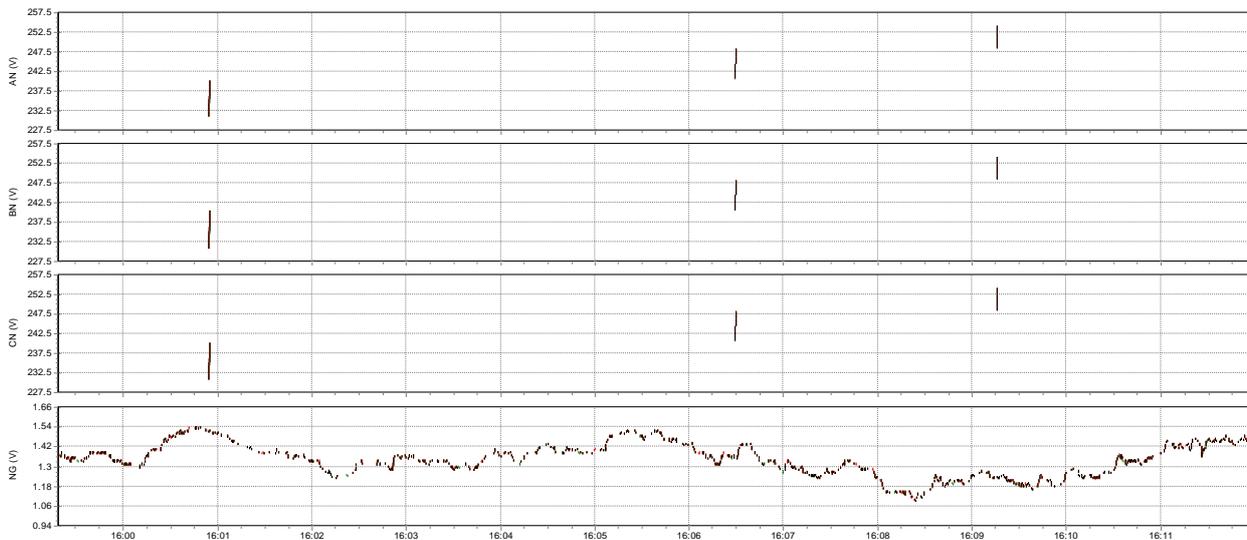
Figure 27 – Voltage at the output of the UPFC (regulation mode) [FC_Meas54]

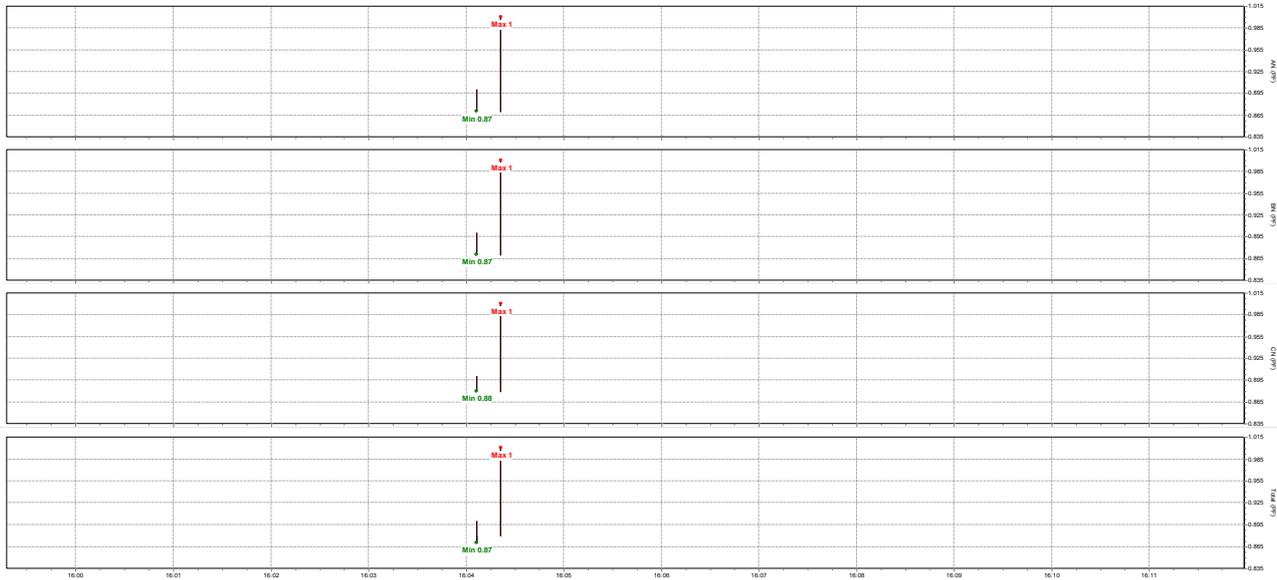
Figure 28 – Variation in power factor at UPFC output (regulation mode) [F_C_Meas54_PF]

The power factor of the AC load on the UPFC was varied between 1, 0.9 and 0.87. The variation in the power factor on the PNDC loadbanks is shown in Figure 28.

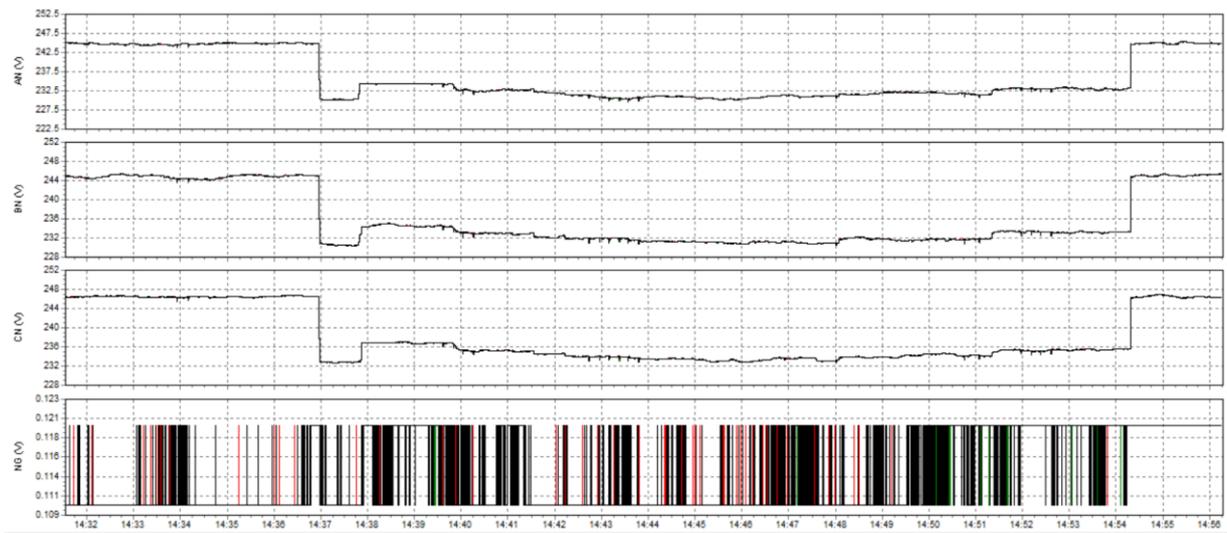
Figure 29 – Voltage at the input of the UPFC [FA_Meas106]

The voltage and current at the input of the UPFC are shown in Figure 29 and Figure 30.

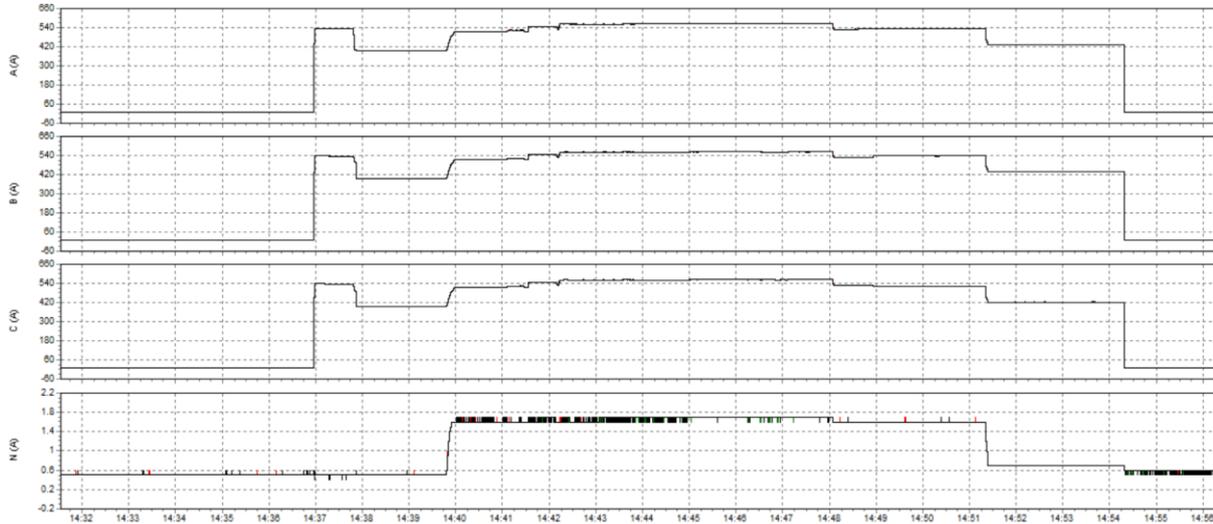
Figure 30 – Current at the input of the UPFC [FA_Meas106]

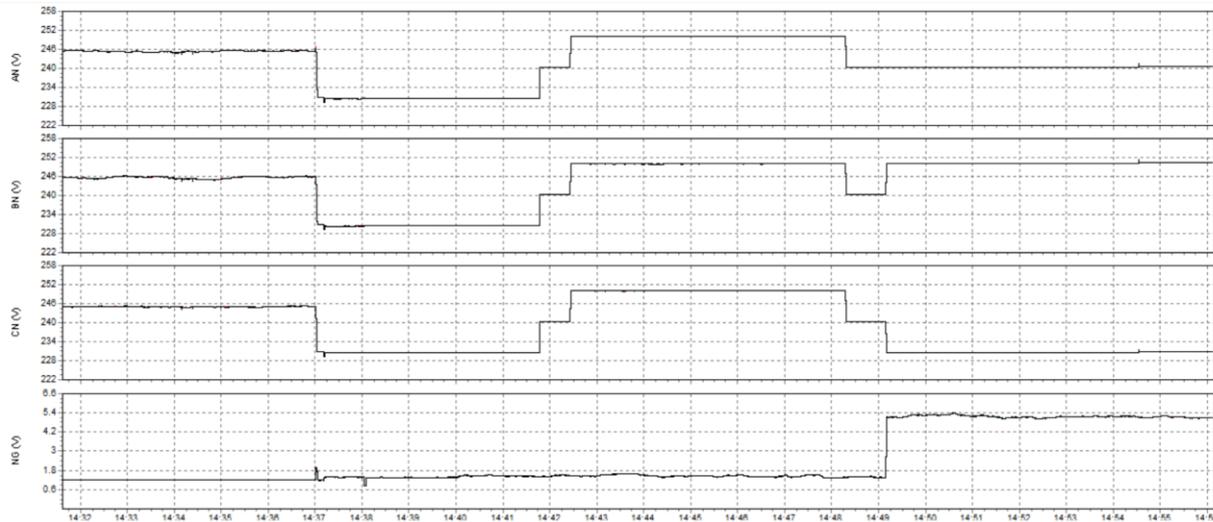
Figure 31 – AC voltage output from the UPFC [FC_meas109]

The total load on the UPFC ranged from 277.8 kVA to 375.6 kVA. The voltage and current at AC the output of the UPFC are shown in Figure 31 and Figure 32.

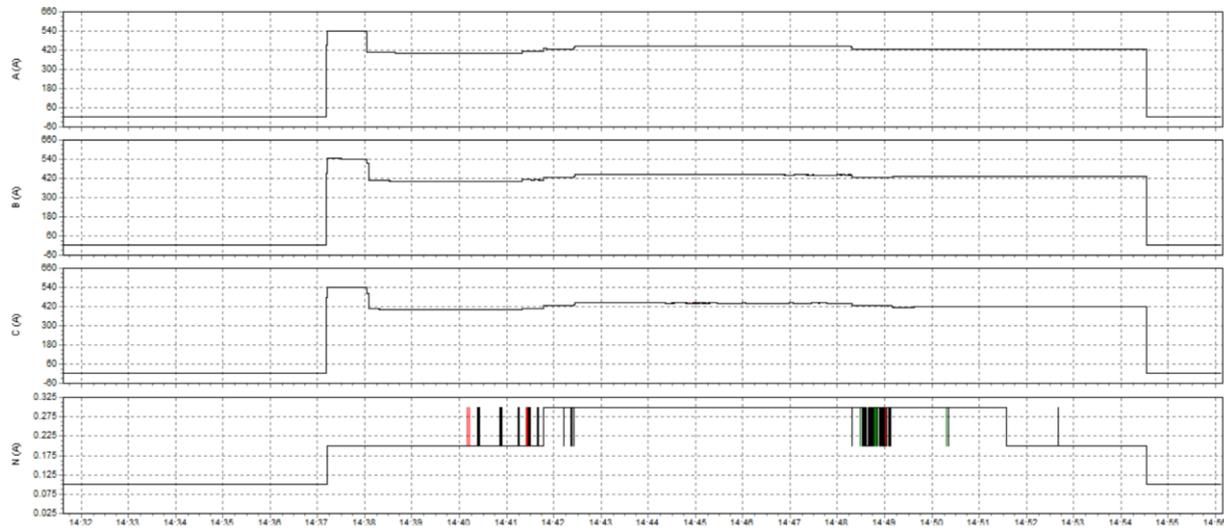
Figure 32 – AC current at the output of the UPFC [FC_meas109]

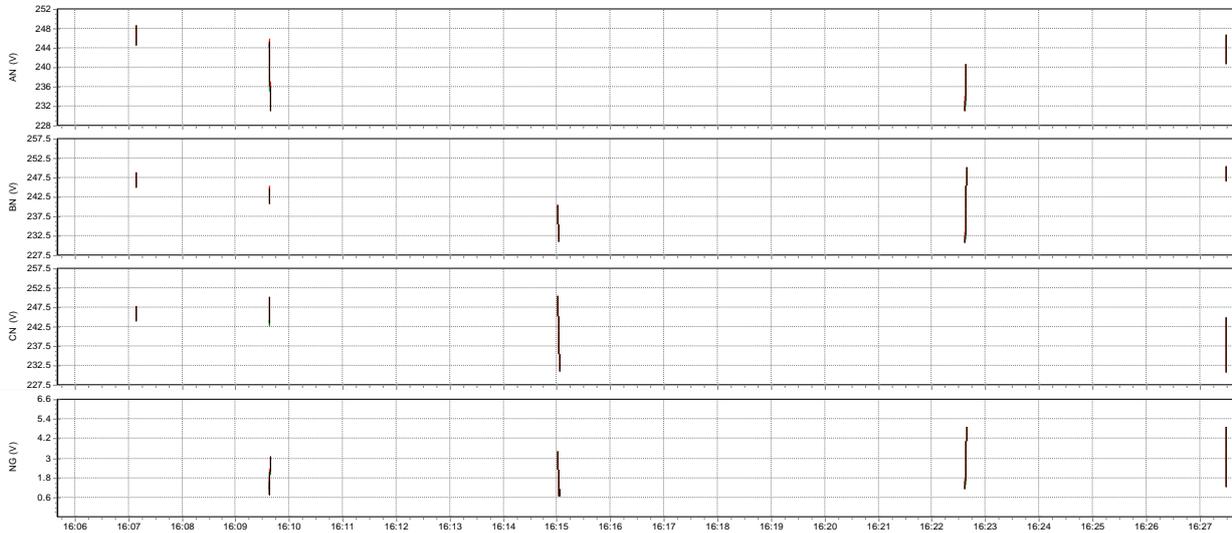
Figure 33 – Voltage at the output of the UPFC (independent voltage regulation) [FC_Meas96]

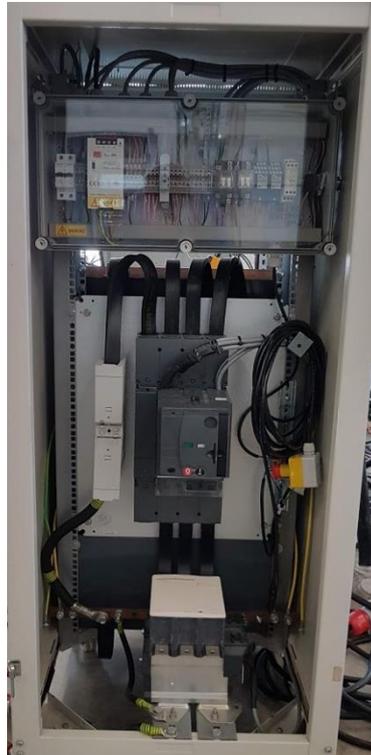
Figure 34 – PNDC AC fault thrower

Faults were applied on the AC output of the UPFC whilst supplying the PNDC AC loadbanks. The AC faults were applied by the PNDC fault thrower (Figure 34). Faults considered were phase to phase, phase to earth, 3 phase and 3 phase to earth.

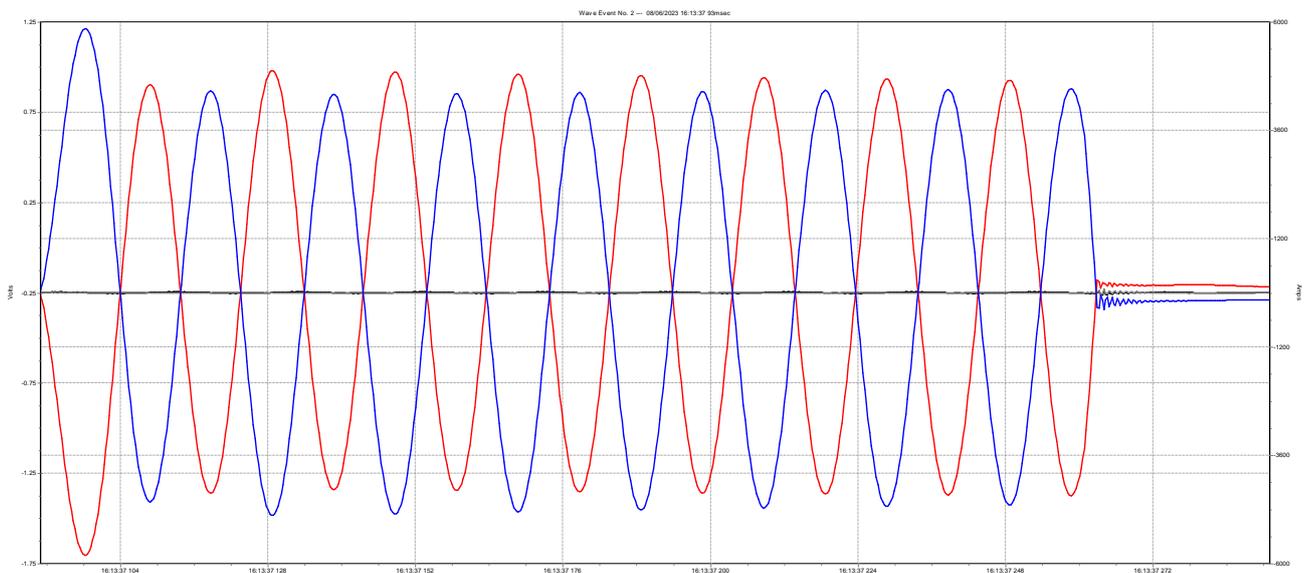
Figure 35 – Phase to ground fault (L2-GND) and resulting fault current for a 315 A fuse [FA_meas 133]

The fault current waveforms for the faults with the 315 A fuses are illustrated in Figure 35, Figure 36 and Figure 37.

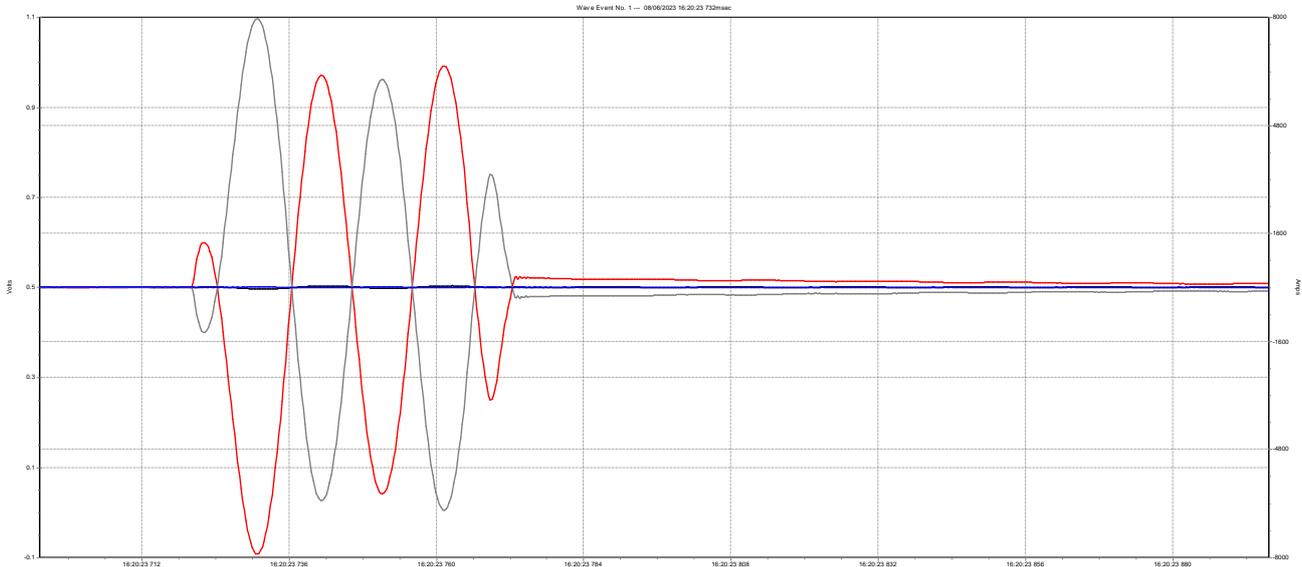
Figure 36 – Phase to phase (L2-L3) fault and resulting current with a 315 A fuse [FA_Meas134_ifault]

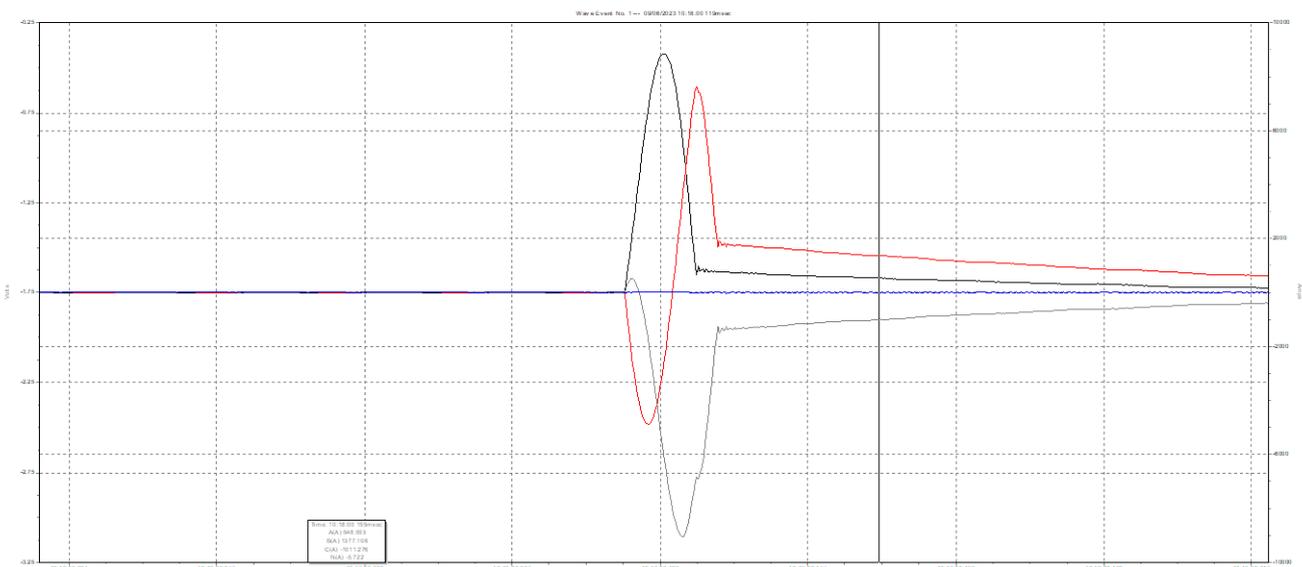
Figure 37 – 3 phase fault and resulting current with 315 A fuses [FA_Meas135_ifault]
