LV ENGINE

LV Engine Solution Integration and Regression Testing

Report Title : LV Engine Deliverable #4 – Integration Testing

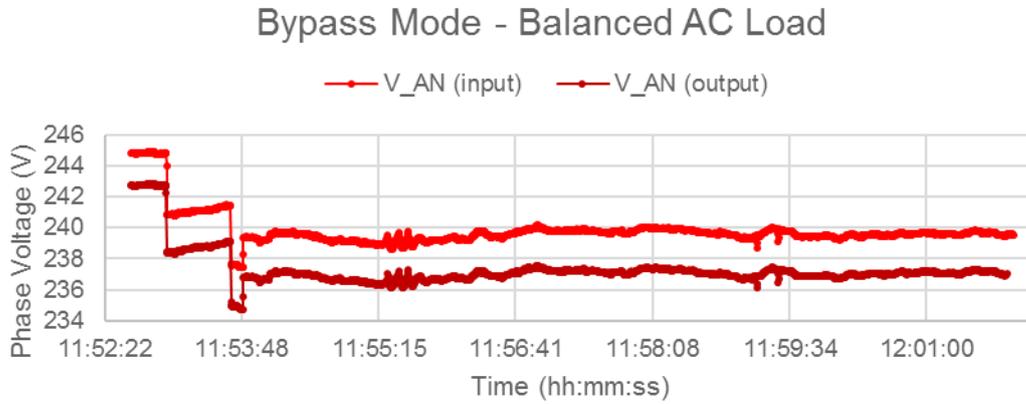
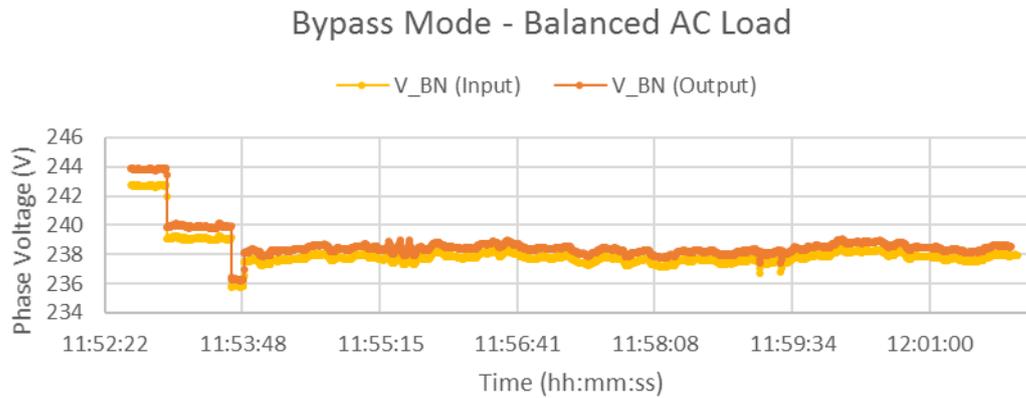
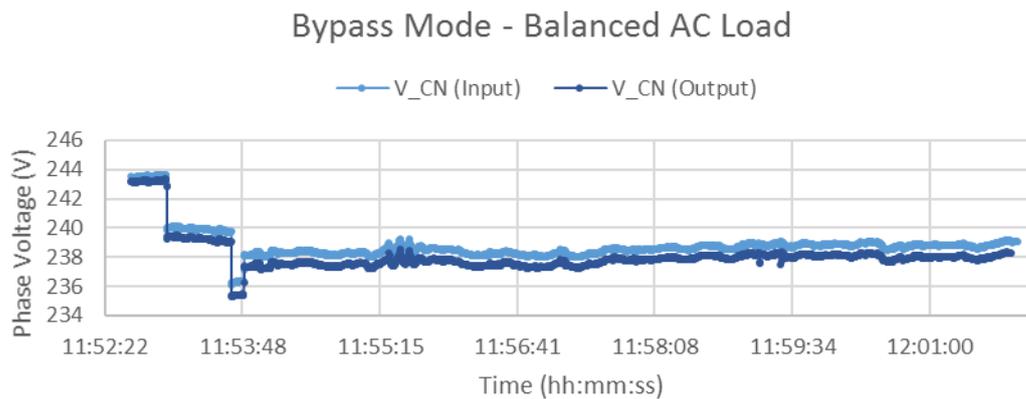
Figure 38 – Phase voltages for bypass mode with a balanced AC load

A balanced AC load was introduced via loadbanks with a maximum load of 227.4 kVA. The load applied by the resistive loadbanks was varied between 84 and 227.4 kVA through the test. The phase voltages at the input and output of the UPFC whilst supplying a balanced AC load is shown in Figure 38.

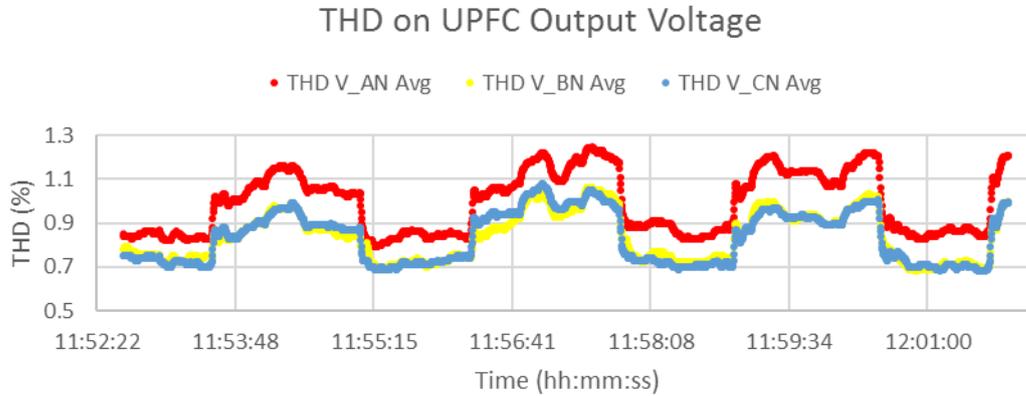
Figure 39 – THD on the output voltage of the UPFC in bypass mode with a balanced AC load

The THD on the output voltages of the UPFC whilst supplying a balanced AC load is shown in Figure 39.

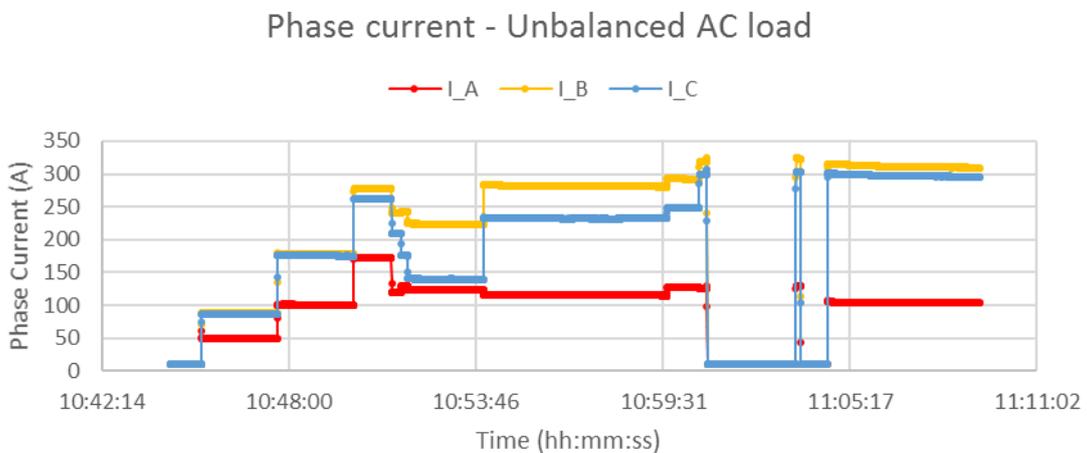
Figure 40 – Phase currents at the input of the UPFC whilst in bypass mode with an unbalanced load

Fuses were removed from the 4 loadbanks used to ensure that the UPFC experienced an unbalanced load. The phase currents at the input of the UPFC are shown in Figure 40.

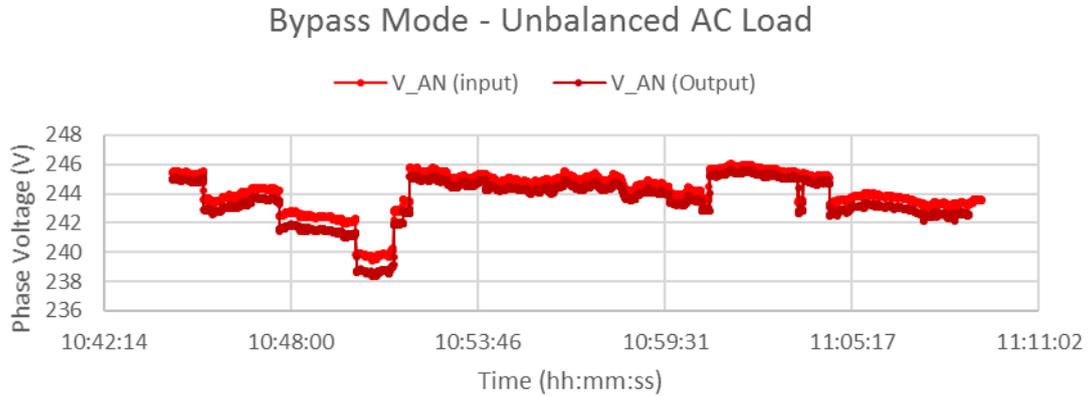
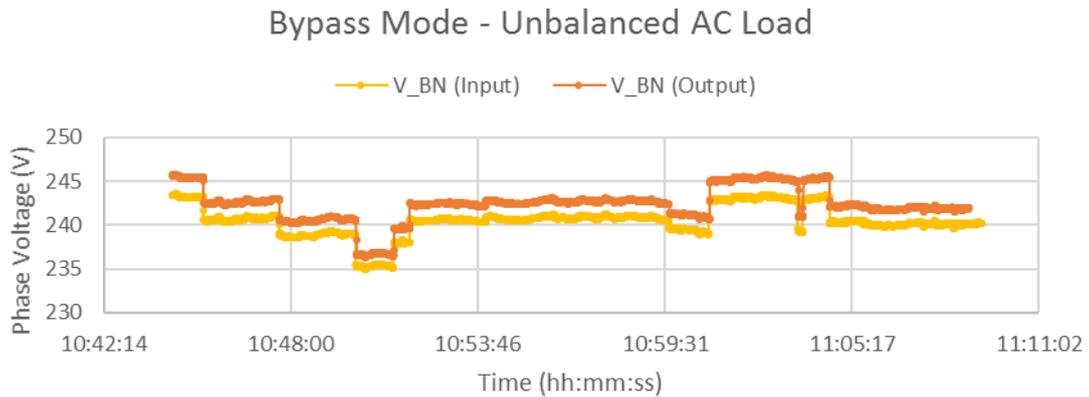
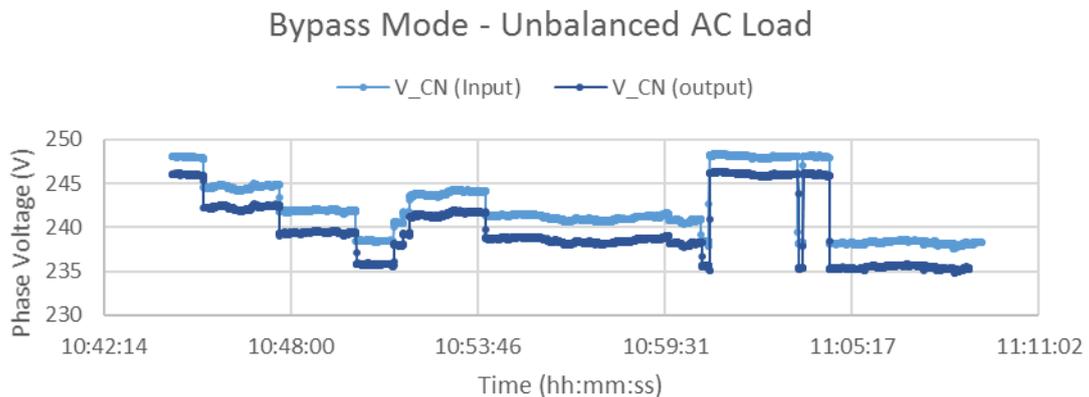
Figure 41 – Phase voltage comparison between the input and output of the UPFC whilst in bypass mode with an unbalanced load

The phase voltages were compared to determine the relative difference between the input and output of the UPFC whilst operating in bypass mode (Figure 41).

The voltage output on phase A was on average 0.63 V lower than the input voltage. On phase B the output voltage was 1.86 V higher and on phase C the output was 2.47 V lower than the input voltage to the UPFC. The THD on the output voltage of the UPFC whilst in bypass mode and supplying an unbalanced load is shown in Figure 42.

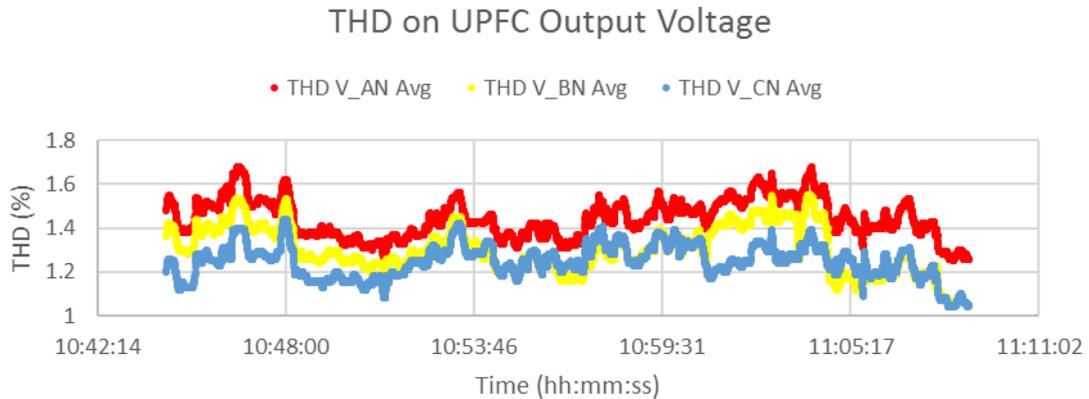
Figure 42 – THD on the UPFC output voltage whilst in bypass mode and when supplying an unbalanced AC load

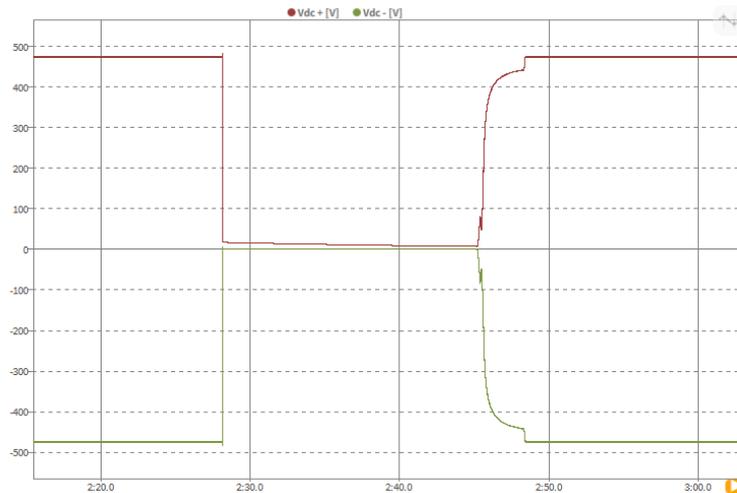
Figure 43 – Pole voltages for a negative pole to earth fault with resistive load (14.5 Ω) with a 10 second auto restore

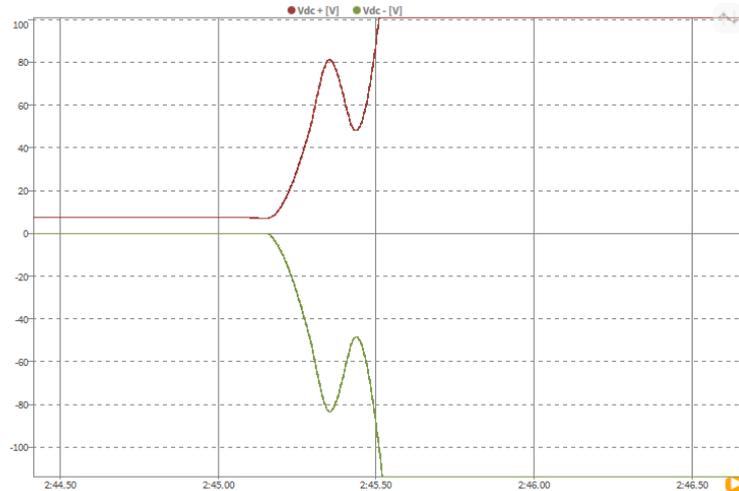
Figure 44 – Auto restore low voltage check

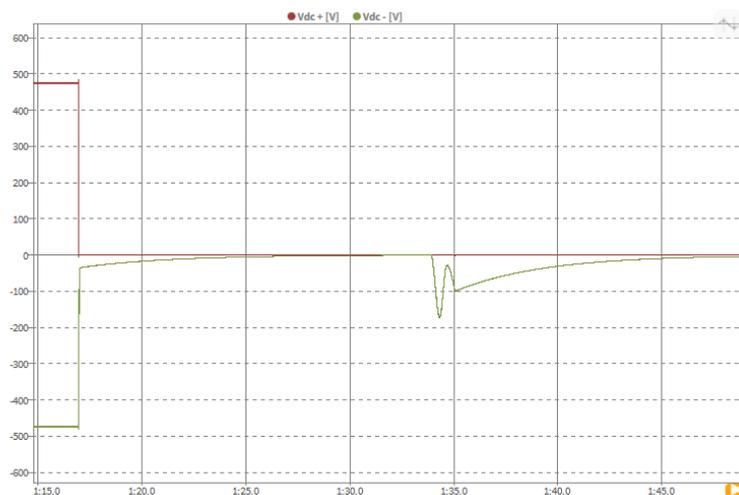
Figure 45 – Positive pole to earth fault in location 1 (LVDC switchboard incomer) and attempted auto restore and subsequent shunt trip

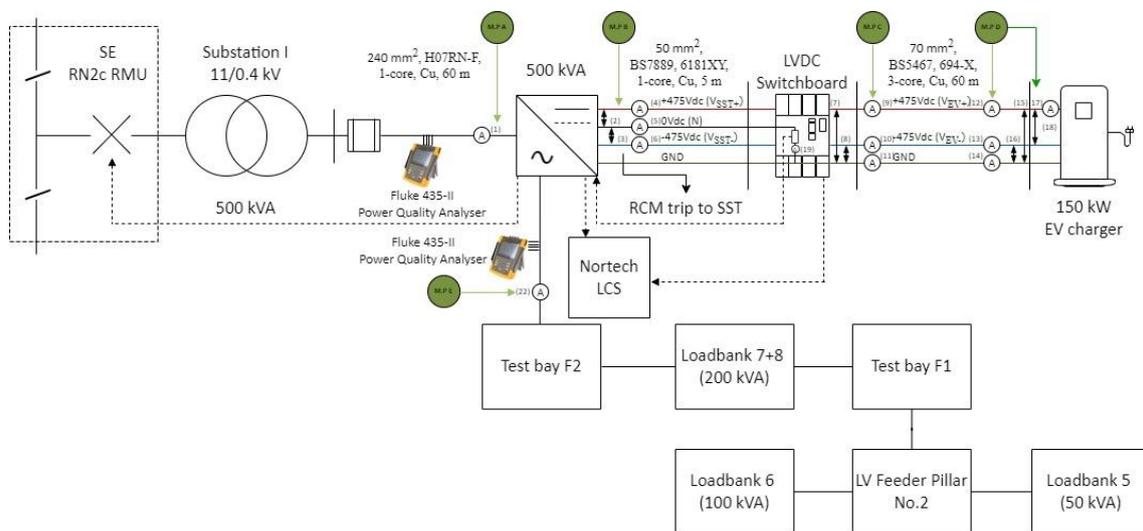
Figure 46 – UPFC supplying the Tritium PKM 150 kW EV charger and the PNDC loadbanks

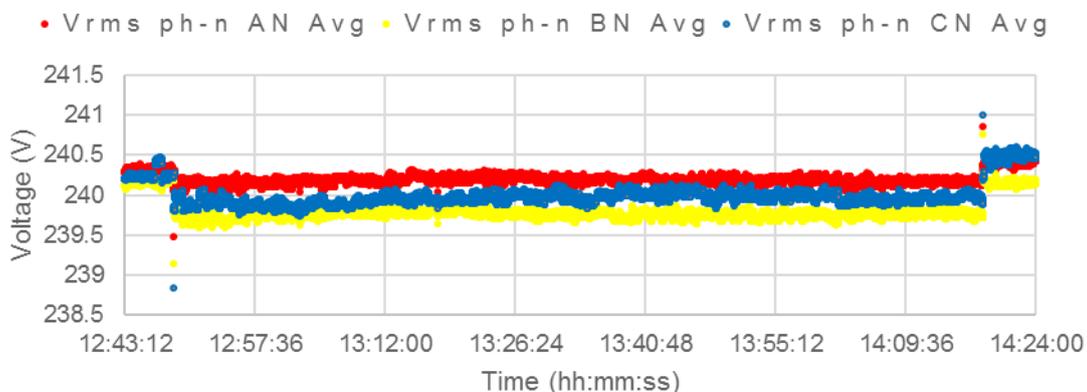
Figure 47 – Phase voltages with regulation at 240 V per phase

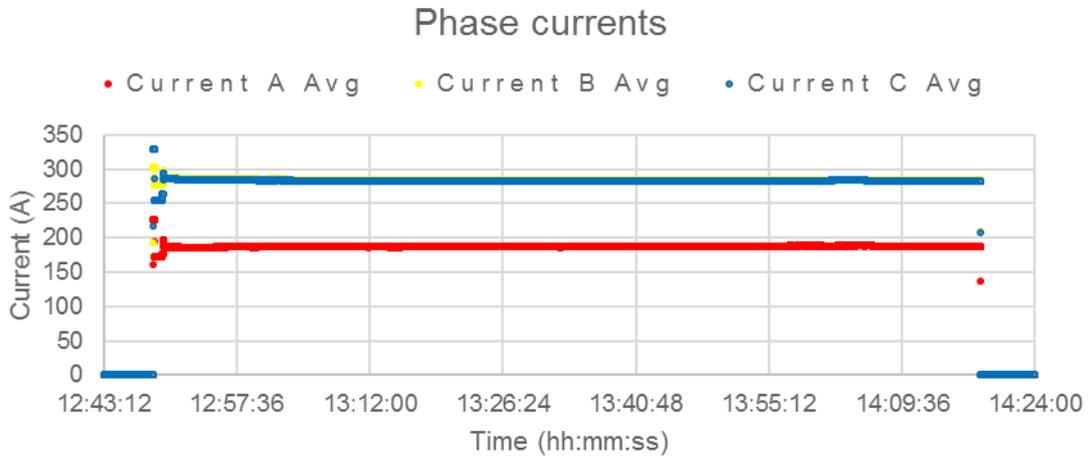
Figure 48 – Phase currents on the AC unbalanced load and PF=0.62

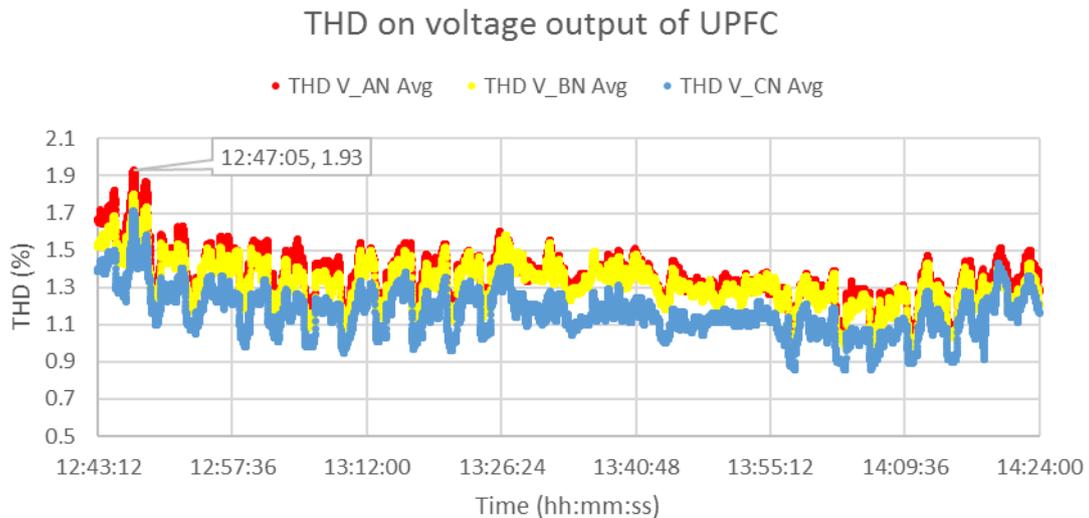
Figure 49 – THD of the output voltage from the UPFC for an AC unbalanced load and PF=0.62

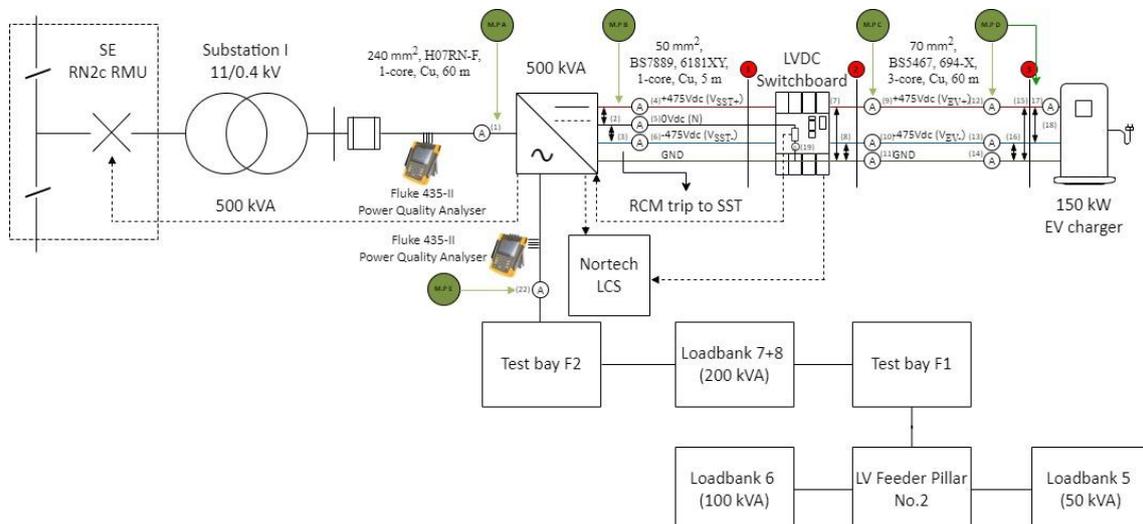
Figure 52 – Test circuit for pole to earth faults on the UPFC with the EV charger in circuit

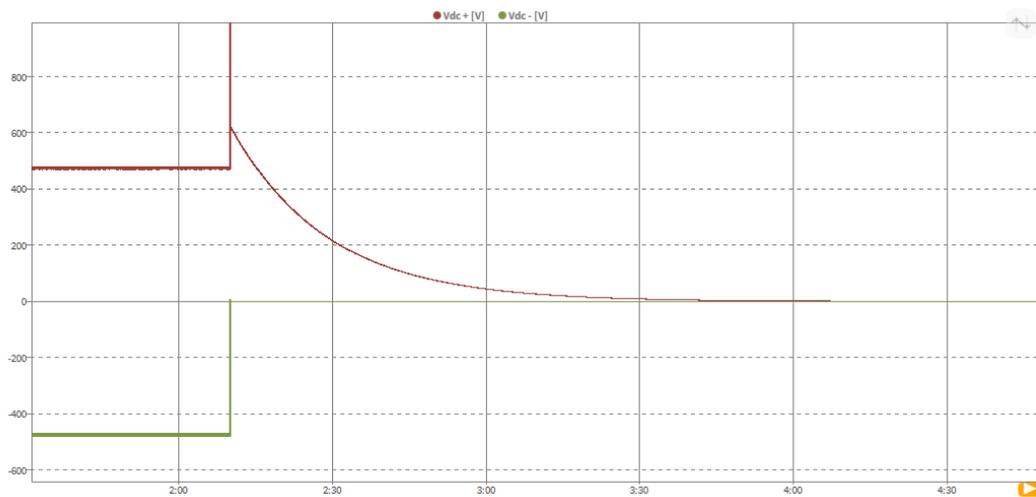
Figure 53 – Pole voltages at the output of the UPFC during a negative pole to earth fault with the EV charger in circuit [Attempt 2]

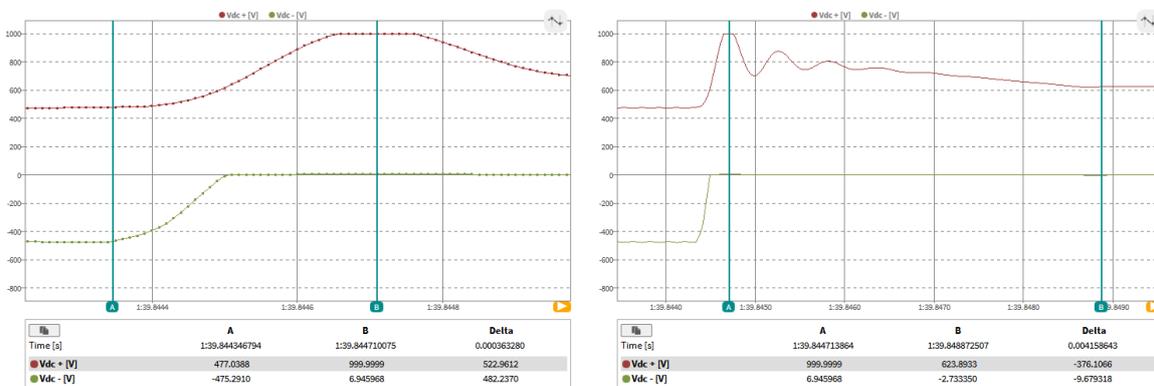
Figure 54 – Voltage at the output of the UPFC, Rise time for the overshoot on the positive pole (left) and setting time for the voltage overshoot in the positive pole (right) [Attempt 2]

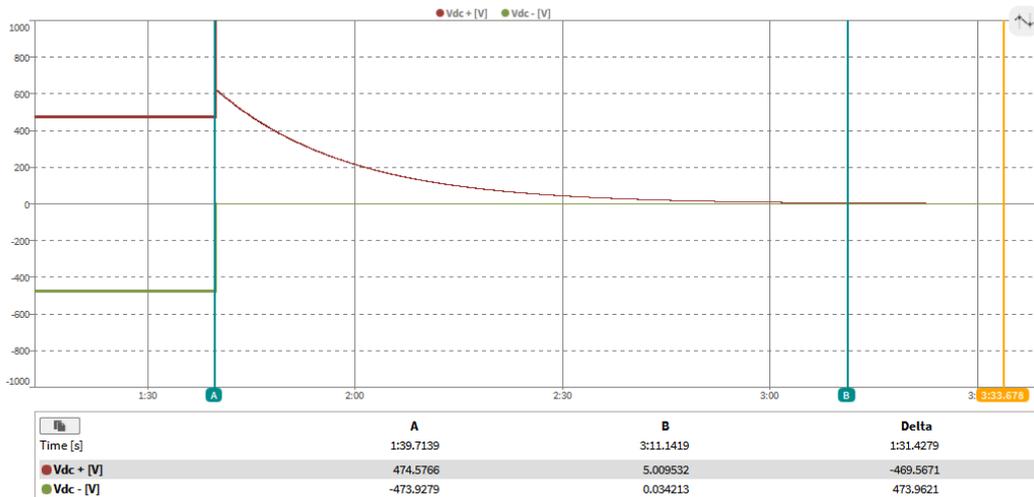
Figure 55 – Positive pole voltage decay via the UPFC bleed resistors [Attempt 2]

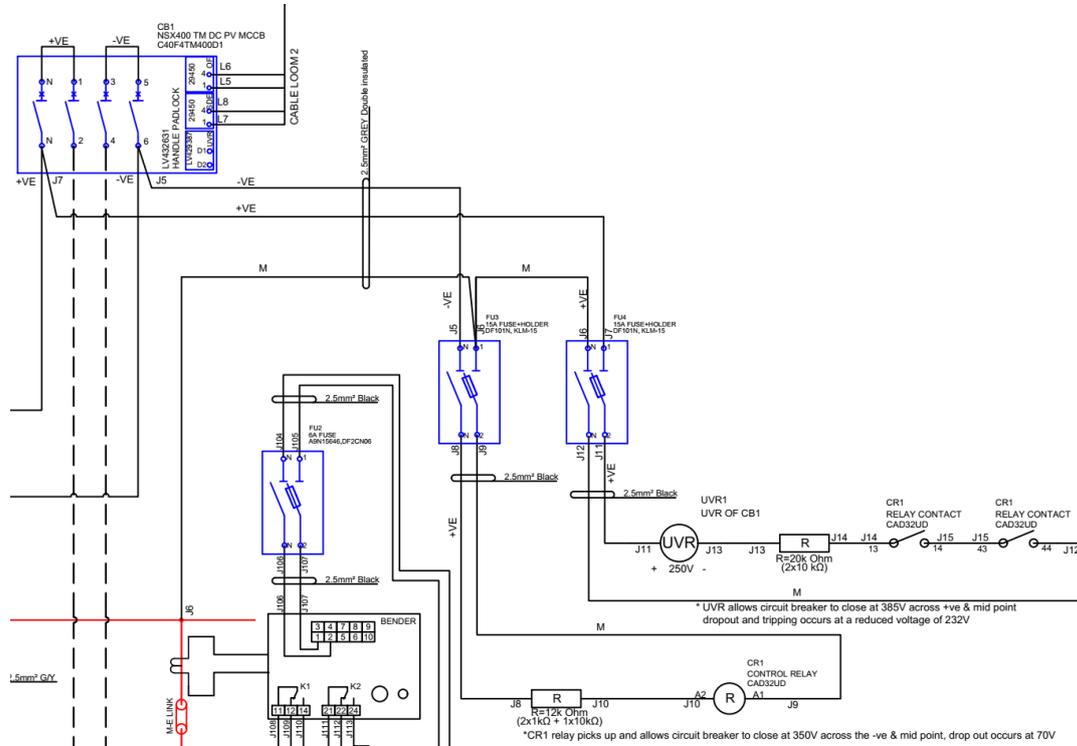
Figure 56 – UVR and series resistance connected between the positive pole and midpoint

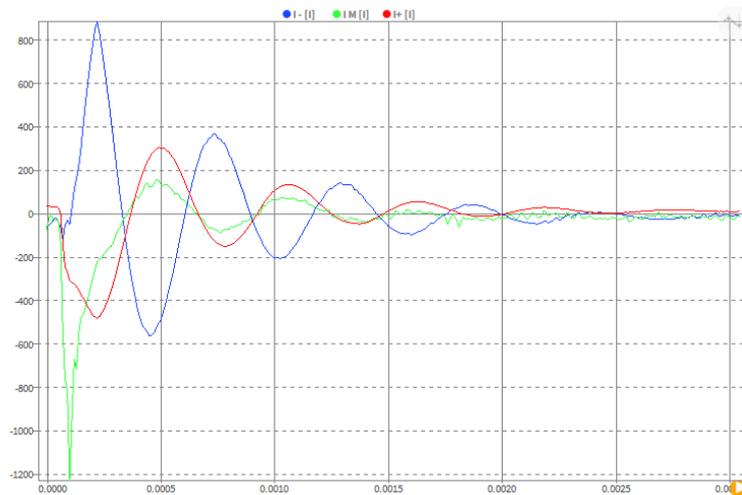
Figure 59 – Fault current for the second negative pole to earth fault at location 1 [Attempt 2]

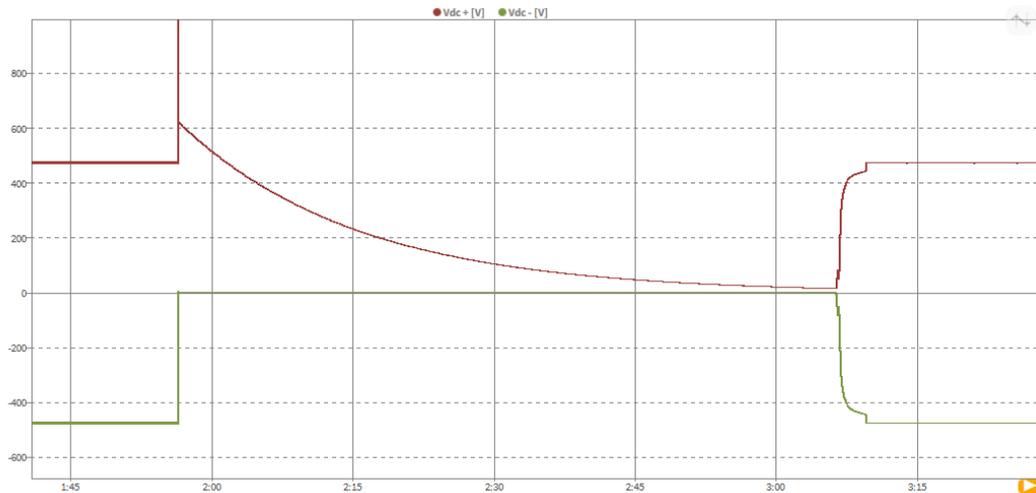
Figure 61 – Negative pole to earth fault at location 2

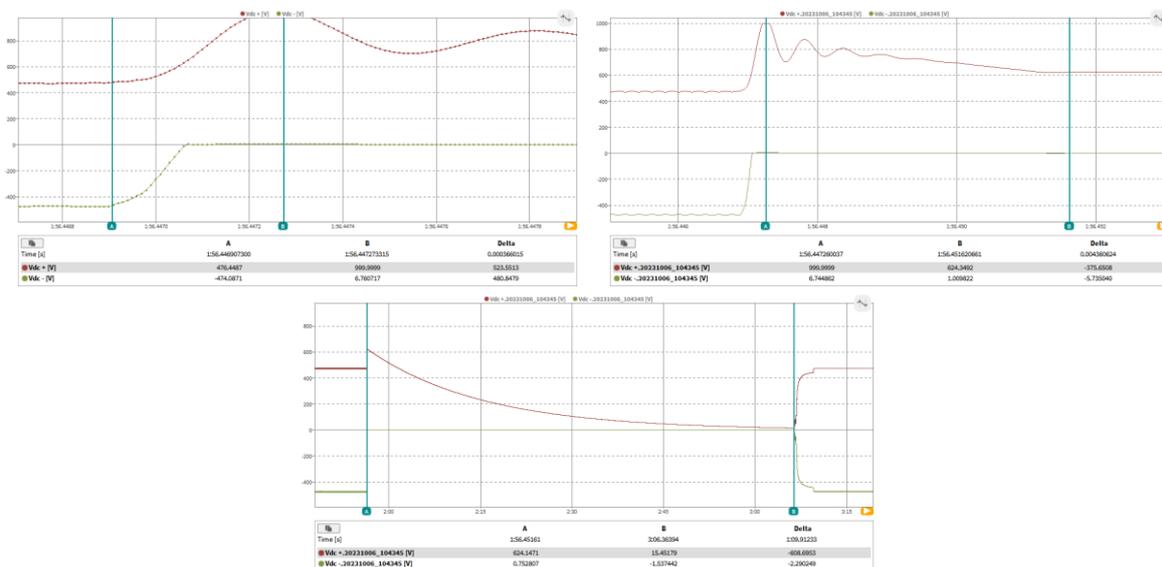
Figure 62 – Voltage rise time on the positive pole (upper left) decay time to 625 V on the positive pole post fault (upper right) and decay time from 625 V to 15.45 volts prior to auto restore operating (lower)

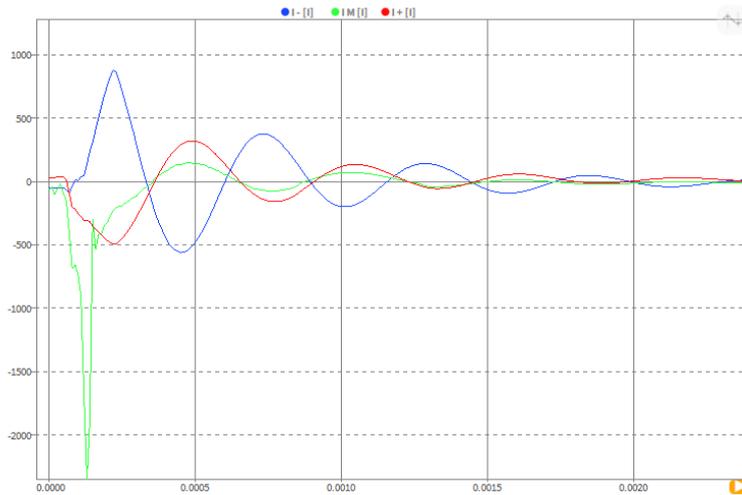
Figure 63 – Fault current contribution of UPFC for a location 2 –P to earth fault

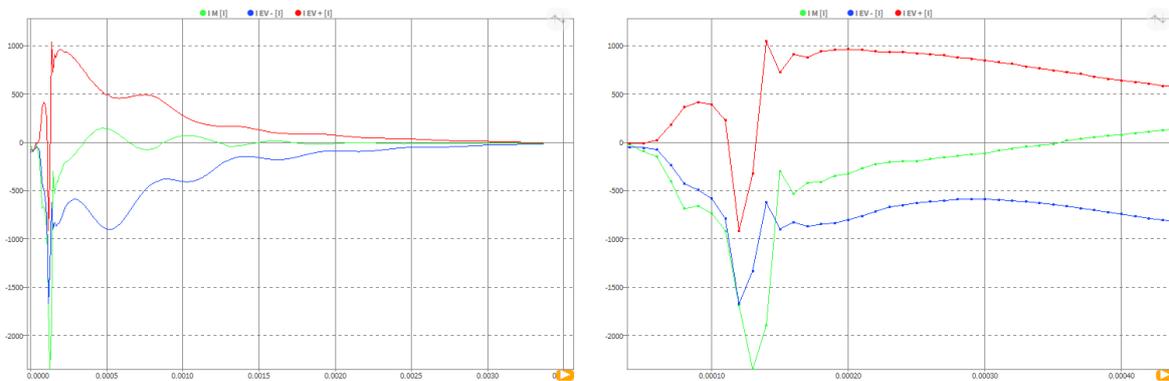
Figure 64 – Fault contribution of EV charger for a fault at location 2; overall behaviour (left) and detailed view of impulse (right)

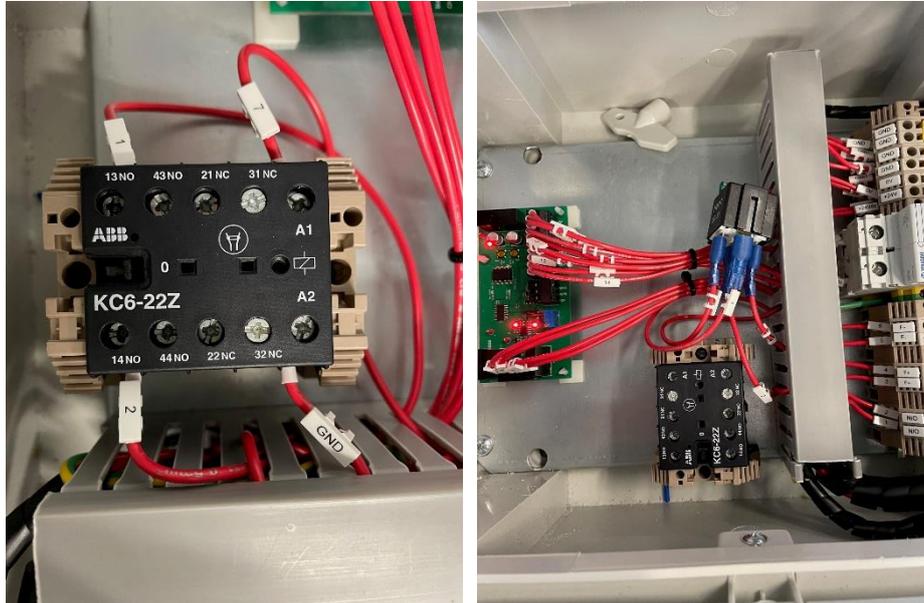
Figure 66 – Enspec internal view ABB KC6-22Z relay (left) Halfords 12 V relay (right)

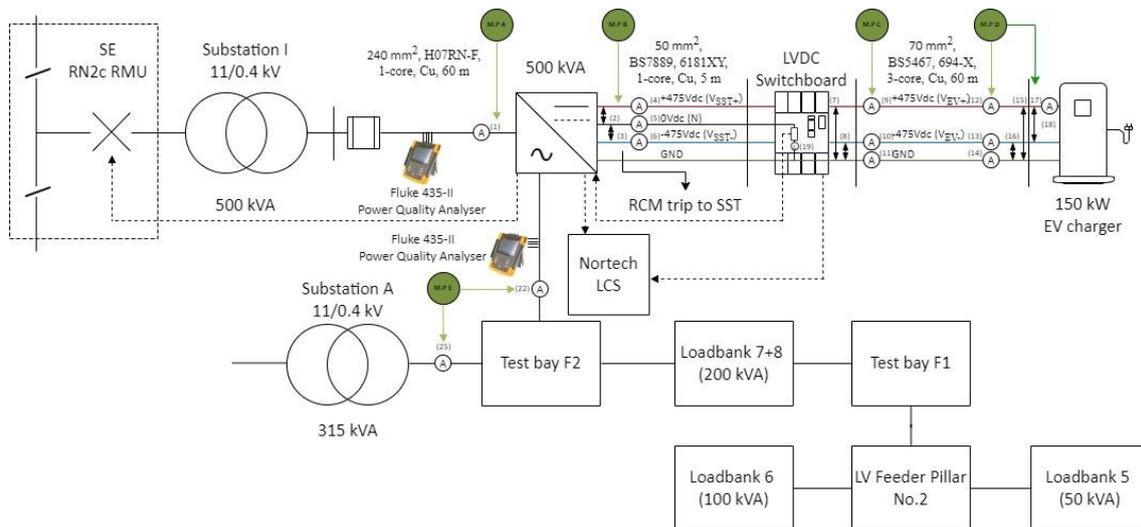
Figure 67 – PNDC test network arrangement for power sharing tests

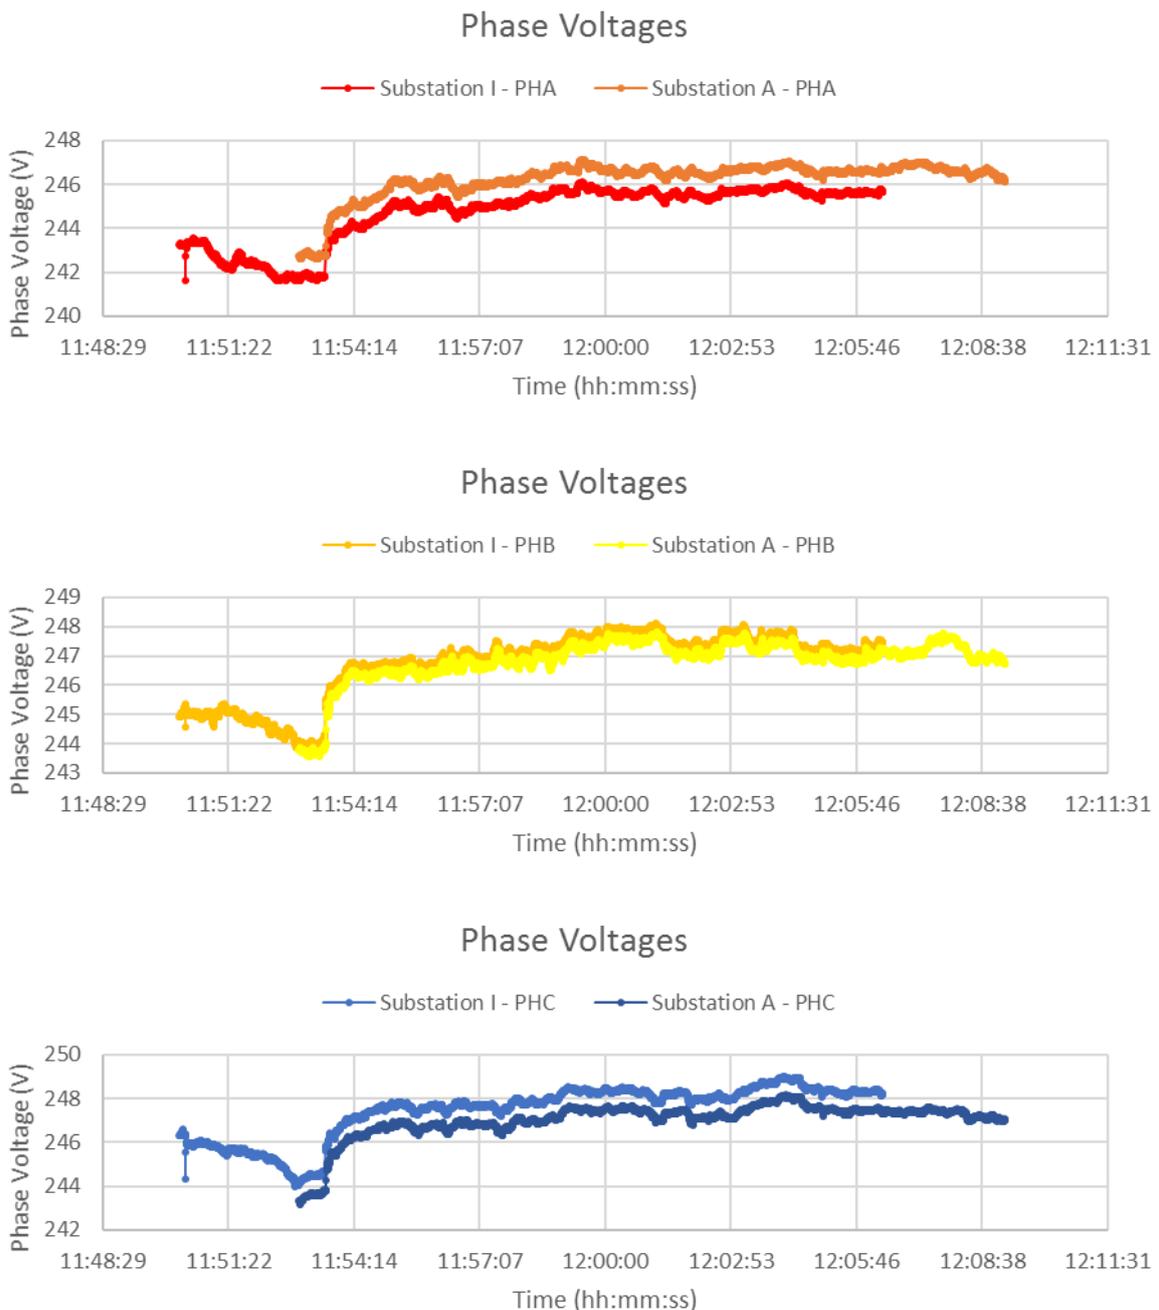
Figure 68 – Baseline phase voltage measurements at substation I and A prior to interconnection

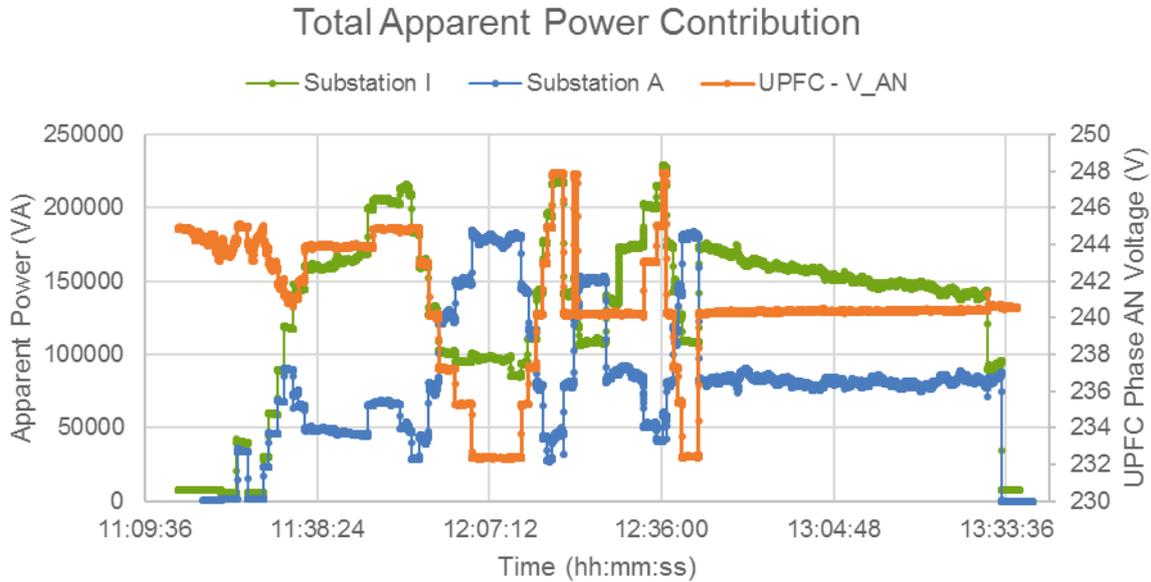
Figure 69 – Total apparent power contribution of substation I and A during power sharing alongside the phase A to neutral voltage at the UPFC output

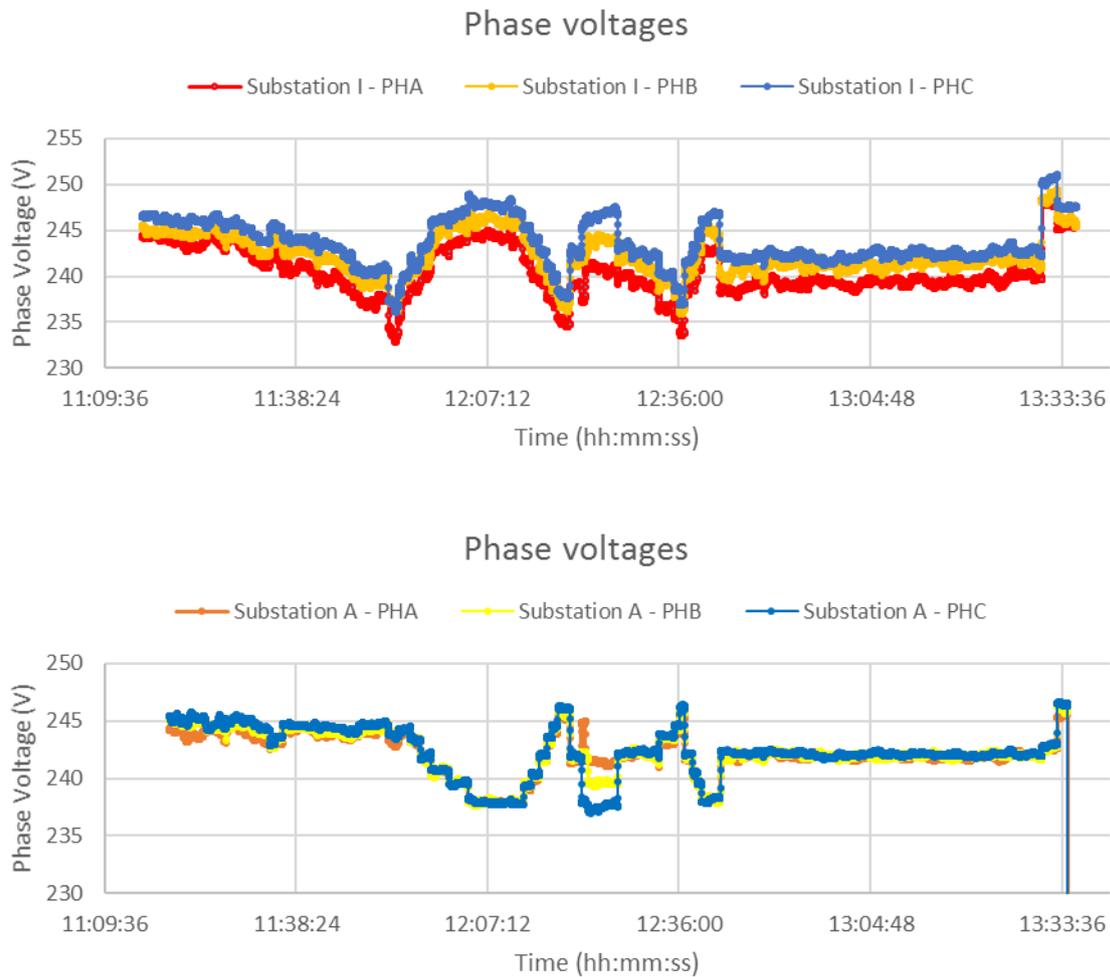
Figure 70 – Phase voltages at substation I (upper) Phase voltages at substation A (lower)

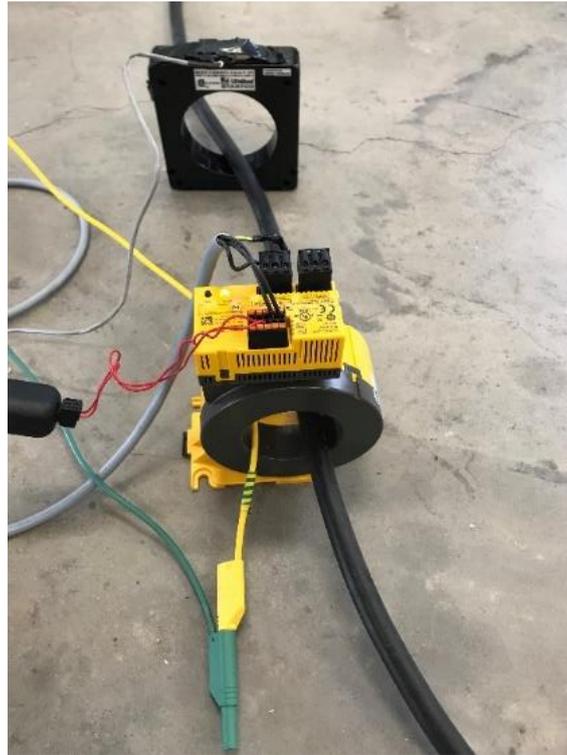
Figure 71 – USB interface with Bender RCMB301

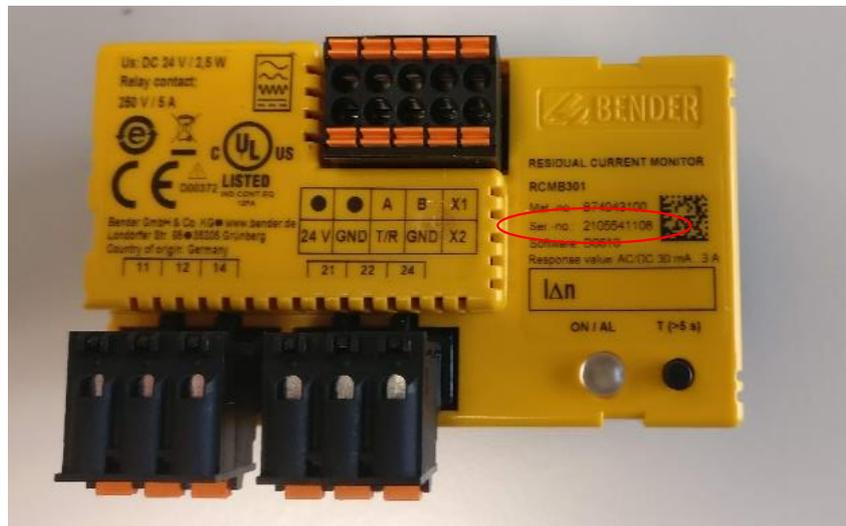
Figure 74 – Bender RCMB301 serial number location

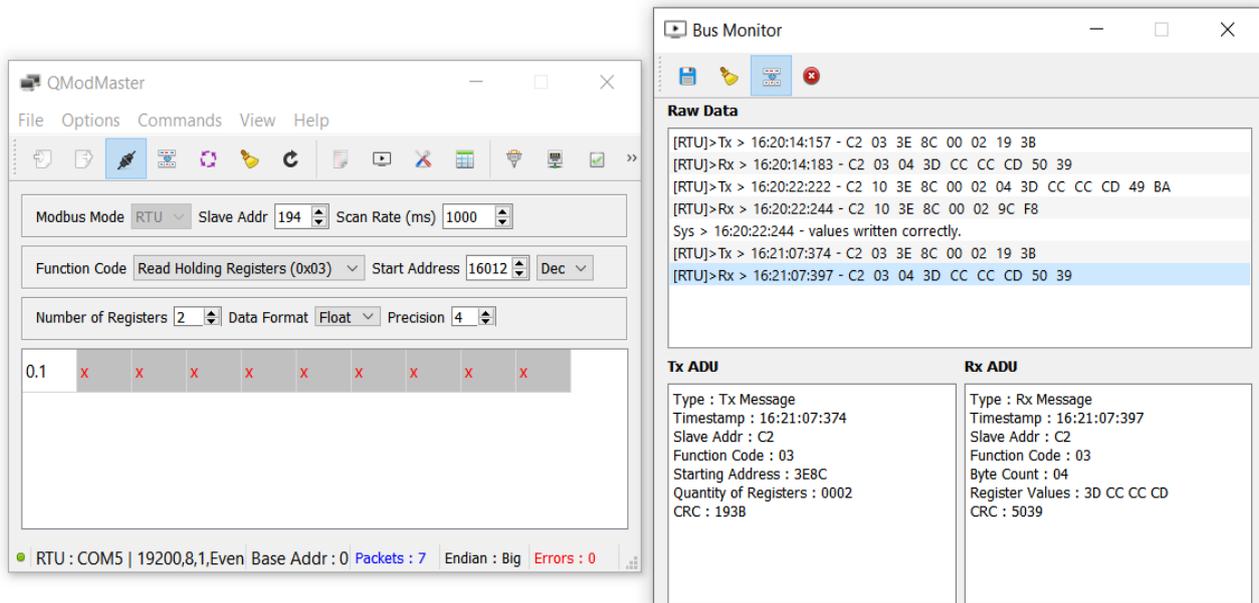
Figure 75 – Reading Modbus address 16012 (limit value alarm)

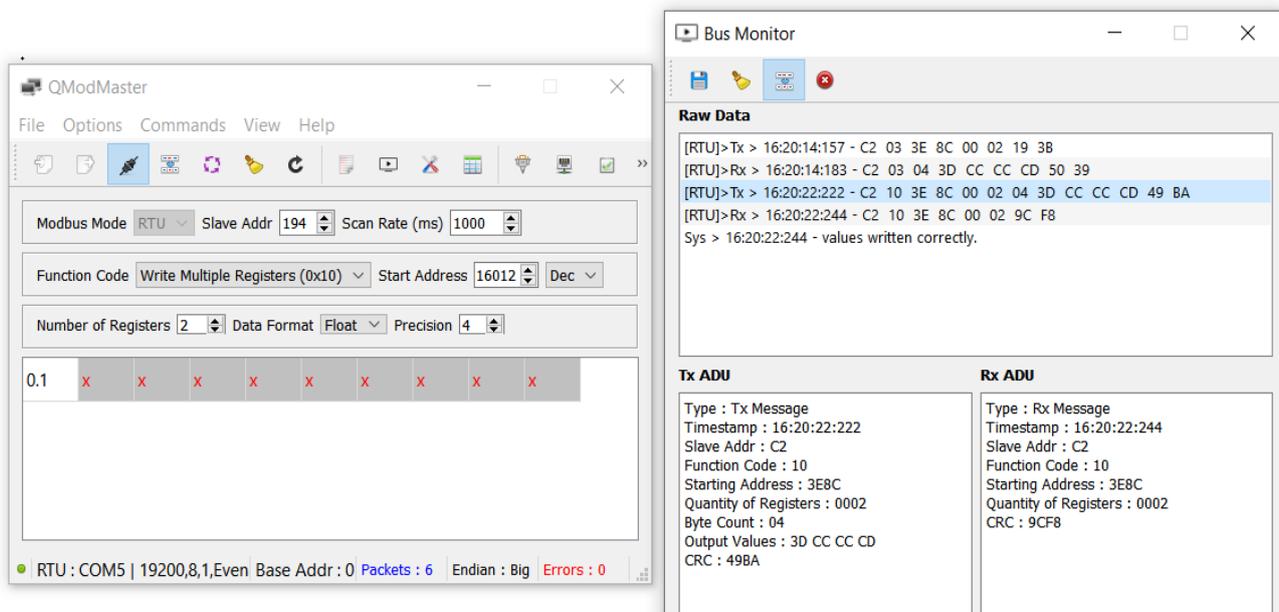
Figure 76 – Writing Modbus address 16012 to set the limit value alarm
