CABLE MAJOR REFURBISHMENT PROGRAMME	
Name of Scheme/Programme	SPNLT2021: Braehead Park – Erskine 132kV Cable Major Refurbishment. SPNLT2022: Galashiels – Hawick 132kV Cable Major Refurbishment. SPNLT2023: Portobello – Shrubhill 275kV Cable Major Refurbishment.
Primary Investment Driver	Asset Health
Scheme reference/mechanism or category	SPNLT2021/Cable SPNLT2022/Cable SPNLT2023/Cable
Output references/type	NLRT2SP2021/Cable NLRT2SP2022/Cable NLRT2SP2023/Cable
Cost	SPNLT2021: £5.0M SPNLT2022: £2.3M SPNLT2023: £4.7M
Delivery Year	2022 – 2026
Reporting Table	C0.7/C2.2a_AP/C2.2a_CI/C2.3/C2.4b/C2.5/C2.5a
Outputs included in RIIO T1 Business Plan	No

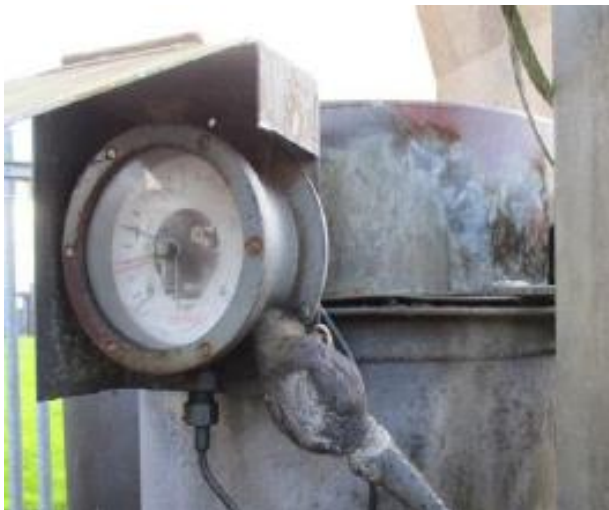
Visual inspection and condition information gathered in 2018 revealed that the equipment in the substation would require work to seal concrete and refurbish the gauges to improve their lifespan. Additionally, due to the age and condition of the equipment at Red Smiddy Compound, a full asbestos survey and removal of identified substances is required before any refurbishment work could commence.

Figure 1: General condition of gauge and pipework at Red Smiddy compound.

- Pre and post testing hydraulic and electrical (including PD).
- Re-engineering of pressuring system.
- Termination and refurbishment with a complete change out of all hydraulic equipment (tanks, gauges, test slide valves, pipe insulators and feed pipes), cleating, base plate insulation and sheath earthing (incl voltage limiters) including all alarms.

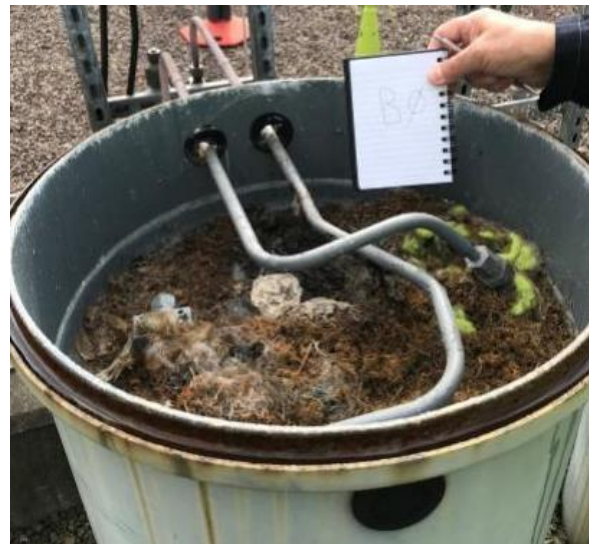
Figure 2: Fluid tank at Braehead compound showing sign of rust.

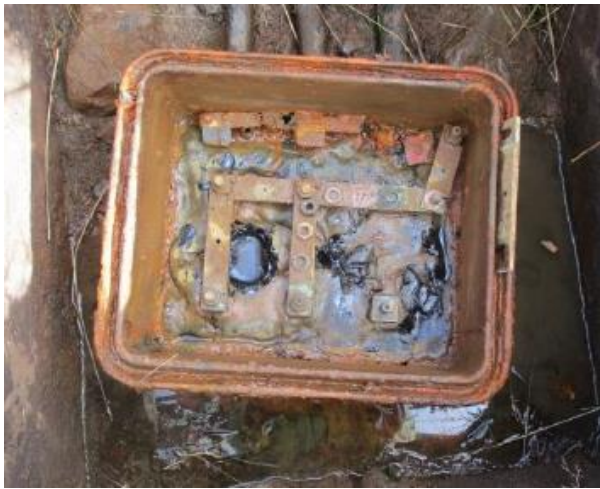
In addition to the above, electrically the circuit is in very poor condition particularly the section along Greenock Road. Most link boxes have water ingress. The link box at BZ15 is in very poor condition as it was found to have link missing and flooded. Gauges inspected at Greenock Road and Braehead Park was found to be working generally, however could benefit from refurbishment.

Figure 3: condition of link box at BZ15.

- Joint bay excavation to check on joint condition, buried tanks/chambers and gauges, link boxes and chambers (including replacement of CPU's/SVLSs/frame and covers).

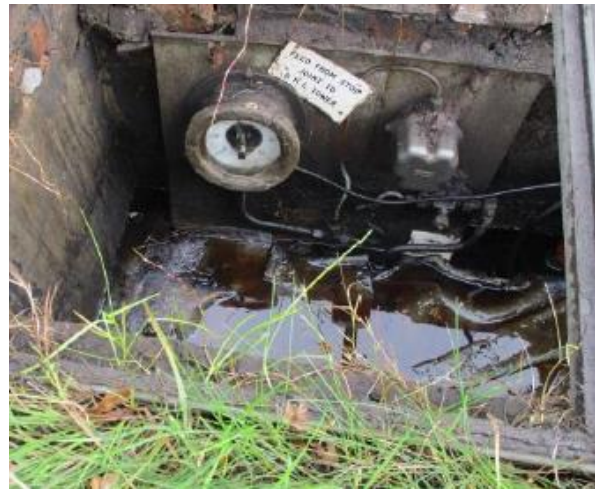
Visual inspection and condition information gathered in 2018 revealed that the equipment in the substation would require work to seal concrete and refurbish the gauges to improve their lifespan. Additionally, immediate attention was required to the timber cleats as a number of these are either missing, broken or showing signs of rot. Link box chambers along the route are in various states of repair with the link box at Greenock Road stop joint starting to crumble and some of the concrete covers no longer sealing the chambers from the elements.

Figure 4: condition of Greenock road stop joint gauge.

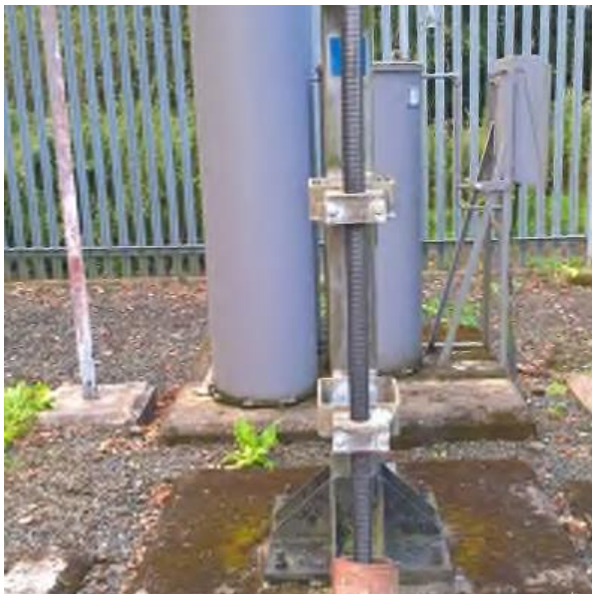
It was also revealed a need for replacement of all wooden cleats, post insulator and rubber feet on oil tanks, aluminium cleats on oil feed pipe to avoid sheath damage. Sealing end structures and tanks are showing signs of corrosion and require replacement to prevent any further deterioration. Red phase termination has a chip on the porcelain insulator which will require an epoxy repair. Holding down bolts on terminations are heavily corroded requiring to be changed out.

Figure 5: tanks starting to show signs of corrosion on lids and bases.

- Termination & refurbishment with a complete change out of all Hydraulic Equipment (tanks, gauges, test slide valves, pipe insulators and feed pipes), cleating, base plate insulation and sheath earthing (incl voltage limiters) including all alarms.

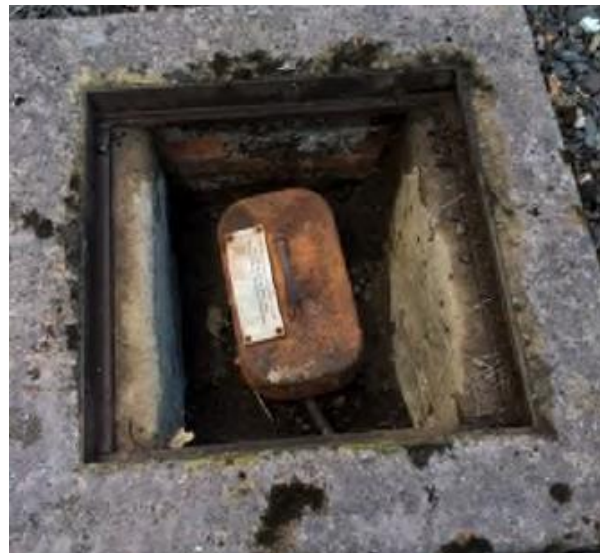
Figure 6: link box corroded.

- Joint bay excavation to check on joint condition, buried tanks/chambers & gauges, link boxes and chambers (including replacement of CPU's/SVLSs/frame and covers).

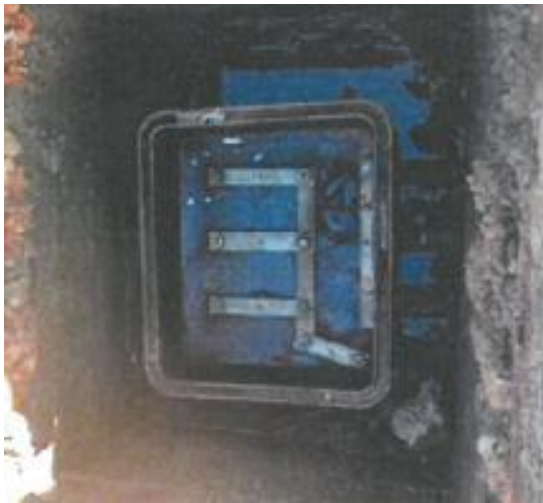
Visual inspection and condition information gathered in 2018 revealed the need for replacement of all plinth mounted tanks, old terminal connections at oil tank positions, all existing oil lines with new armoured oil lines and old oil tanks, gauges and alarms. In addition, the replacement of existing CCPU's with new SVL units at all link boxes along with an assessment of link boxes positions and the re-siting to more accessible locations to be considered.

Figure 9: typical link box. Compound blistering and signs of water ingress.

- Joint bay excavation to check on joint condition, buried tanks/chambers & gauges, link boxes and chambers (including replacement of CPU's/SVLSs/frame and covers).

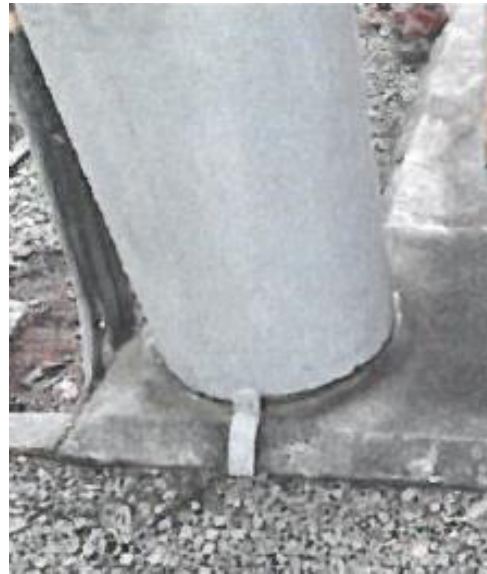
Figure 10: tanks showing signs of corrosion on bases.

- Pre and Post testing Hydraulic & Electrical (including PD).
- Re-engineering of pressuring system.
- Termination & refurbishment with a complete change out of all Hydraulic Equipment (tanks, gauges, test slide valves, pipe insulators and feed pipes), cleating, base plate insulation and sheath earthing (incl voltage limiters) including all alarms.
