<b>CABLE SEALING END PROACTIVE PROGRAMME</b>	
<b>Name of Scheme/Programme</b>	SPNLT20113
<b>Primary Investment Driver</b>	Asset Health
<b>Scheme reference/mechanism or category</b>	SPNLT20113/Cable
<b>Output references/type</b>	NLRT2SP20113/Cable
<b>Cost</b>	£7.9M
<b>Delivery Year</b>	2022 – 2026
<b>Reporting Table</b>	C0.7/5.18
<b>Outputs included in RIIO T1 Business Plan</b>	No

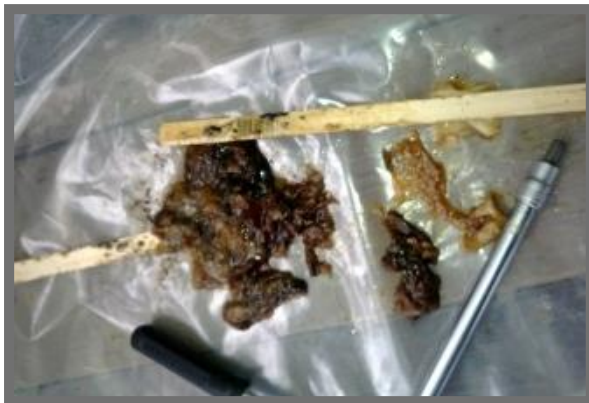
Figure 1 (Meadowhead): oil contamination March 16.

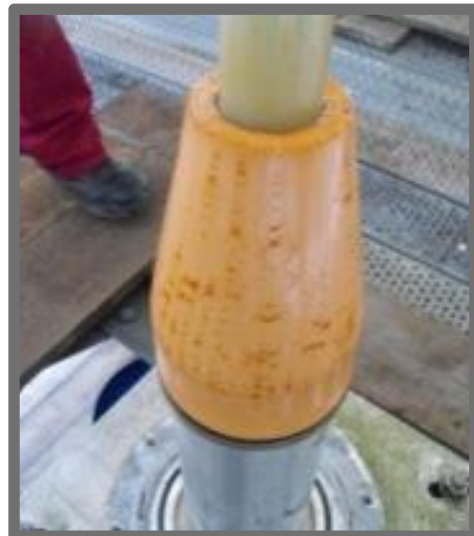
Figure 2 (Gretna): oil result failure April 16.

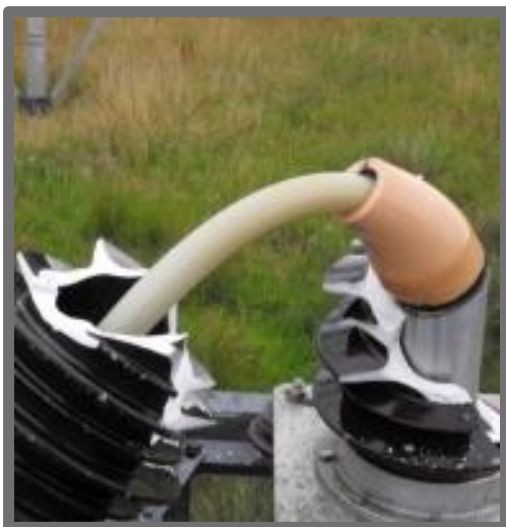
Figure 3 (Gretna): failure August 2016.

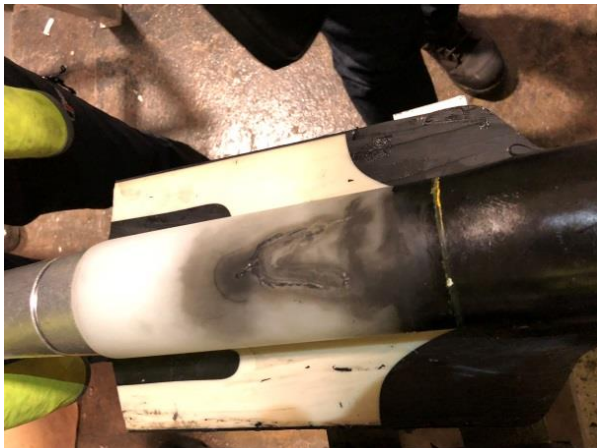
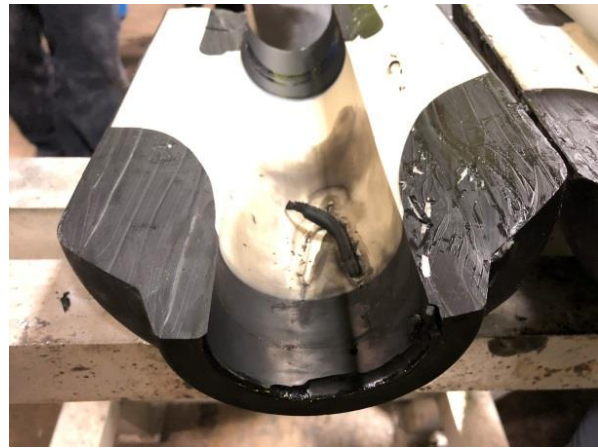
- [REDACTED] 132kV [REDACTED] GIS Termination.
- The termination failed a HVAC commissioning test following installation at Blackhill 132kV Substation.

Figure 5: post-mortem termination inspection.

Figure 6: post-mortem termination inspection.

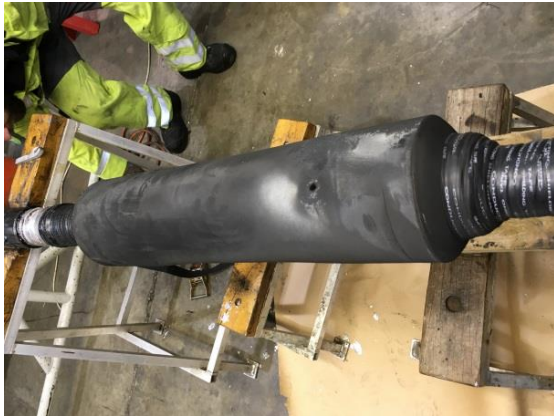
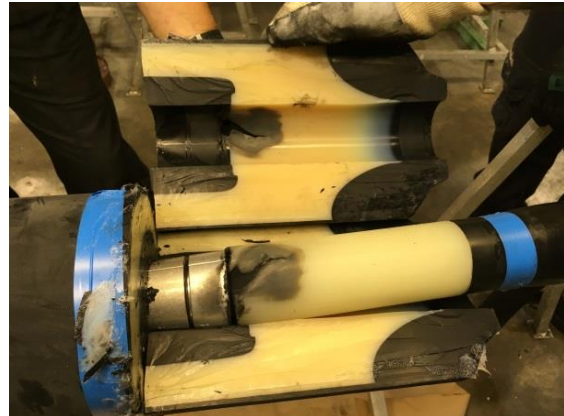
- [REDACTED] 132kV [REDACTED] joint [REDACTED].
- During the high voltage commissioning test on the Percival Lane (Runcorn – Salt Union 132kV circuit) a failure was recorded on the yellow phase.
- The high voltage test level applied was 90kV, due to the age of the existing cable. Failure occurred after 1 minute.

Figure 7: post-mortem termination inspection.

Figure 8: post-mortem termination inspection.

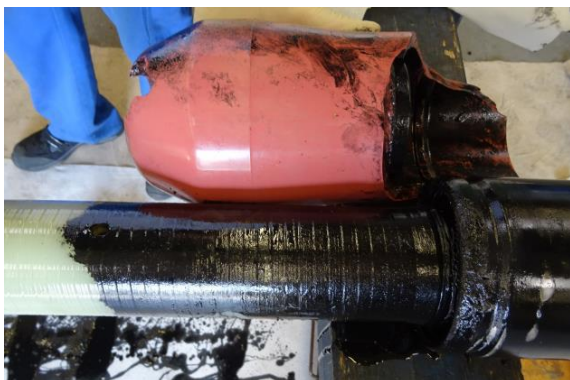
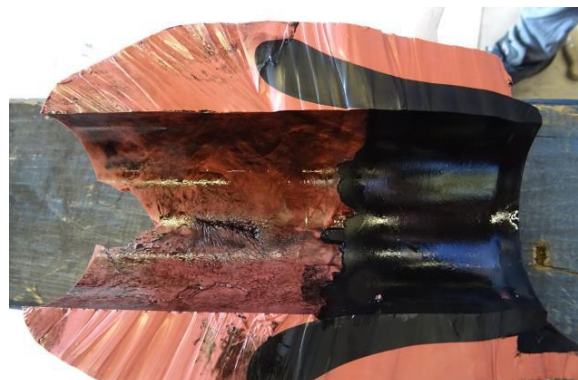
- [REDACTED] 132kV [REDACTED].
- A 132 kV outdoor cable sealing end of type [REDACTED] failed on 03rd of July 2018. The outdoor sealing-end was installed Harestanes – Moffat 132 kV cable circuit. The cable system had been commissioned in August 2013.

Figure 9: post-mortem termination inspection.

Figure 10: post-mortem termination inspection.

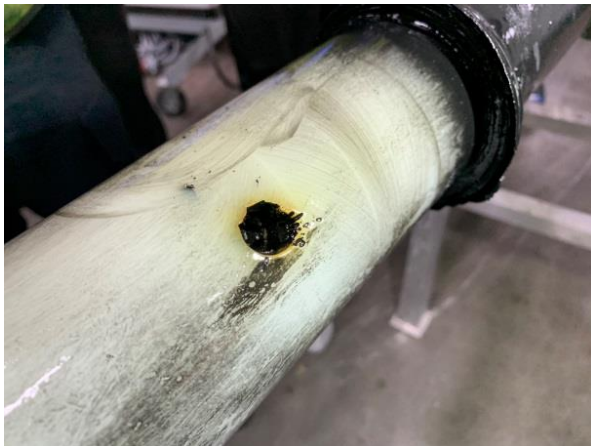
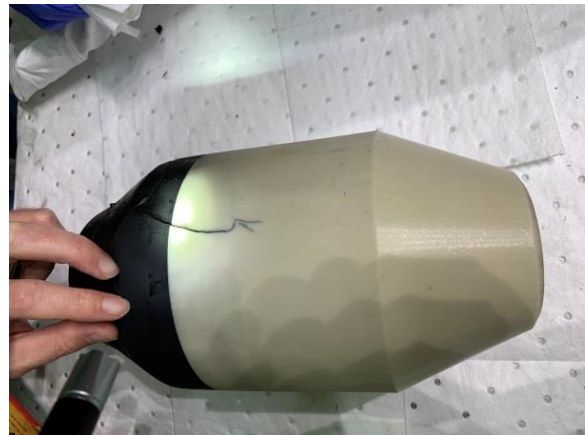
- [REDACTED] 132kV [REDACTED].
- On 14/09/2018 a failure occurred during normal operation of an OTC-145 outdoor termination. The failure was identified as Dunhill/New Cumnock circuit 1A yellow phase cable sealing end at the Blackhill 132kV substation.

Figure 11: post-mortem termination inspection.

Figure 12: post-mortem termination inspection.
