# **Westfield Substation Extension**

## **Arboriculture Report**

**Version 4 Issued 20/04/26**

Prepared by: **RTS Forestry**

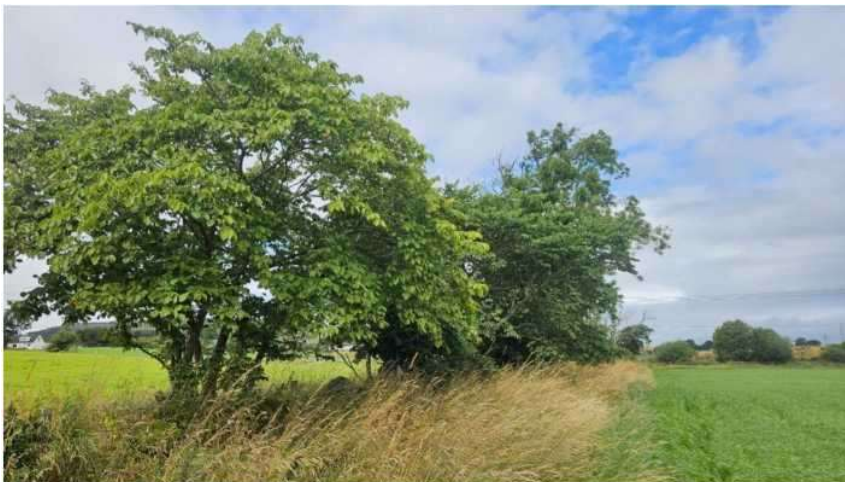
*Fig. 1a Placemark 2 - Westfield*

Trees between *Placemark 1 and 11* and at *Placemark 46* (See Table 1.1) are remnants of old hedgerows composed of Hawthorn (*Crataegus monogyna*), Ash (*Fraxinus excelsior*) and Wych Elm (*Ulmus glabra*) with much of the Ash in severe decline due to *Chalara*. Details of individual trees surveyed are found in Table 1.2.

The remnant hedge trees at *Placemark 1 to 11* are within the proposed development area. These are of overall low quality due to the prevalence of Ash Dieback disease-*Chalara* in the mature Ash. Compensatory planting would be appropriate mitigation with an alternative species selected to replace those Ash trees which are removed.

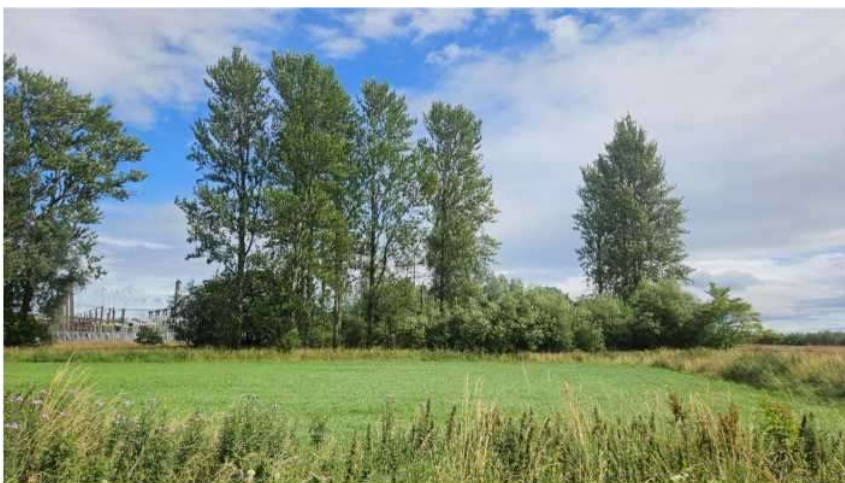
*Fig. 1c Placemark 15 - Westfield*

Outside of the site boundary, at *Placemark 14 to 25* an area of densely planted wet woodland of approximately 0.66ha is composed of White willow (*Salix alba*), Alder (*Alnus glutinosa*) and Black Poplar (*Populus x euramericana*). It is largely impenetrable due to dense branching. A number of large willow and poplar have blown over due to their height and the wet ground conditions. Standing trees are healthy, with multiple stems and large canopies. They are a significant in terms of their height and prominence in the surrounding landscape.

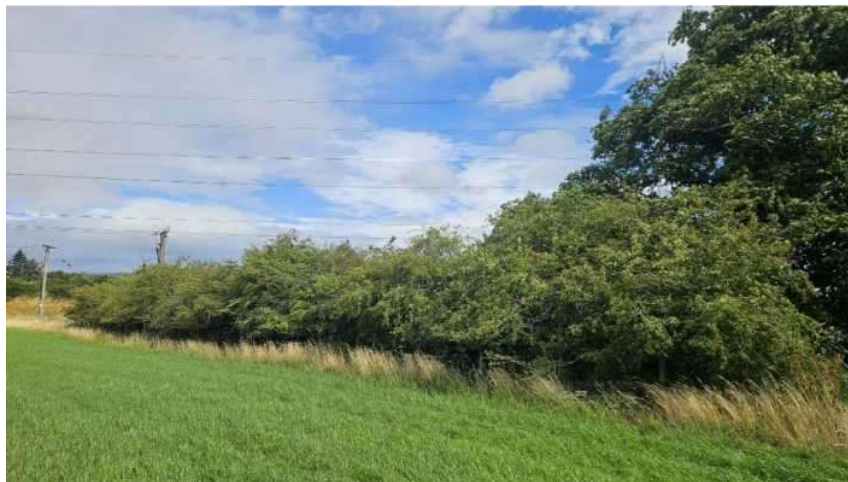
*Fig. 1e Placemark 31 - Westfield*

A mature hedge runs from *Placemark 26 to Placemark 33*. The hedge is in good condition with a species mix including Wych elm (*Ulmus glabra*), Hawthorn, Holly (*Ilex aquifolium*) and Sycamore. Trees are closely planted and the hedge provides some screening looking east towards the existing substation.

Hedge trees and scrub covering an area of approximately 0.68ha (*Placemark 26 to 31 and Placemark 33*) are within the proposed development boundary and growing within the buffer of the existing OHL. These are mostly low-growing species which could continue to be managed to maintain a safe height below those overhead powerlines crossing the site. Hedges of this type are a common feature of field boundaries in the context of the surrounding landscape.

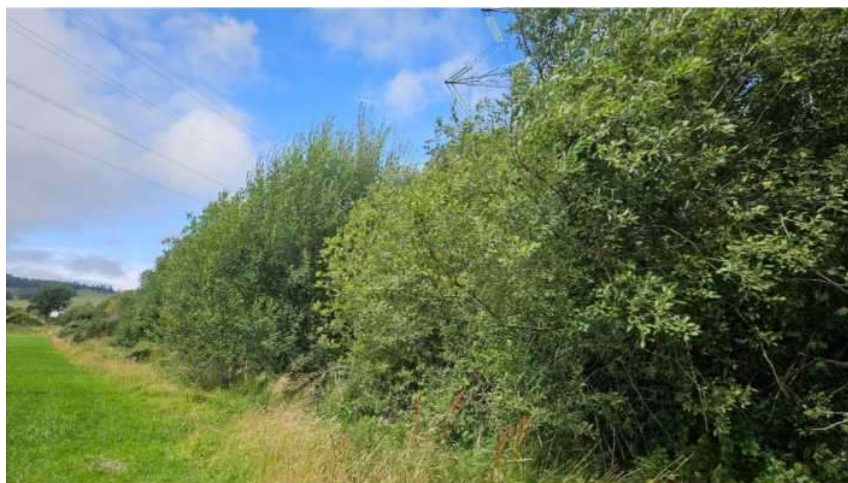
*Fig. 1g Placemark 38 - Westfield*

The roadside scrub/hedge between *Placemarks 37 & 42* is in good condition and is significant for its diverse species mix.

A total of 730 linear meters of scrub/hedge within the site boundary could be removed. As there are no designations within any of these areas, compensatory hedge planting is a feasible means of mitigation.
