SP ENERGY NETWORKS

Case Study:

HV cable damage covered with insulating tape during excavations to install drainage pipes

Case Study - Latent HV Cable Damage Found With Red Insulating Tape Attached

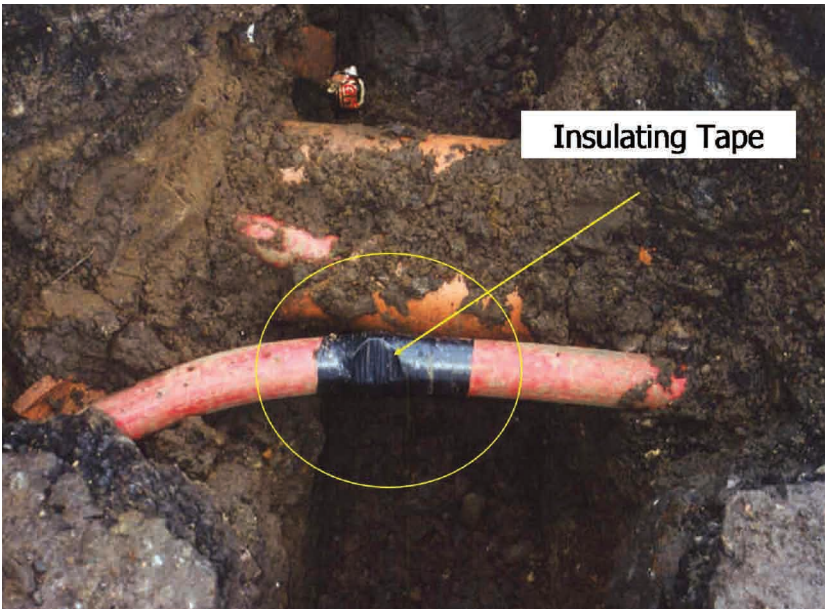
The above image highlights an HV cable damage with a covering of insulating tape applied by an operative.

The employee placed himself in danger by applying the insulating tape, the level of damage to the cable could easily have led to the cable blowing out onto the operatives face whilst the tape was being applied with the real possibility for severe burns/loss of sight/ facial disfigurement. When a cable strike has taken place the correct course of action is to evacuate the excavation immediately, secure/protect the area and report the incident to ScottishPower's emergency number (shown opposite).

Prior to any excavations taking place cable records should always be consulted.

Always assume cables are live.

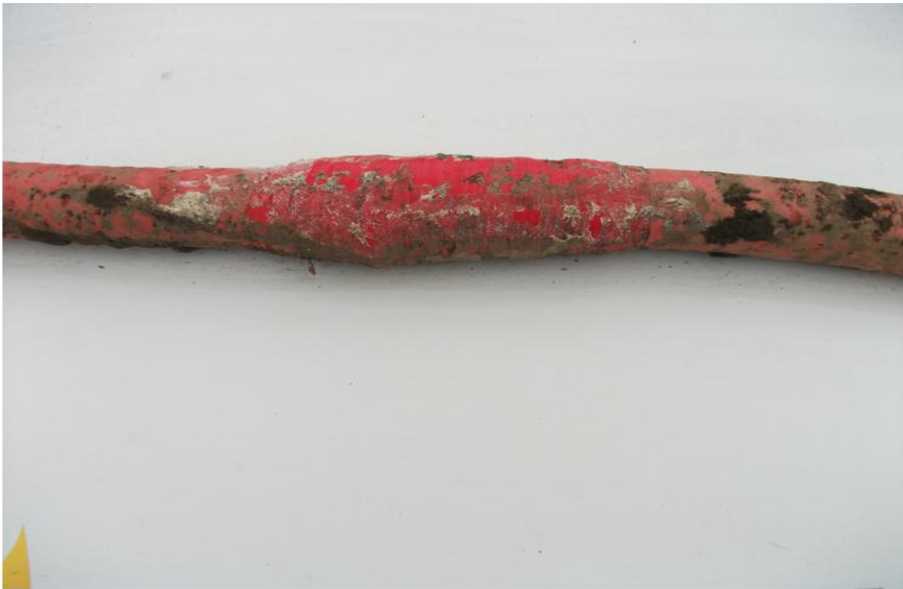
The above image highlights a section of HV cable found with red insulating tape covering the point of damage. The operative who placed the insulating tape around the cable, not only placed themselves in danger, they left a dangerous situation for operatives excavating at this location at a later date.

Failure to report the cable damage at the time of the cable strike incident occurring is an irresponsible action. The consequences of failing to report a cable strike and attempting an unauthorised repair could lead to serious injuries being inflicted on the third party involved and unsuspecting contractors.

**All Cable Strike Incidents Are To Be Reported
Immediately To SP Energy Networks Emergency Number:
0845 2727 999**
