Assessment of overhead line  
performance during severe storms

Prepared for:  
Scottish Power Energy Networks

# Assessment of Overhead Line Performance during severe storms

Report No:  
82880

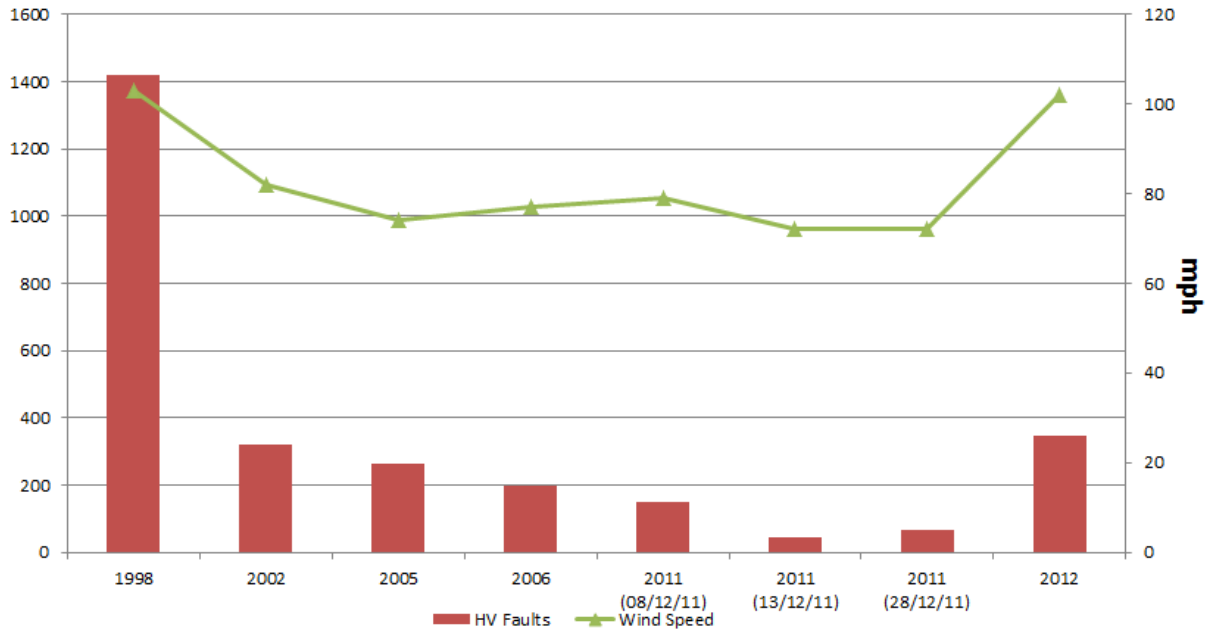
**Figure 8 – HV Faults Vs. Maximum Wind Speeds**

**In conclusion, from the eight storm events illustrated in Figure 8 the 1998 and 2012 storm events are the most comparable.**

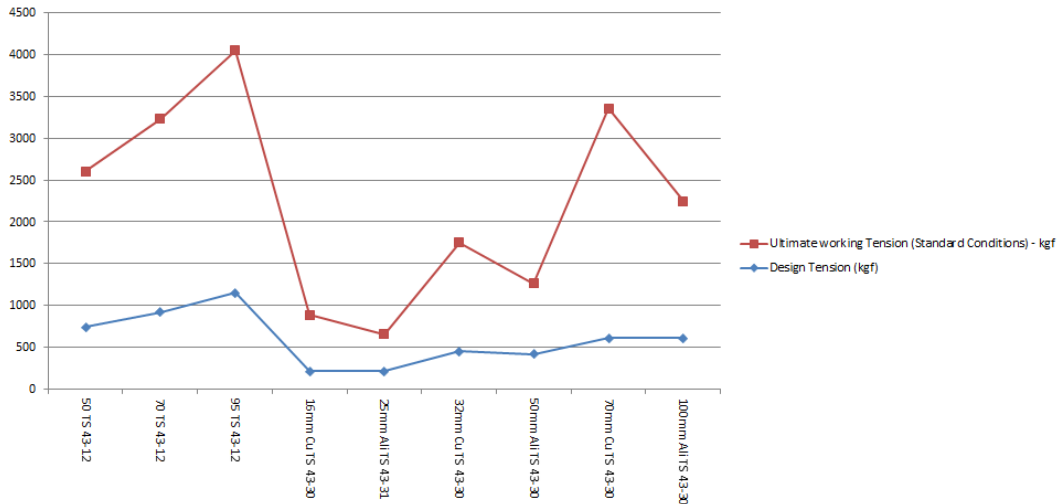
Figure 16 – LV Constructions

Figure 16 illustrates the difference between the conductors design and ultimate working tensions; all three of the ABC conductors show a very large extra capacity over its design tension. This can sometimes be detrimental to an OHL as poles become the weakest link. ABC has such tension capabilities that it has been witnessed were stays have pulled through their concrete blocks and the pole snapped before the conductor failed. This can be remedied by introducing weak parts in the suspension or tension fittings.

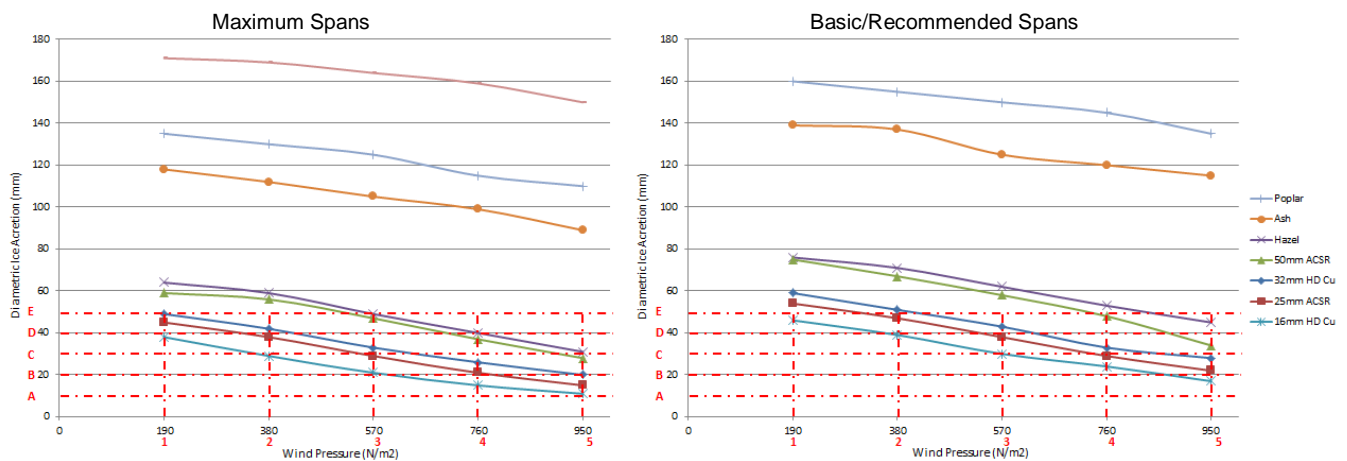
Figure 18 – OHL Conductors

Lines designed in accordance with ENA TS 43-40 are more likely to withstand the likely wind and ice loadings as identified within the relevant UK weather zone maps. Figure 18 shows the conductor failure curves against the wind and ice loadings for span lengths equal to the basic/recommended and maximum span lengths. These findings have been replicated from the STP project S0283 [17]. The conductor failure curves display the maximum conductor load that can theoretically be applied to the conductor. It illustrates the load at which the

conductor would fail either by reaching its elastic limit or by exceeding the conductors actual ultimate tensile strength (UTS). The graphs have the 43-40 weather areas overlaid in red, for extra clarity  $380\text{N/m}^2$  is equal to 55.7mph,  $570\text{N/m}^2$  is equal to 68mph and  $760\text{N/m}^2$  is equivalent to 78.9mph. Upas is only displayed in the maximum span length graph as the L35 specification recommended span length of 80m greatly out performs the programme (used for calculations) limit of 180mm diametric ice accretion.

**Figure 18 identifies that Hazel conductor 'maximum spans' can withstand 1E, 2E, 3D, 4C and 5B ENA TS 43-40 weather co-ordinates. SPEN rate their L10 specification (Hazel conductor) to a maximum of 2D & 3C weather co-ordinates, and anecdotal evidence suggests that it performed very well during the 2012 storm event.**

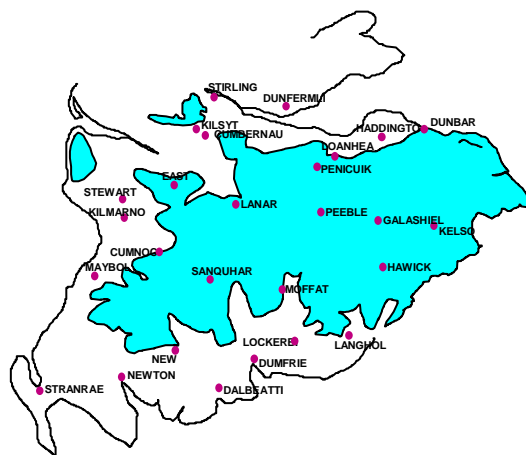
**Figure 20 – Severe Weather Map**

The comparison between the ENA TS 43-40 weather zone maps and SPEN's severe weather map illustrates that SPEN's severe weather map would benefit from some refinement.

- Ayrshire & Clyde South has a small severe weather area (Approximately the bottom half of the small blue area above Stewarton (Figure 20)). All of Ayrshire & Clyde South region's 77 faults occurred within the non-severe weather areas. Although the severe weather area is quite small it would have been expected, given the large number of faults for this region, that some damage would have occurred within it.

- The Central & Fife region has a severe weather area (above Kilsyth (Figure 20)), which accounts for approximately 20% of the region. This region suffered the largest amount of HV faults; however none had occurred within the severe weather area. It would have been expected to see damage within the severe weather area given its size and the number of faults report in this region.

- The Glasgow & Clyde North region has a small severe weather area (Approximately the top half of the small blue area above Stewarton (Figure 20)). Given the small severe weather area and the relatively small amount of HV faults that occurred in this region, no conclusion can be drawn from the fact that all of the faults occurred within the non-severe area.

As Figure 22 illustrates the Ayrshire & Clyde South, Central & Fife and Edinburgh & Lothians regions' HV faults were all classified as occurring within non-severe weather areas; however Figure 20 identifies severe weather areas within these regions.

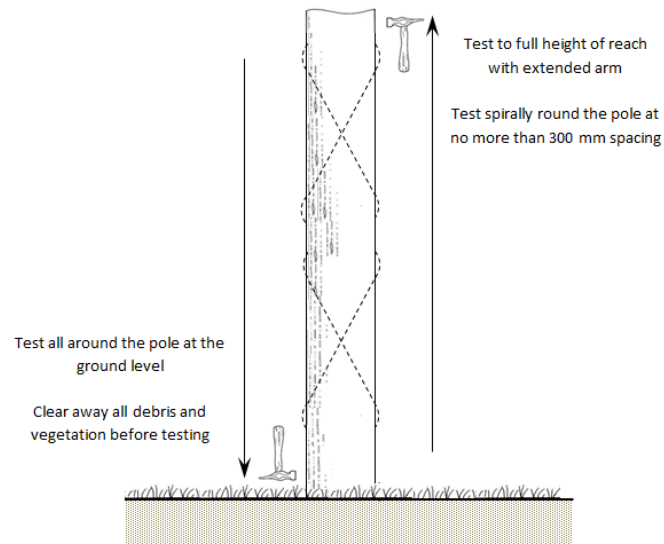
**Figure 26 – Hammer Test**

Inspectors carrying out OHL inspections evaluate a poles condition through visual inspection and a hammer test (Figure 26). The pole's condition is then reported in the AIS system as OK or defective. If SPEN encounter a larger than usual amount of defective poles, a further evaluation is carried out by an outside contractor to ascertain the levels of decay using more advanced pole testing methods.

When poles are evaluated with such a basic test as a hammer test poles that are in really good, normal or really poor condition are easily identified. Poles that the inspector is not sure about, end up being classed as defective just to be on the safe side. If the AIS pole evaluation was categorised into 4 levels such as 'New', 'OK Normal Wear', 'Poor' and 'Bad Work Required', the poles that are not easily determined with a hammer test would fall into the 'Poor' category and could be tested further. Some UK DNOs ask their inspection contractor to carry out the further test on site with equipment that can easily be carried to the pole such as a 'Matson Corer' or 'Purl Tester'.

Whilst pole testing using the ‘Hammer Test’ is very subjective using a condition rating should improve the quality of pole testing. It can also increase the ability to audit an inspectors work as level 3 poles (‘Poor’) should never be reported as any other level, just as level 4 poles (‘Bad, Work Required’) should only ever be reported as level 4.
