SP Energy Networks 2015–2023 Business Plan

11kV Substation Plant Strategy

SP Energy Networks

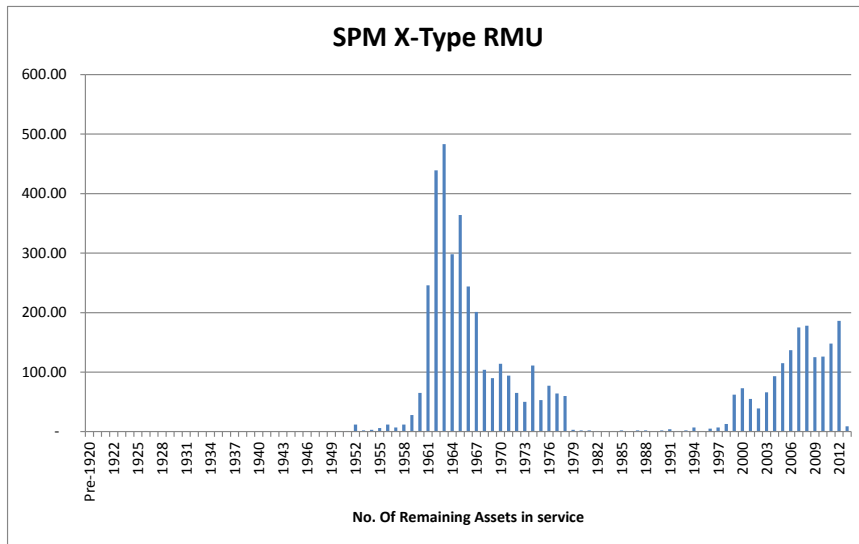
SP Energy Networks has a population of approximately 25,000 ring main units and we plan to replace or refurbish 17.4% during ED1. These high volume units are now showing sign of deterioration and are becoming operationally inadequate.

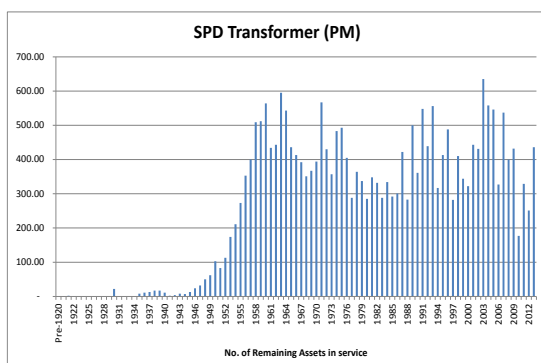
We have approximately 87,000 ground mounted and pole mounted transformers and we plan to replace or refurbish 5%. Our risk based strategy to ensure staff and public safety from HV Transformers is based on;

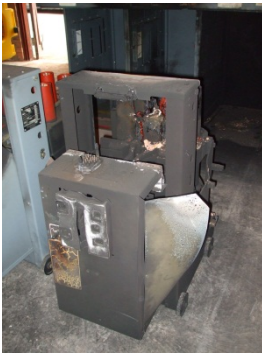
VMX circuit breakers

One recent developing issue has been the early failures of GEC VMX switchgear which are vacuum circuit breakers installed in the 1980's and 1990's, mainly in SPM (population of over 1000). A number of these are on critical primary switchboards that are part of demand groups supplying more than 10,000 customers. These switchboards are very susceptible to the environment they are kept in. Failures of these units have been where the unit is in a damp environment. Our strategy is to replace a percentage of our VMX population that reduces the risk to an acceptable level and also allows us to manage the population going forward. We will start with the worst condition first. These will be VMX in the substation buildings that have, or had, the highest humidity/poorest heating, or a known history of discharging breakers that we have nursed back to serviceability. Most of these will be the early versions which cannot be refurbished so the entire switchboard will need to be replaced. However later versions can be refurbished and these will be sent back to works and will provide spares for others reported as audibly discharging. By the end of ED1 we will have replaced 13% of the VMX population in the ED1 period, and will also have generated enough refurbished spare circuit breakers to keep the remaining VMX switchboard population serviceable. We will deal with the remaining VMX in ED2, by which time we may need to further accelerate the replacement rate.

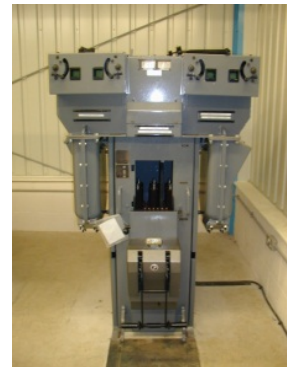
Early 1950's indoor ocb RMU originally fitted with direct manual mechanism un-potted 150MVA type TDB ocb. All ocbs rebuilt to revised 250MVA design by Baldwin and Francis between 1976 and 1985 (hence JPBF). Rebuilt OCB uses original ocb top plate tank, bushings and drive crank. All new mechanism and contact system/turbulators (pots). The internal of the top plate suffers from crystalline rusting due to condensation in an identical manner to the latter manufactured PDB ocbs replaced under DPRC5.

Its onset was delayed by attempted internal re-painting during the rebuild. These ocbs are unique in having ferrous top plates (other makes/types use non-ferrous (and hence nonmagnetic castings). RMU oil switches identical to later NX RMU and are fully rated. Design is very vulnerable to failure if rainwater from roof leak falls on unit – no protection for oil switch tank breather under test access lids. No manufacturer support from either J&P or Baldwin and Francis. No spare parts available other than 'pattern-part' ocb contacts. OCB uses extension earthing kit (new kits purchased from B&F in early 1980's) earth kits beginning to wear out and tested replacements unavailable.

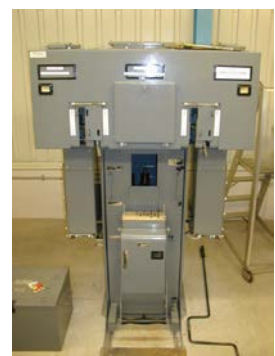
SWS RMN4 RMU

Mid 1950's indoor ocb RMU originally early types fitted with direct manual mechanism un-potted 150MVA type 'C4' ocb with 'H04' mechanism. All C4 ocbs replaced between 1976 and 1985 with SWS D4XDM type adapted to fit the original ocb carriage. Later RMN4 RMUs had original 250MVA C4X ocb with porcelain bushings, many of which have developed bitumen compound leaks into the ocb oil tank and externally due to natural deterioration of rubber/cork gaskets. OCB can be refurbished by Hawker Siddeley but price similar to all new non-oil RMU. No manufacturer support and no parts available for oil switches, RMU housings or ocb mechanisms. Manufacturers and others can supply only pattern-part contacts. OCB uses extension earthing kits supplied in mid to late 1950's. Many now becoming unserviceable and replacements are unavailable.

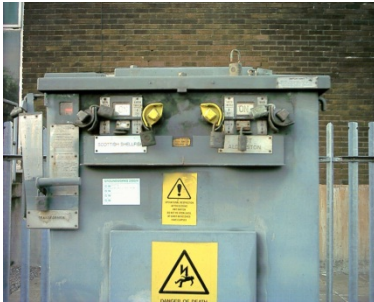
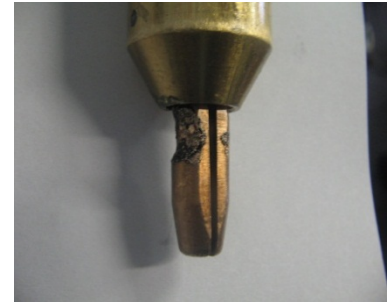
Reyrolle ROKSS RMU

Oil filled switchfuse RMU purchased by SSEB from mid 1970's. An asset failure and fatality generated an SOP 1998/0198/00 which banned live operation due to test bushing spacer dislocation in to HV oil tank. SOP2001/0374 banned live operation on all units manufactured before 1982 due to failure of low tensile contact fixing bolts which were irreparable, and the installation of new barrier boards.
