SP Energy Networks 2015–2023 Business Plan

Assessment of Overhead Line Performance

Assessment of Overhead Line Performance during severe storms

Report No:
82880

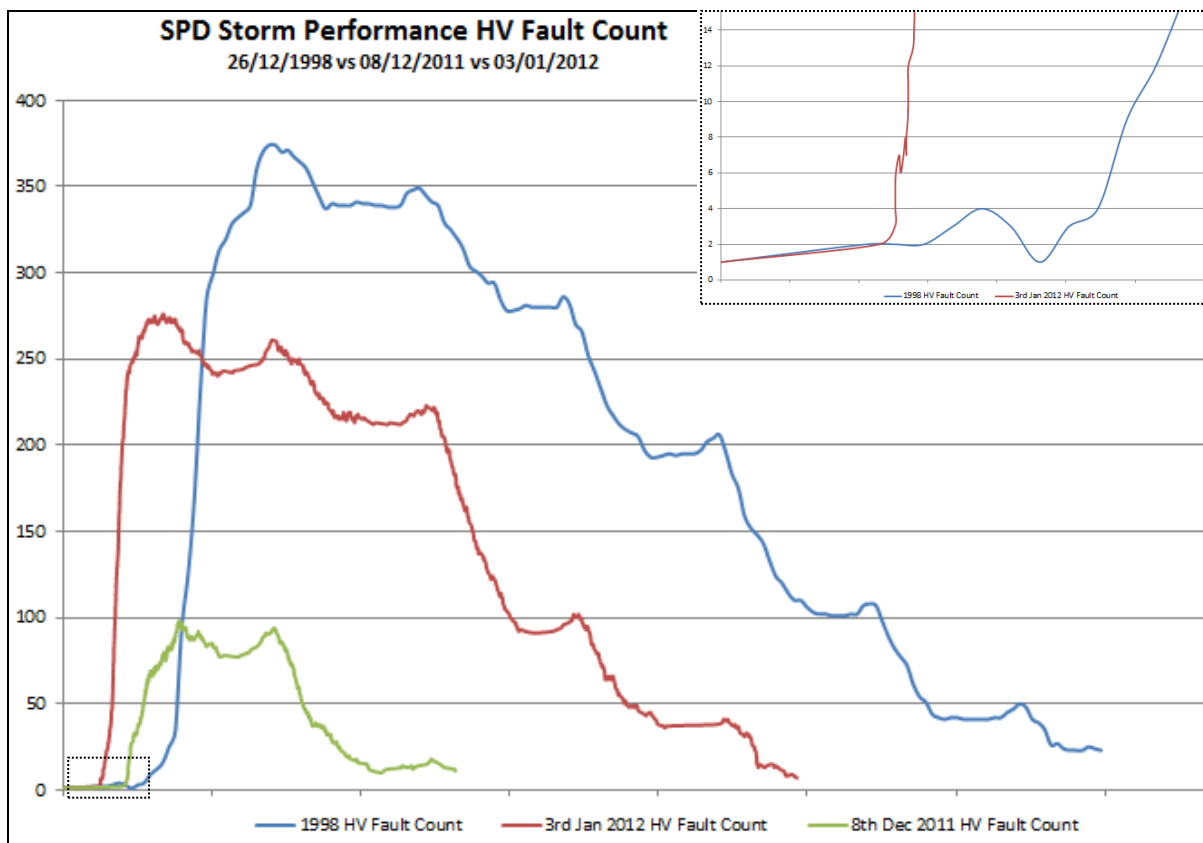
Figure 10 illustrates the HV damage fault counts for the storm events of the 26th Decemeber 1998, 8th Decemebr 2011 and the 03rd January 2012. It can be seen that the two storm events of 1998 and 2012 are fairly similar in shape, except that the peak in the 2012 graph is 31% smaller than the 1998 graph (in reality the 1998 graph would be much larger due to the under reporting problem). The cutout at the top right corner of Figure 10 expands the start of the storm event and shows that the storm event of 2012 (2011 graph removed for clarity) had a much more explosive impact. An analysis was carried out on the first 34 faults reported on both of the storm events, this figure was selected as it is approximately where each of the graphs start to rise in parallel. The storm event of 1998 reached 34 faults at 19:09 which was 14 hours 7 minutes after the initial fault, the storm event of 2012 reached 34 faults at 07:35 which was 2 hours 5 minutes after the initial fault was recorded.

Figure 10 – HV Fault Count

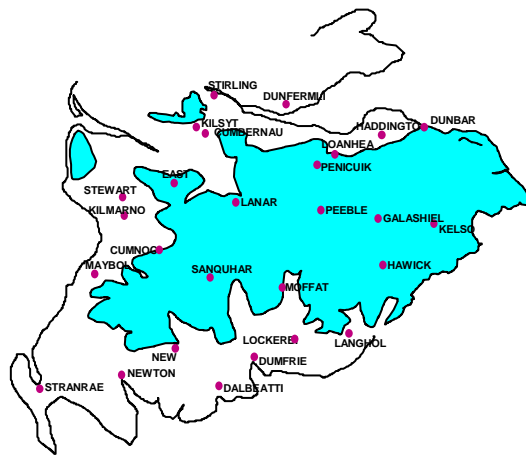
Scottish Power with assistance from the Met Office developed a severe weather map for the Scottish network (Figure 20). The severe weather map illustrates two distinct weather areas:

- Severe (Blue) – with mean hourly wind speeds up to 70mph, gusts up to 105mph.
- Normal – with mean hourly wind speeds up to 50mph, gusts up to 75mph.

Figure 20 – Severe Weather Map

The comparison between the ENA TS 43-40 weather zone maps and SPEN's severe weather map illustrates that SPEN's severe weather map would benefit from some refinement.

The severe weather map (Figure 20) identifies that:

- Ayrshire & Clyde South has a small severe weather area (Approximately the bottom half of the small blue area above Stewarton (Figure 20)). All of Ayrshire & Clyde South region's 77 faults occurred within the non-severe weather areas. Although the severe weather area is quite small it would have been expected, given the large number of faults for this region, that some damage would have occurred within it.

- The Central & Fife region has a severe weather area (above Kilsyth (Figure 20)), which accounts for approximately 20% of the region. This region suffered the largest amount of HV faults; however none had occurred within the severe weather area. It would have been expected to see damage within the severe weather area given its size and the number of faults report in this region.

- The Glasgow & Clyde North region has a small severe weather area (Approximately the top half of the small blue area above Stewarton (Figure 20)). Given the small severe weather area and the relatively small amount of HV faults that occurred in this region, no conclusion can be drawn from the fact that all of the faults occurred within the non-severe area.

As Figure 22 illustrates the Ayrshire & Clyde South, Central & Fife and Edinburgh & Lothians regions' HV faults were all classified as occurring within non-severe weather areas; however Figure 20 identifies severe weather areas within these regions.

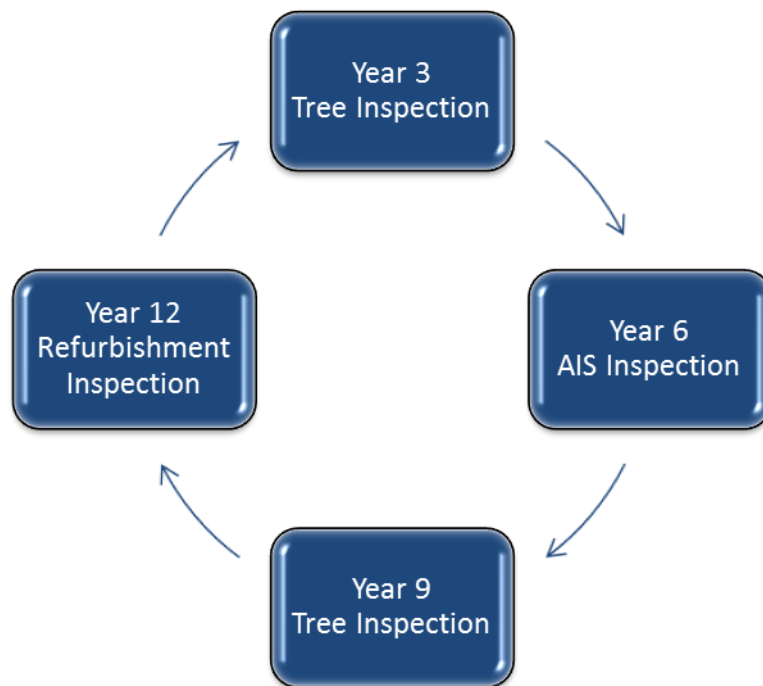
SPEN currently carry out AIS inspections every 6 years pole poles categorised as normal risk, high risk poles are inspected on a more regular 3 year basis. Figure 25 illustrates the timeline of inspections for OHL circuits. It shows that inspections are carried out for the vegetation management programme every 3 years, OHL inspections are carried out every 6 years (3 years for high risk poles). The OHLs are refurbished every 12 years (8% of population), the interim OHL inspection between refurbishments are to catch any defects between refurbishments. No decayed poles will be expected during these inspections as inspectors are asked to assess the poles on Refurbishment inspections for a minimum of 12 years life. OHLs will be evaluated at the 12 year period for refurbishment, 1% of the circuits would be selected for re-building.

Figure 25 – Inspection Timeline

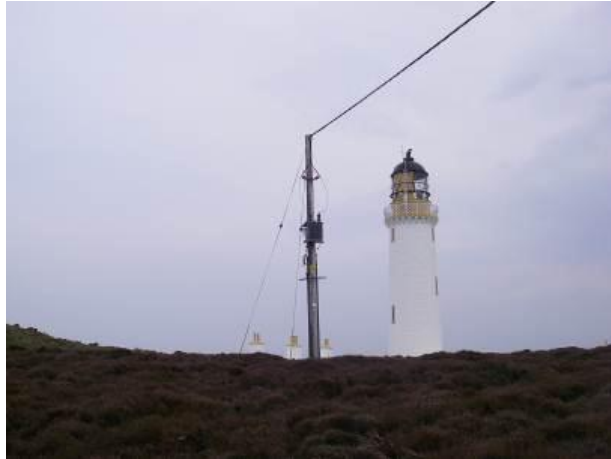
The internal design of the cable affects the way vibrations and galloping are damped by the cable. At EA Technology's test field on the Shetlands the Ericsson cables were installed on spans up to 90 meters for a period of 18 months [20]. The cables were monitored by load cells and video cameras and performed well under weather conditions with wind speeds (10 minutes average) of up to 82 knots (94 mph). Ericsson cables were further tested at EA Technologies Deadwater Fell test site [21].

If a falling tree lands on an Ericsson OHL, there is a risk that the cable could fail if the tree falls close to a terminal or section pole. If it however fell in the middle of the OHL then the cable will stay intact by slipping through the suspension clamps; there could also be some elongation of the cable. After removal of the tree the line would require re-regulating and any elongation removed through the nearest termination.

Figure 28 – Ericsson Cable (Mull of Galloway Lighthouse)

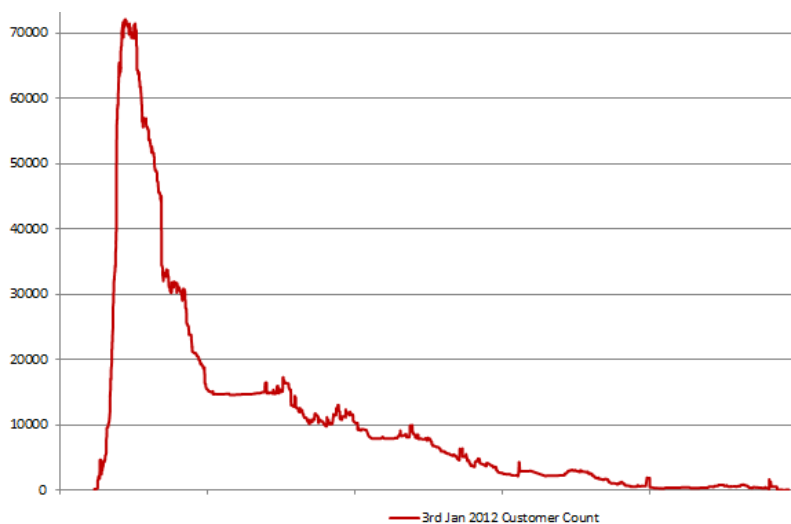
Figure 31 – Customer Count

The majority of the LV faults are, as would be expected in the less than 20 connected customer’s category. As the customer interruption count curve shows in Figure 31, the tail end reduces a lot slower than the start of the storm event; this is due to the amount of less than 20 connected customer faults. One metric that is important to a DNOs customers after a storm event, is being off supply for longer than 48 hours. During the storm event of 2012 4,792 customers were off supply for more than 48 hours, this is a reduction of 66% over the 1998 storm.
