SP Energy Networks 2015–2023 Business Plan

Civil Strategy and Plans

SP Energy Networks

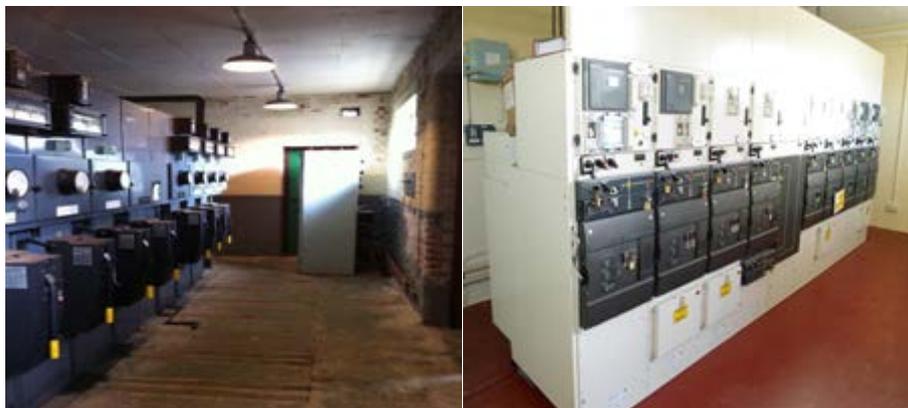
Figure 3 - 11kV switch room before & after plant replacement works

When carrying out major electrical works at our substations, we ensure the substation is left in a condition where minimal civil refurbishment works is required in future years by returning the substation overall Health Index to a HI3.

Our integrated approach is linked to our asset replacement and refurbishment programmes. Whilst modern switchgear is designed to work in a range of temperature and humidity conditions, experience has shown us that modern equipment is more susceptible to poor environmental conditions in comparison to older oil filled switchgear. Water, dust and pollutants can initiate or accelerate partial discharge activity in the equipment, which can reduce the performance and lifespan of the asset and result in disruptive failure.

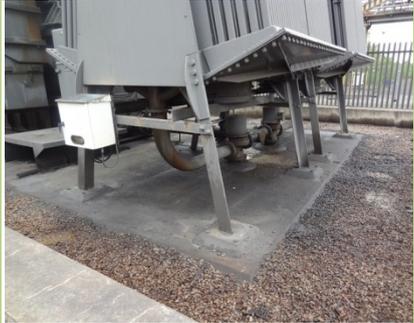
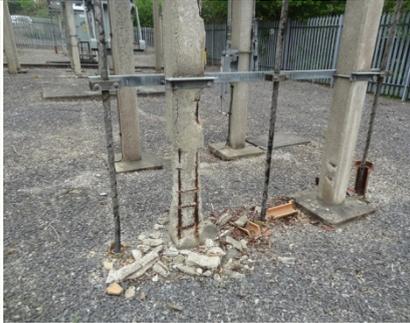
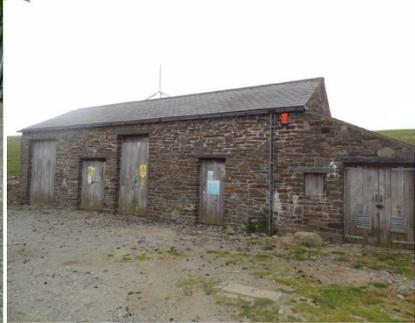
Each of these components is allocated a Health Index score by an assessor when carrying out onsite condition assessments. For larger sites this will typically result in a detailed substation report with detail at a granular level.

Concrete foundations	Major supporting structure	Building – Primary substation

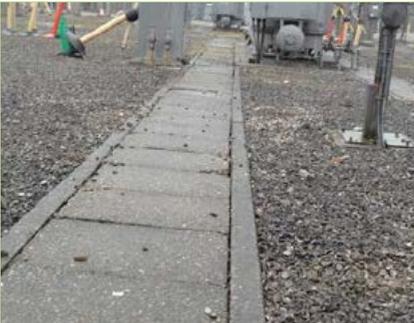
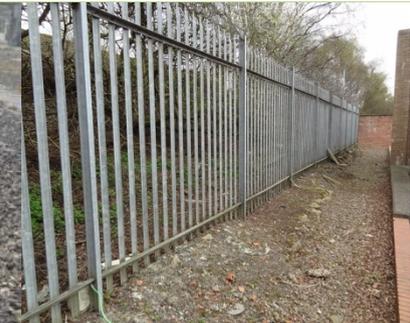
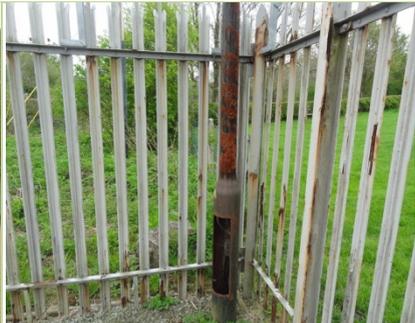
Trenches & Manholes Cable Trench	Compound Fences & Retaining Walls Palisade Fence	Non Supporting Structures Lighting column at end of life
