### Case Study: Low Voltage Mains Cable found damaged

### Case Study: Low Voltage Cable Strike With Excavator

# Case Study: Low voltage service cable repair

### Case Study: Low Voltage Cable Strike With Mini Excavator

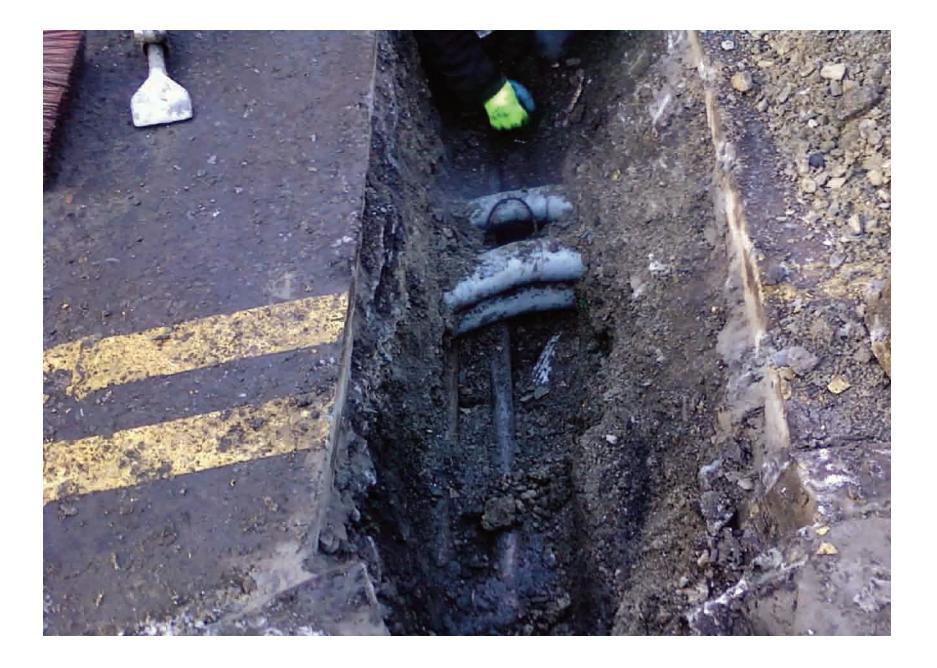
The above image demonstrates latent cable damage.

The damage to the Low voltage mains cable was not reported to ScottishPower when the contractor installed the ducting on top of electricity cables.

Customers in the area were experiencing loss of supplies to their properties and ScottishPower engineers located the loss of supply problem to the above location. As the cable damage was not reported to ScottishPower the situation resulted in damage to the newly installed ducting, a situation that could have been avoided if the cable strike had been reported when it happened, as they installed the ducting on top of ScottishPower apparatus.

Please note: separation between underground utilities is important to avoid damage to other utilities apparatus. Reporting cable strikes at the time of occurrence will avoid inconvenience to customers and reduce costs to third parties.

Prior to any excavations taking place cable records should always be consulted.

Always assume cables are present and live until proved otherwise.

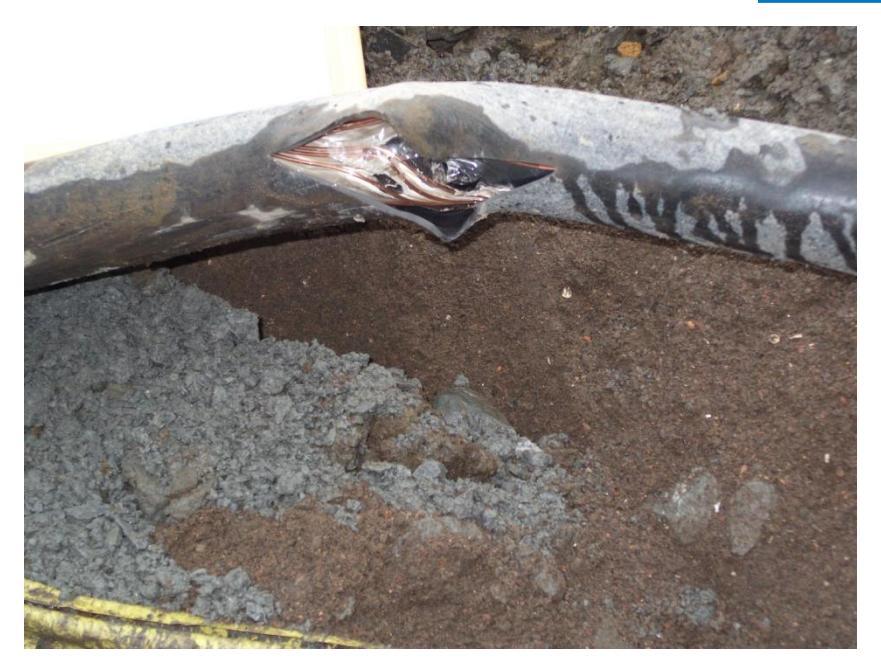
The above image clearly demonstrates the impact on the underground ScottishPower network, when an excavator came into contact with a low voltage cable (240 (4) Waveform)

The contractor's task was to carry out excavations to install underground drainage apparatus, ScottishPower cable records and cable locator on site. Contractors on site had installed the cables previously and were clearly aware of the location of the cable route. During the excavations to progress the drainage works the high voltage cable was located, however an excavator came into contact with the low voltage cable, despite a ScottishPower sub-station being situated in close vicinity to the works taking place. Fortunately on this occasion no injuries were sustained to the operatives. Excavations require to be planned professionally to avoid cable strikes/serious injuries to operatives.

### Adherence To HSG47 Strongly Recommended

Always assume cables are present and live until proved otherwise.

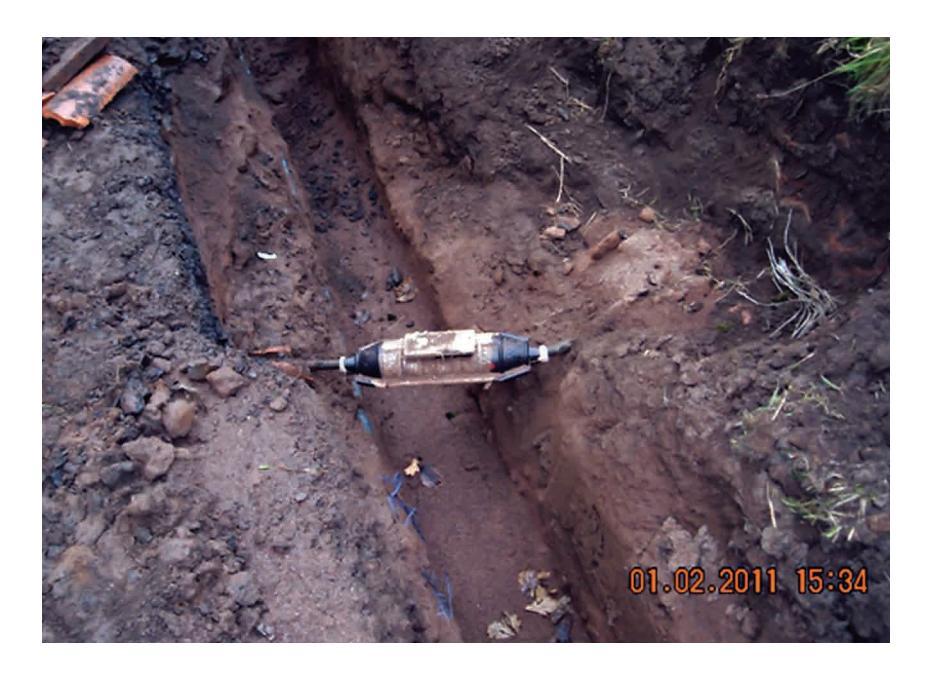
The above image highlights a repair to a ScottishPower low voltage service cable.

The cable was evident on the contractor's cable records; however the operatives still managed to strike the cable with a mini-excavator with the potential to cause injuries to himself and his colleagues. Prior to main excavations taking place, trial holes should always be carried out to locate the line and depth of all utilities throughout the project. Before the use of a mechanical excavator takes place a risk assessment should always be carried out to confirm that it is safe to progress the works with the mini excavator/ JCB/track machine etc.

Adherence to HSG47 strongly recommended.

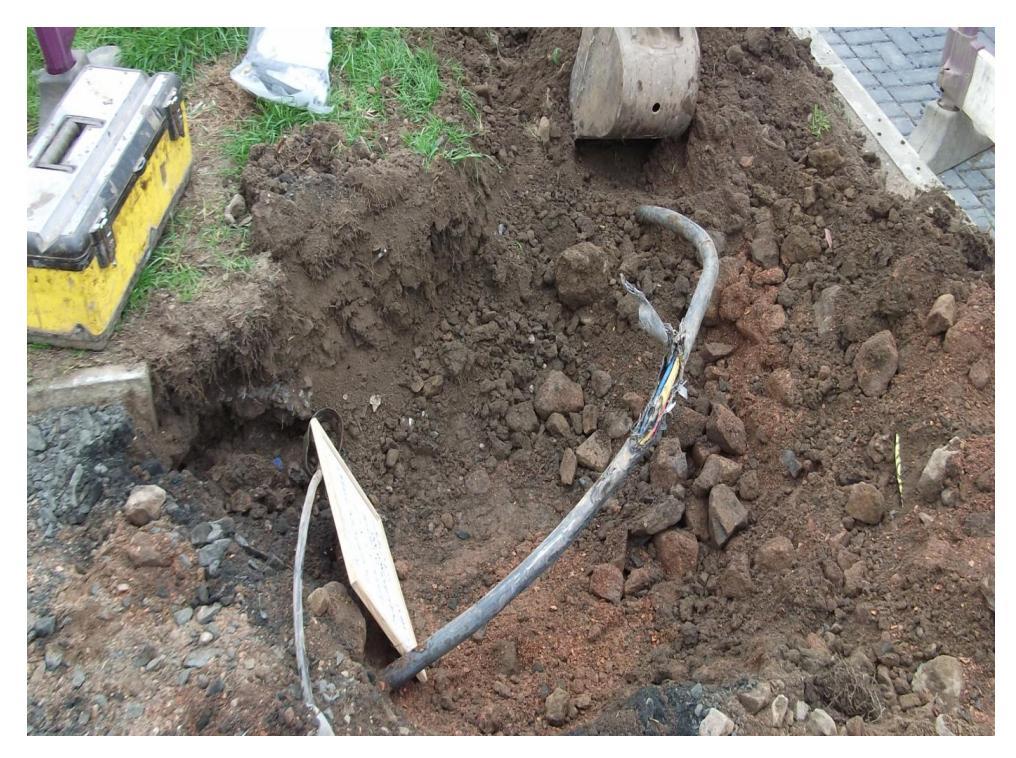
The above image highlights the consequences of utilising a mini excavator in close proximity to a low voltage cable.

The low voltage cable strike occurred when the operatives were carrying out excavations to install kerbing in a grassy area. In this case the cable strike was entirely preventable, if the contractor/operatives had adhered to HSG47 the cable strike would not have occurred. Engaging an excavator prior to hand excavating / locating underground services is a clear case of non adherence to HSG47 with the real possibility of serious injuries to personnel.

To avoid cable strikes to the ScottishPower underground network seek advice prior to excavations commencing.

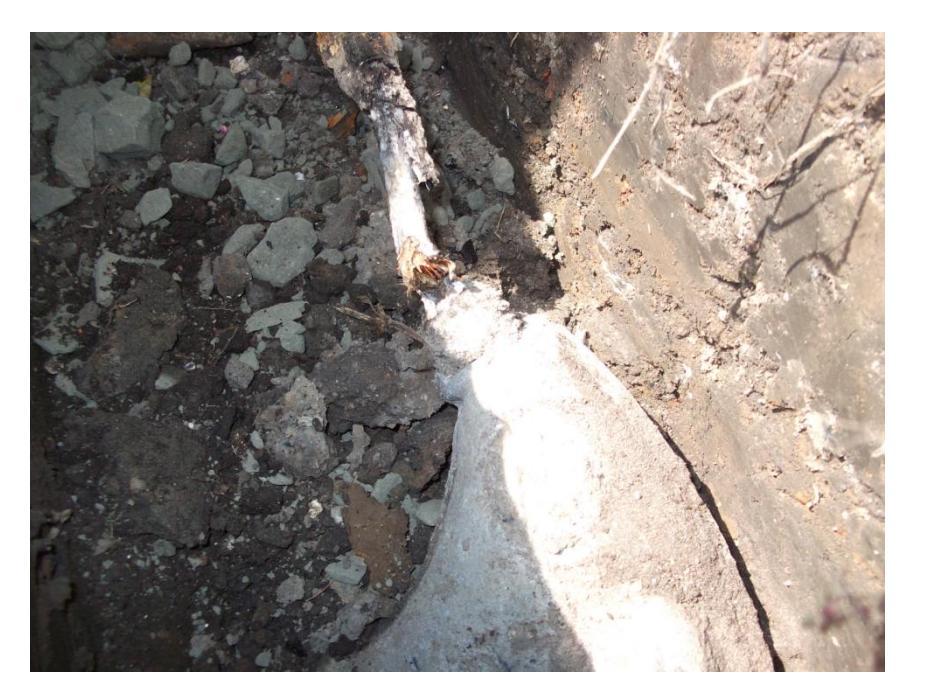
The above image highlights a low voltage cable strike to ScottishPower's underground electrical network.

The above image highlights a low voltage cable strike to ScottishPower's underground electrical network. The service cable, 0.225(2) was damaged at the lead tee joint, this type of cable is an older type cable wrapped in taped armours. The task for the operatives at this location was to install street-lighting ducting for the local authority. The cable strike was not reported to ScottishPower at the time of the incident occurring, for some reason the operatives on site presumed that the cable was out of use, the cable was in fact live. When a cable strike has taken place the correct course of action is to evacuate the excavation immediately, secure/protect the area and report the incident to the Network Operator.

## Prior to any excavations taking place cable records should always be consulted.

Always assume cables are present and live until proved otherwise.

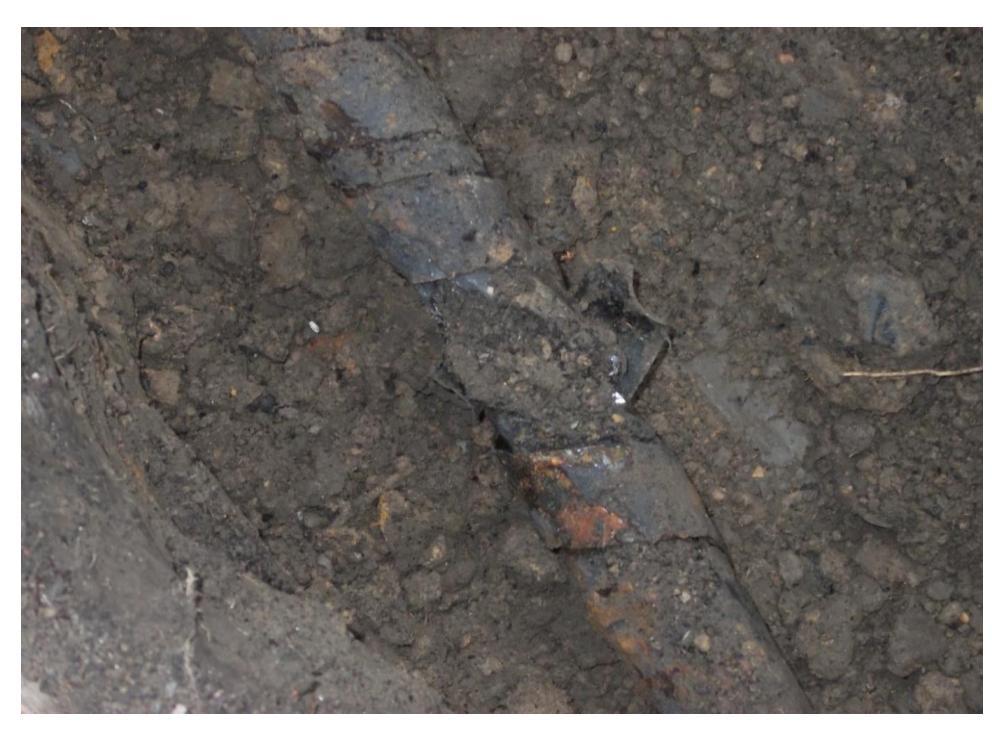
The above image highlights a situation when a moling device came into contact with a low voltage (.3(4) PILC) main cable, the operatives task was to install an underground pipe at the locus. During the works the moling device inadvertently came into contact with the cable causing a loss of electricity supplies to customers. This design of cable is an older type cable called PILC, (Paper Insulated, Lead Covered) looking at the cable it can clearly be seen that the outer skin of the cable is covered in taped armour, this type of cable was widely used on the underground electricity network. SP Energy Networks cable records were supplied to the operatives by the contractor and were accurate, cable locator on site, depth of cable 600mm. The investigation into this incident found that contact with the electricity cable was avoidable if adherence to HSG47 had been implemented.

### **Setting A Moling Device In the Direction Of Underground Electricity Cables Is Not Recommended This Type Of Action Could lead to Serious Injuries**
