# **Omega West 132kV Diversion**

**Environmental Information**

SP Energy Networks February 2022

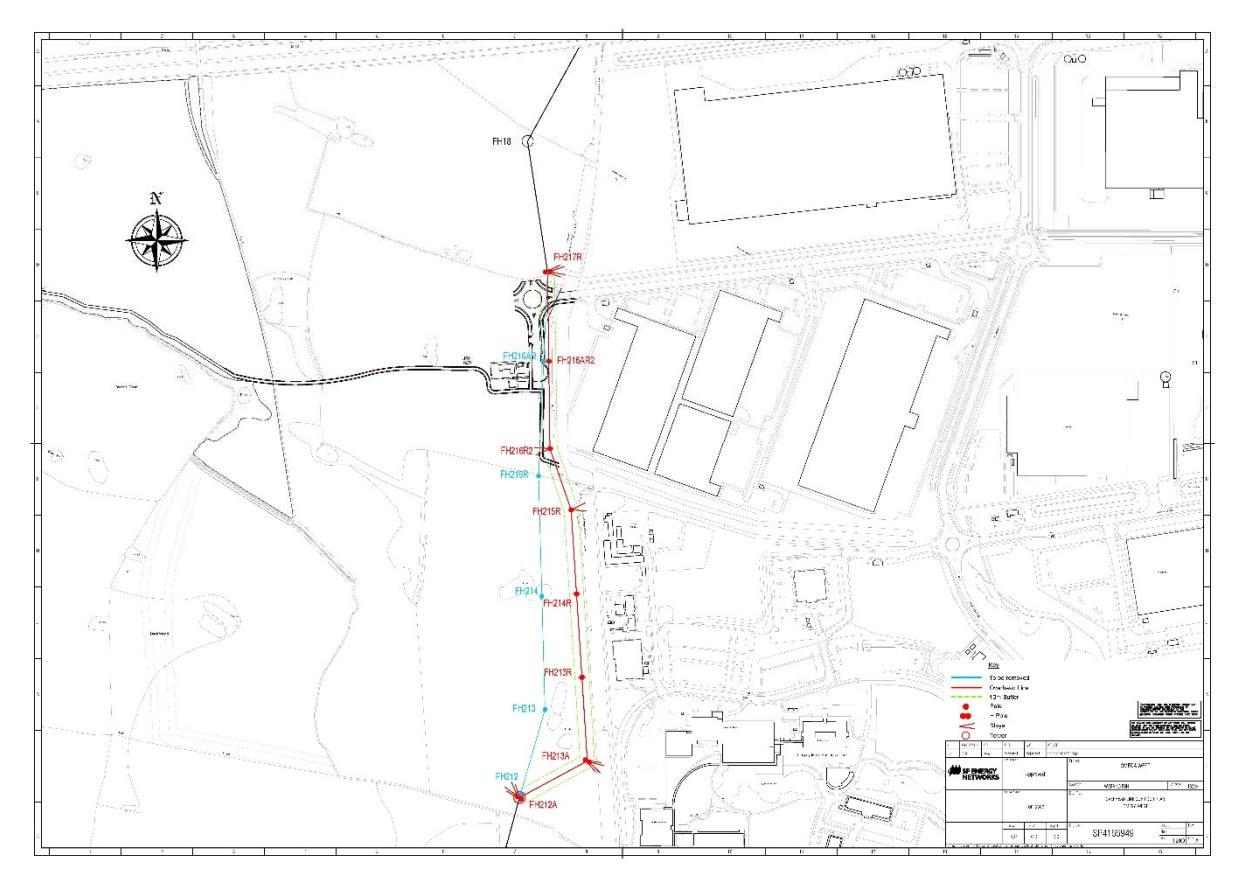
Figure 1.1: Proposed 132kV Diversion

- 1.1.2 In order to achieve this, SPEN propose to construct a temporary diversion of the 132kV overhead line circuit that currently runs through this site. This is required for the duration of the works and will be facilitated by the construction of seven wood poles (18m in height) spanning 793 metres within the developer's landtake area (refer to figure 1.1, below). These poles will be in place for a period not exceeding two years and will be constructed in the same "Trident" design as the existing poles. Illustrations of the proposed pole type is include below.

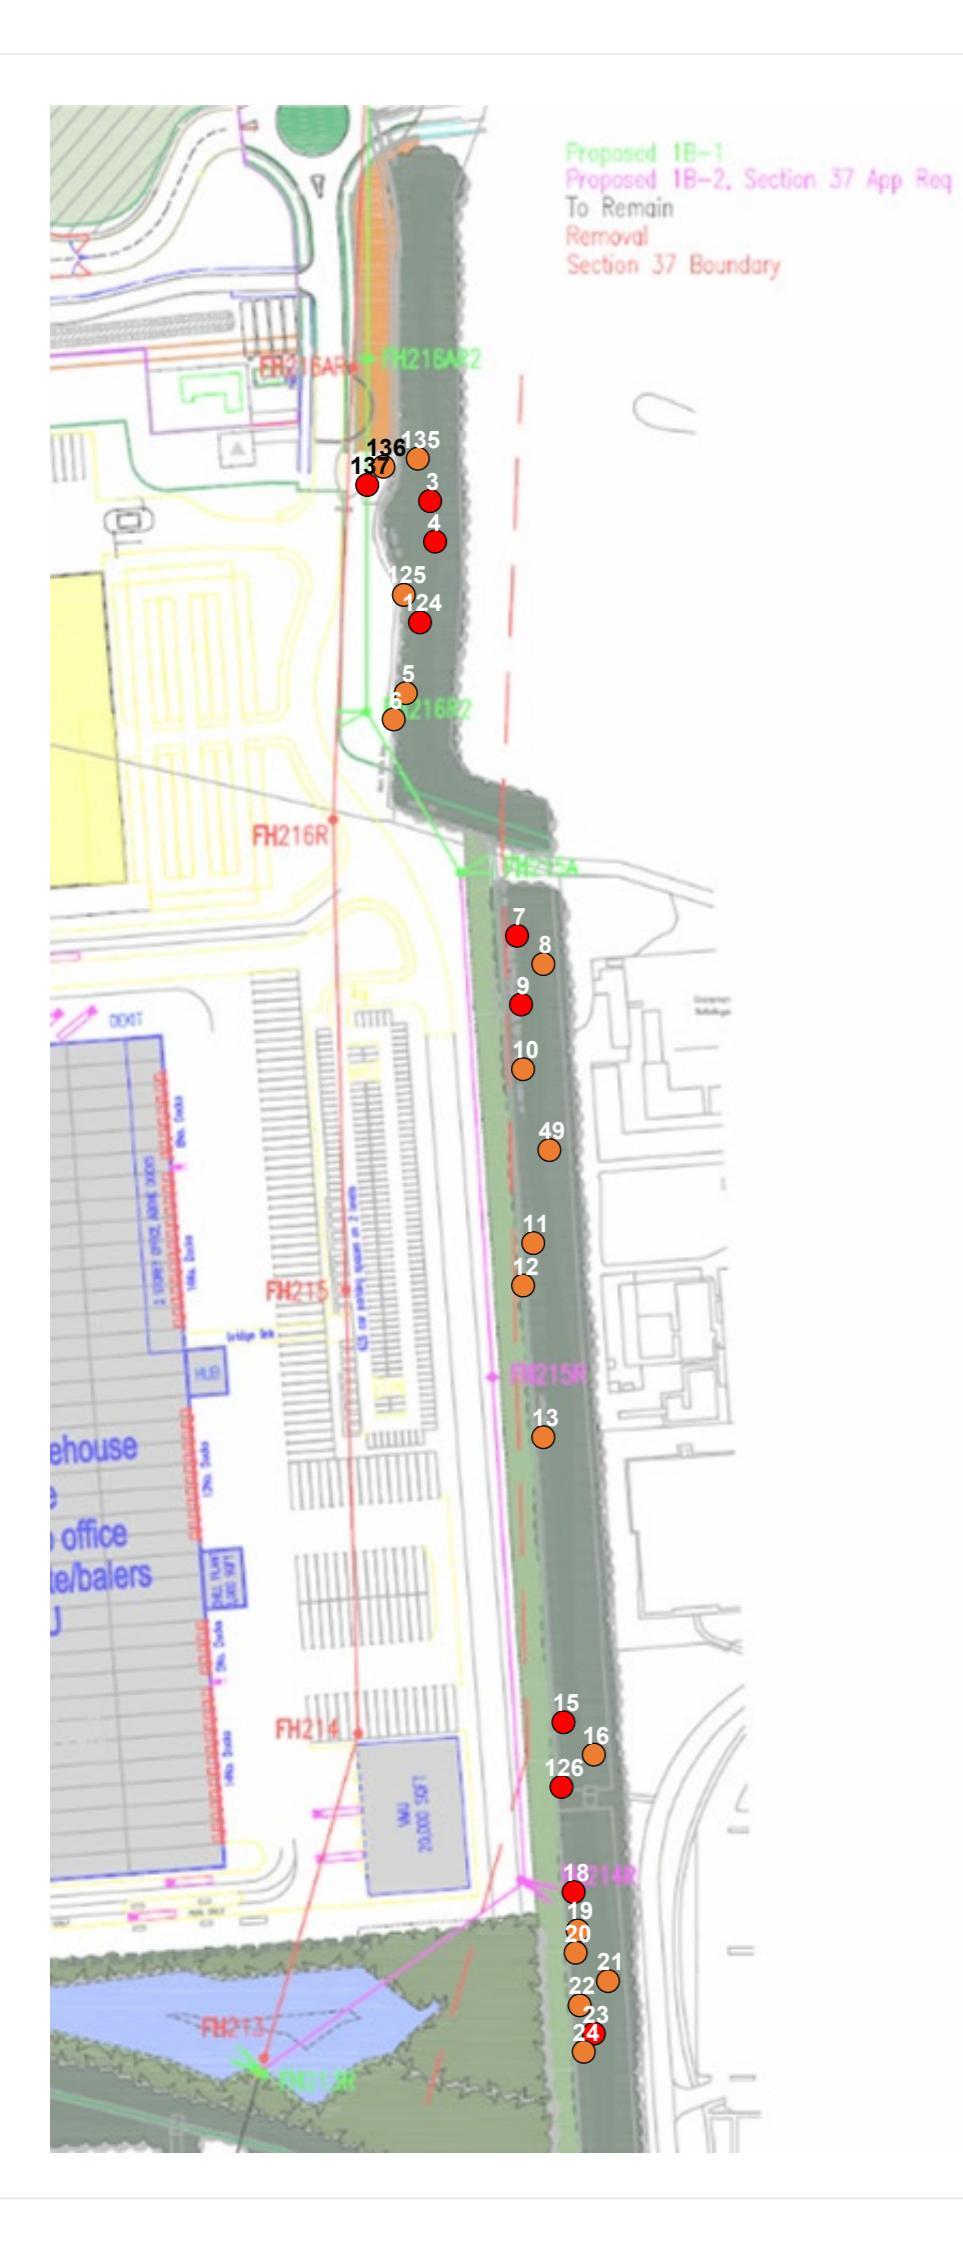
**APPENDIX A: BAT MITIGATION**

The 2021 bat survey of trees did not find any trees with bats present at the time of survey. However, the survey found that a number of them had the potential to provide an opportunity for bats to use them (roost in them) in the future. Therefore, there is targeted mitigation for such a tree, as depicted in the drawing here, should one wish to fell or otherwise carry out surgery to a tree. This data is valid until Spring 2023, after which another survey is required prior to any tree works.

## For works that affect those trees shown left

- A bat licensed person must be present
- Trees are to be soft felled
- The potential roost feature(s) on the tree should be cut off in a section and roped down to ground and the licensed person is to be allowed to inspect the feature prior to the remaining tree being soft felled.
- The bat licensed person may halt works for further inspection
- If a bat is discovered a licence from Natural England will be required to further adversely affect the tree.
- The bat licensed person has the final word.

- 2.2.2 Specific bat mitigation is also proposed. This is included in Appendix A with the proposed mitigation outlined below:
  - bat licensed person must be present

- Trees are to be soft felled
  - The potential roost feature(s) on the tree should be cut off in a section and roped down to ground and the licensed person is to be allowed to inspect the feature prior to the remaining tree being soft felled
