Case Study: Low voltage cable joint embedded in concrete

Case Study: Concreting Over Underground Cables (1)

Concreting Over Underground Cables (2)

Case Study: Concreting in Proximity To Underground Cables

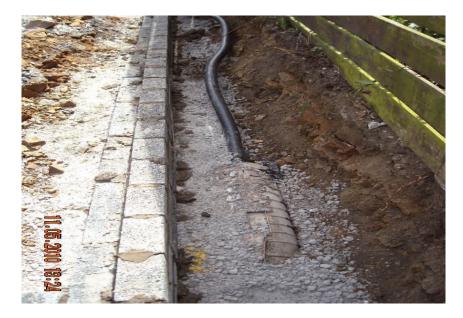
The above image highlights a situation which occurs all too frequently, no cable records or cable locator on site, customer in the process of constructing a garage damages a distribution cable.

The cable is repaired; the foundations are laid with the overspill of concrete encasing the low voltage repair joint. Covering ScottishPowers cable in concrete is not an acceptable practice with the possibility of the concrete corroding the cable and the cable joint. The key to avoiding contact with electricity cables in this type of situation is to plan the job correctly: Cable record enquiries are to be directed to ScottishPower Data Management section on the telephone number below.

Prior to any excavations taking place cable records should always be consulted.

Always assume cables are present and live until proved otherwise.

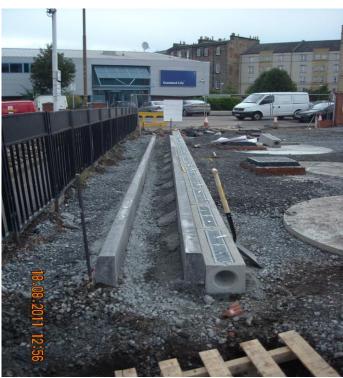
The task was to install drainage for a car park and a concrete structure to enable a fence to be installed on top of the concrete foundation.

In between the kerb stones in the above image, concrete was to be poured forming the foundation for the proposed fence. At the newly installed kerbs/drainage system location ScottishPower had numerous low and high voltage underground cables running to a nearby substation. Construction site were advised to remove all newly installed kerbs/drainage to ensure that ScottishPower had unrestricted access to the underground electrical network. This situation was caused by poor planning, the contractor being informed by the client that there were no underground cables on site. The advice given to the contractor on site by SP Energy Networks consisted of:

Never accept utility information by word of mouth, always seek written confirmation regarding the possibility of underground electrical plant at all site locations. Always procure cable records from utilities prior to undertaking ground penetration operations or construction works.

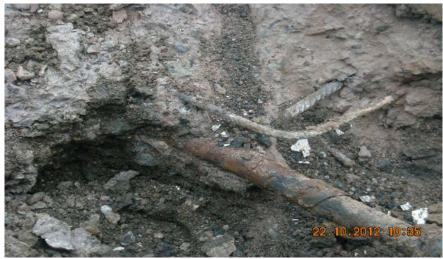
The above image highlights a situation which occurs on a frequent basis on local footpaths/ highways.

The task for ScottishPower EnergyNetworks was to install a new service cable for a business. Having located the required electrical cable to joint the new service onto it was found that the existing cable had been surrounded with concrete. Encasing the underground electrical network with concrete causes ScottishPower inconvenience as it restricts access to the cables and in older type cables, wire or tape armour the concrete can have a detrimental impact on the network causing cables to go into a fault situation.

Scottish Power Energy Networks underground Cables Are Not To Be Concreted over At Any Time
