Erskine to Devo Moor
for SPEN

Figure 8.1: Ecology Study Area

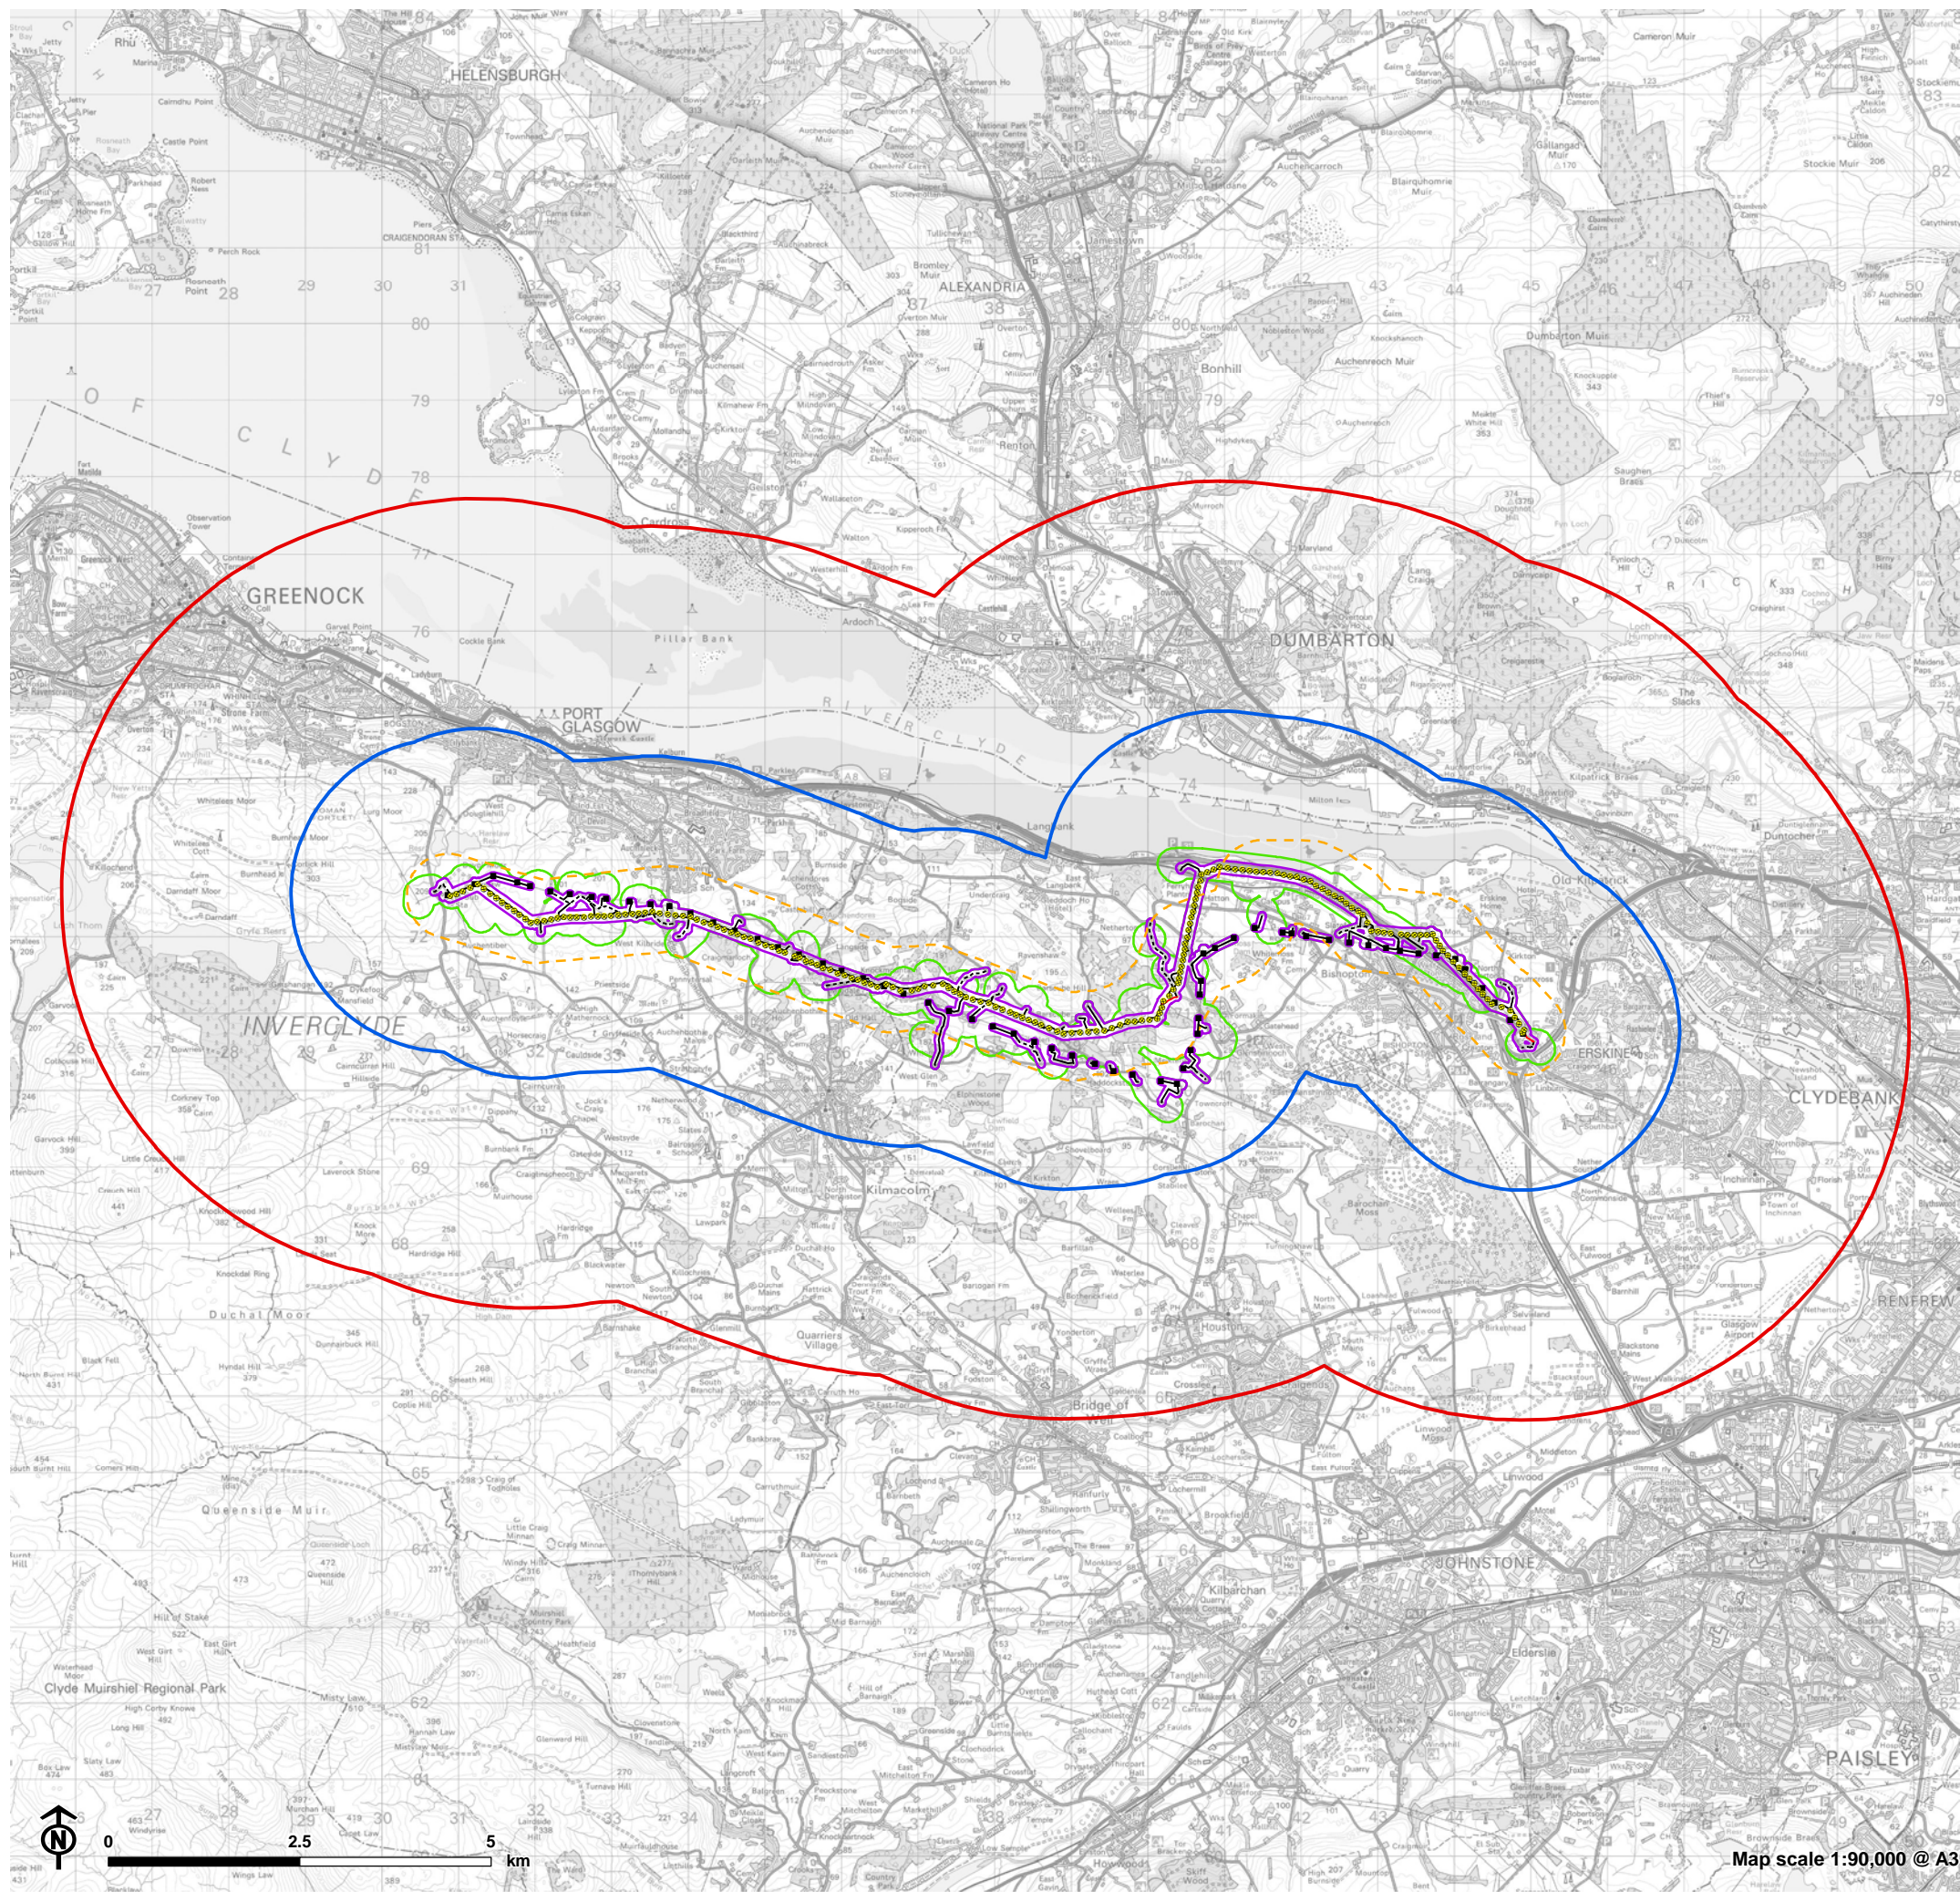
- New 132kV OHL (wood pole)
- Existing 132kV OHL (towers to be removed)
- New Access
- New Access (Stone)
- - - Existing Access
- 5km – statutory designated sites
- 2km – non-statutory designated sites
- Study area for aquatic protected species
- Study area for terrestrial protected species and habitat survey
- Study area for ornithology
