1. SCOPE

This document details the application of SOP 402 (Applicable to Lucy Switchgear LV Boards pre-1970) issued by the Energy Networks Association.

EQUIPMENT TYPE	Lucy Switchgear LV Boards pre-1970
ORIGINATING COMPANY	Northern Powergrid
DATE	15 June 2016
NUMBER INSTALLED IN ENERGY NETWORKS NORTH	1109
NUMBER INSTALLED IN ENERGY NETWORKS SOUTH	897
REASON	A flashover occurred on an LV fuseboard whilst the operator was withdrawing a fuse carrier at a Distribution substation.
STATUS IN INITIATING COMPANY	<p>This restriction applies to the pre-1970s Lucy LV board (see photos included). The Lucy LV board can be identified by the following common and distinctive features.</p> <ul style="list-style-type: none">• Large porcelain fuses with flat blade contacts.• The fuses/contacts have no facility to hinge or vertically align the fuse when inserting the fuse.• The MDI panel is at the top of the LV board as shown in the photograph.• The LV board has distinctive bolted transformer links equipped with a shielded handle. <p>If in doubt as the LV board type, operatives should assume this Operational Restriction applies. For any access to a substation containing a pre-1970s Lucy LV board the

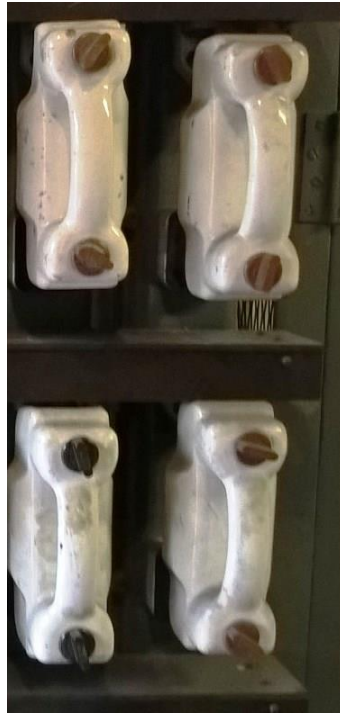
Before Remediation with gap below Fuse Carrier

The NPG Panel of Inquiry concluded that the fuse carrier moved downwards whilst the middle phase fuse carrier was being withdrawn from the LV board – the upper jaws moved forward and made contact with the earthed steel upright of the fuseway making a circuit between the live busbar jaw and the earthed steelwork. The NPG recommendation is for the fitting of an insulated “ledge” to take up some of the space between the feeder side of the fuse carriers and the insulation shield for the busbar below. The “ledge” is a 25mm cellular layer of polycarbonate (Marlon ST Longlife clear) with a layer of solid 6mm polycarbonate (Marlon FS clear) above it and secured with tie-wraps to the upper surface.

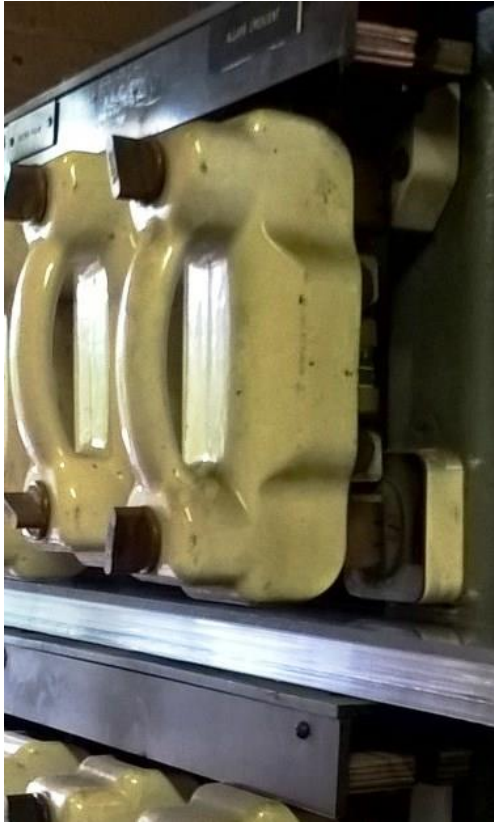
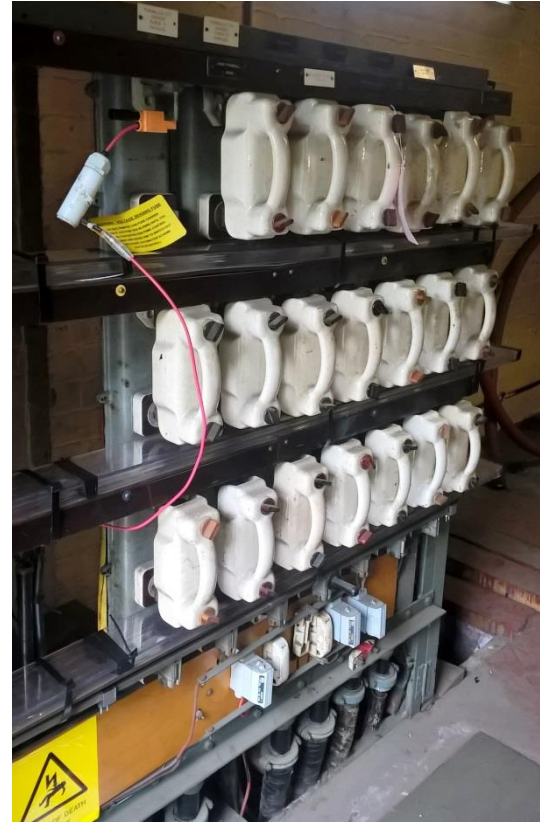
After Remediation with gap taken up by the Insulated Ledge
