Case Study: HV Cable Strike With Steel Pin Whilst Erecting A Marquee:

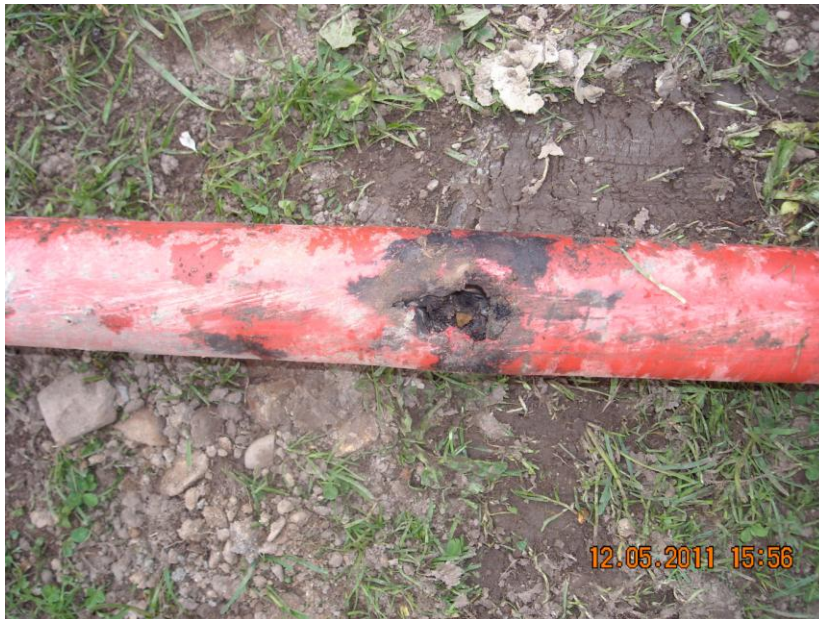
The above image demonstrates the impact on an HV cable when a 910mm long steel pin was driven into the ground.

The task was to erect a marquee for a charity event on a section of ground which had been used for the same purpose for the previous 3 years, fortunately on this occasion, the operatives received no injuries.

The investigation into this incident discovered that no cable records had been consulted prior to the erection of the marquee and that the use of a cable locator had not taken place.

ScottishPower cable records should always be consulted prior to any ground penetration taking place. Cable record enquiries are to be directed to ScottishPower Data Management section.

Prior to any excavations taking place cable records should always be consulted.
