Flexible Networks for a Low Carbon Future

Real Time Thermal Rating System

- Phase I Asset
Condition Assessment

Report No.: 14-2132

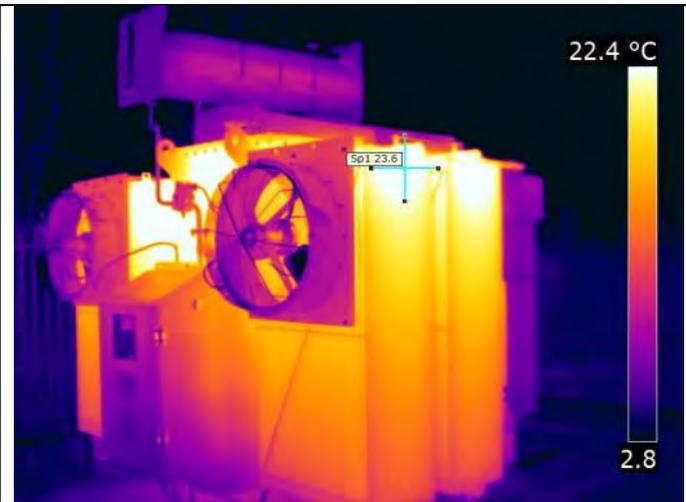
<p>22.4 °C Sp1 23.6 2.8</p>	<p>No indication of thermal issues.</p>

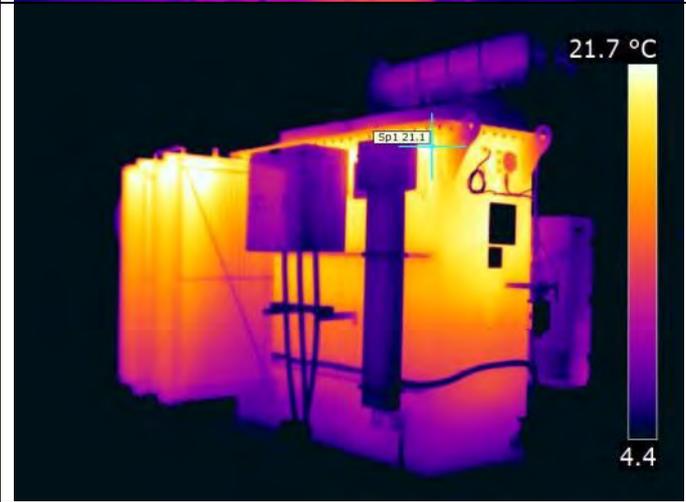
<p>21.7 °C Sp1 21.1 4.4</p>	<p>No indication of thermal issues.</p>

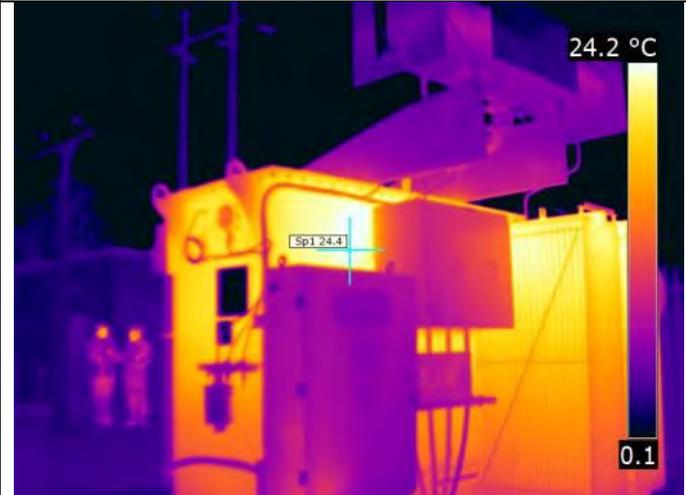
<p>24.2 °C Sp1 24.4 0.1</p>	<p>No indication of thermal issues. Highest observed temperature on tank surface was roughly 25 °C.</p>

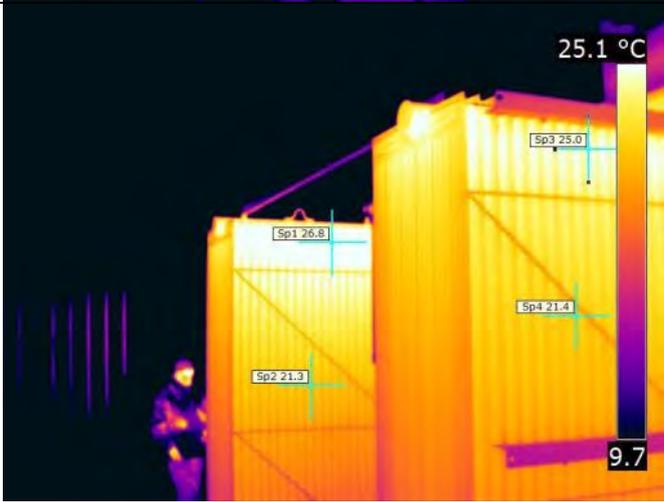
<p>A thermal image of a transformer with four temperature markers: Sp1 (26.8), Sp2 (21.3), Sp3 (25.0), and Sp4 (21.4). The temperature scale on the right ranges from 9.7 °C (dark purple) to 25.1 °C (yellow). The transformer is mostly yellow and orange, indicating temperatures between 20 °C and 27.5 °C.</p>	<p>No indication of thermal issues.</p>

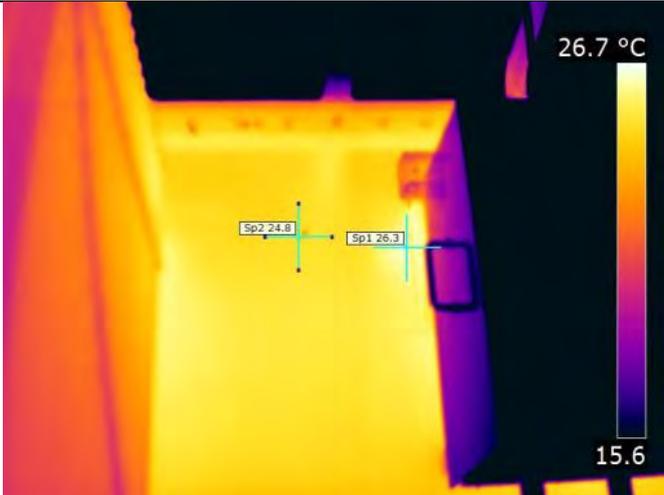
<p>A thermal image of a transformer with two temperature markers: Sp1 (26.3) and Sp2 (24.8). The temperature scale on the right ranges from 15.6 °C (dark purple) to 26.7 °C (yellow). The transformer is mostly yellow and orange, indicating temperatures between 20 °C and 27.5 °C.</p>	<p>Highest observed temperature on tank surface was roughly 25 °C.</p>

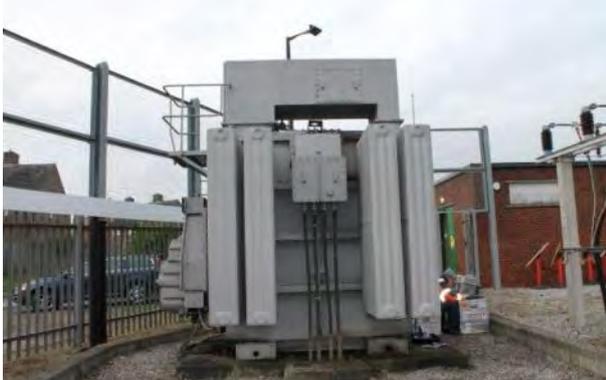
<p>Overview pictures of transformer T1 at substation Yockings Gate.</p> <p>No severe signs of damage, deterioration and leakage, except for the middle phase of the 33 kV cable in the termination box.</p>

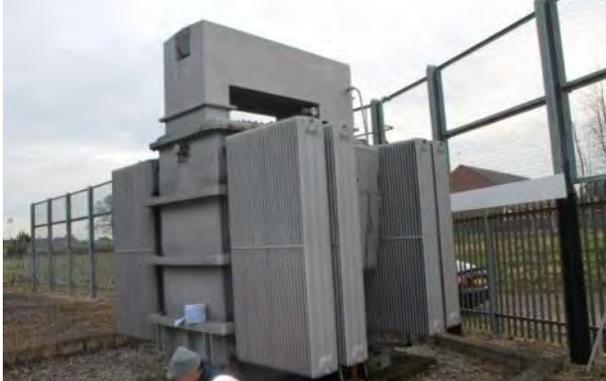
<p>Some small rust spots were observed at different locations.</p>

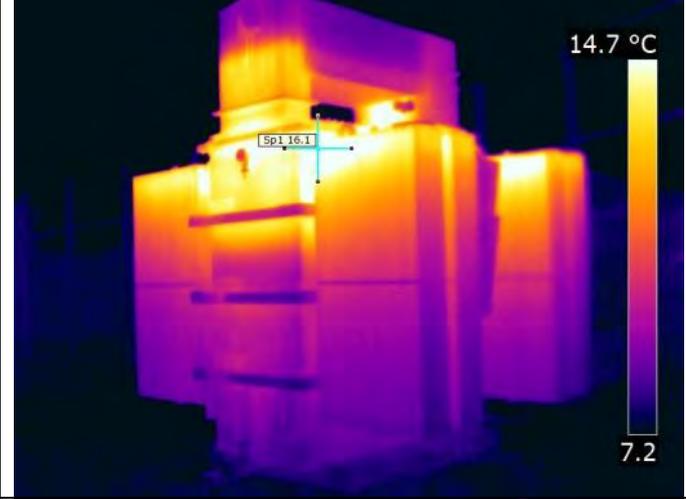
<p>14.7 °C 7.2</p> <p>Sp1 16.1</p>	<p>No indication of thermal issues.</p>

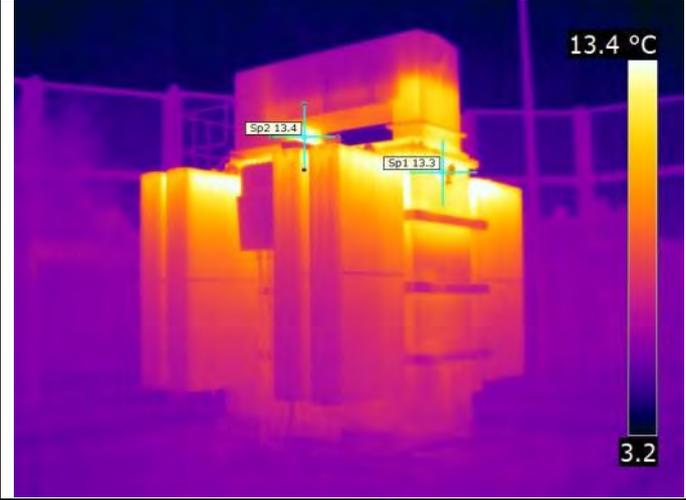
<p>13.4 °C 3.2</p> <p>Sp2 13.4 Sp1 13.3</p>	<p>No indication of thermal issues.</p>

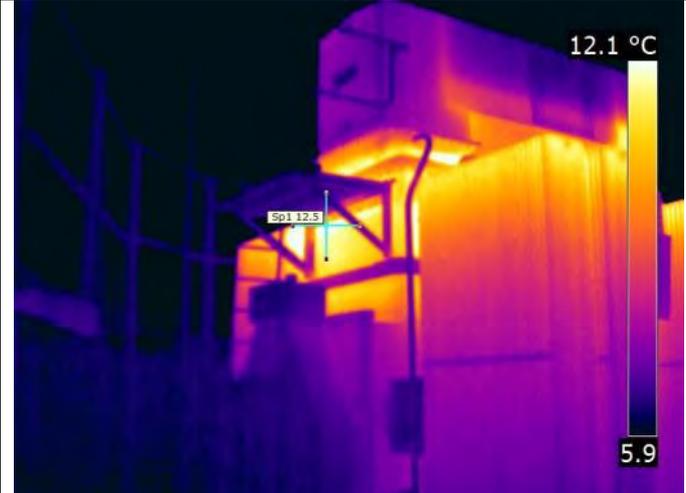
<p>12.1 °C 5.9</p> <p>Sp1 12.5</p>	<p>No indication of thermal issues.</p>

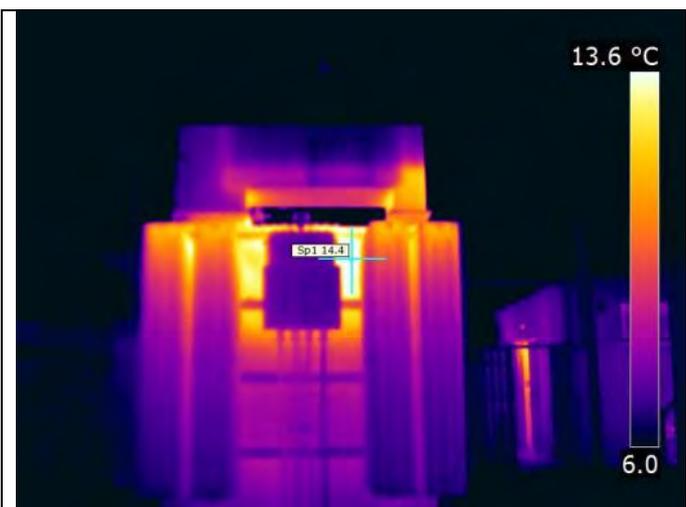
<p>Highest observed temperature on tank surface was roughly 15 °C.</p>

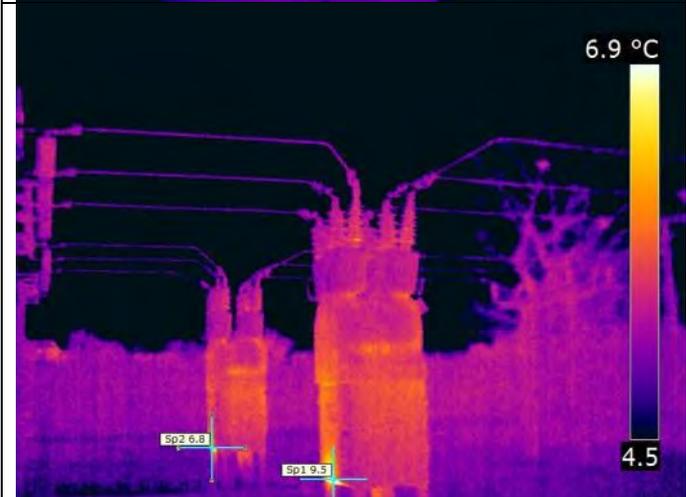
<p>No thermal issues were found in 33 kV-switchyard.</p>

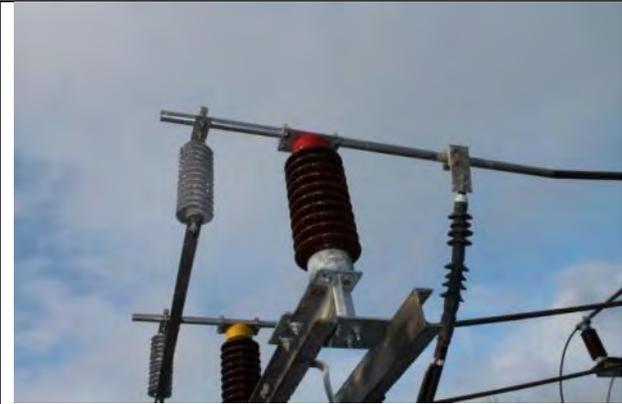
<p>Terminations of 33 kV feeding cables. New cables have been installed in 2013.</p>

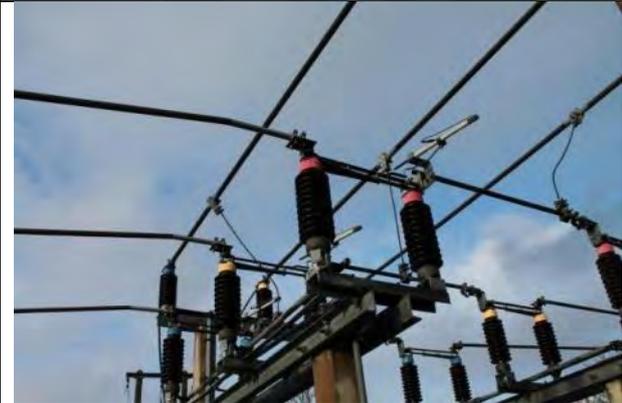
<p>Other components in the bay show no signs for deterioration or damage.</p>

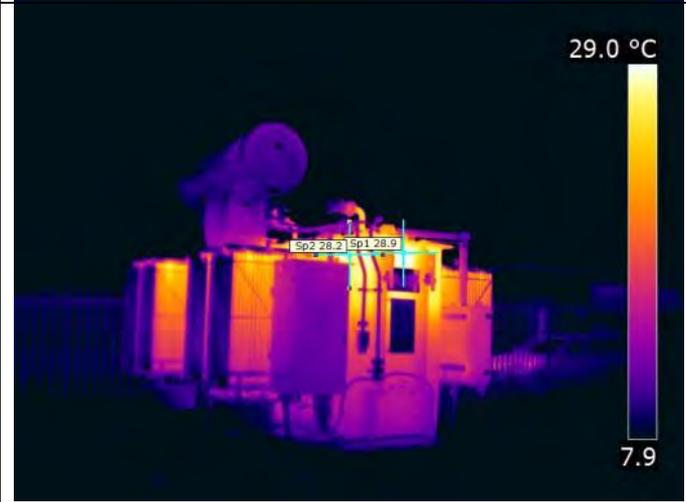
<p>29.0 °C</p> <p>Sp2 28.2 Sp1 28.9</p> <p>7.9</p>	<p>Highest observed temperature on tank surface was roughly 28 °C.</p>

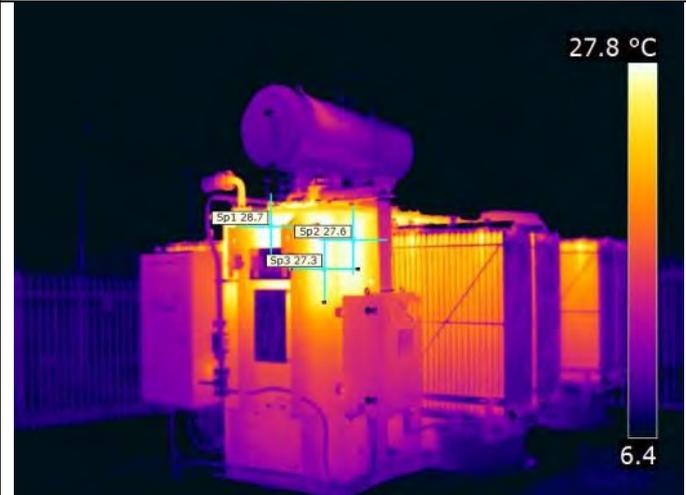
<p>No thermal issues were found in 33 kV-switchyard.</p>
	<p>No thermal issues were found in 33 kV-switchyard.</p>

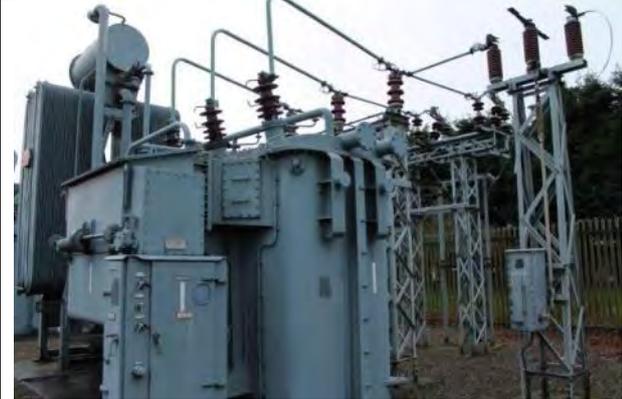
<p>Overview picture of transformer T1 at substation St. Andrews.</p> <p>No severe signs of damage, deterioration and leakage.</p>

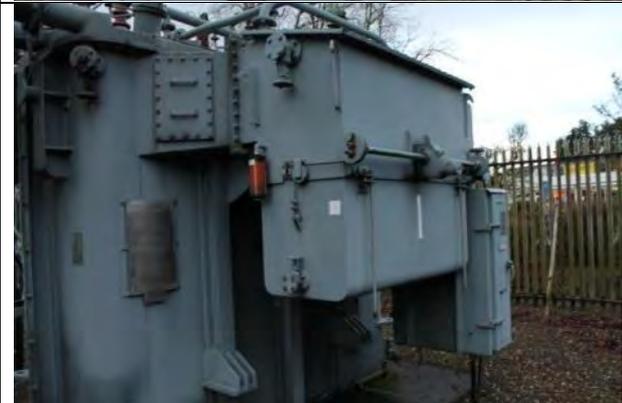
<p>Picture of the tap-changer compartment.</p> <p>No severe signs of damage, deterioration and leakage.</p>

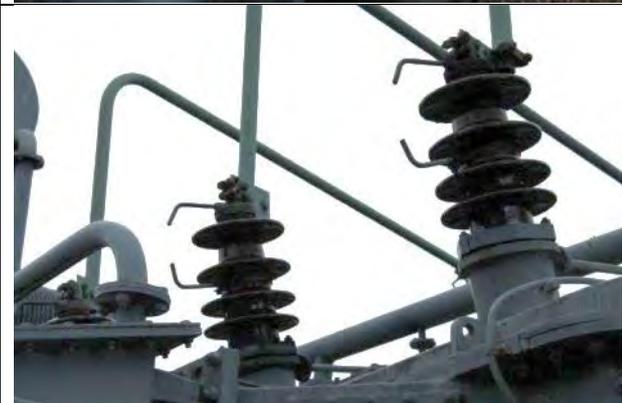
<p>Picture of two 33 kV bushings.</p> <p>No signs of damage or deterioration on the 33 kV and 11 kV bushings.</p>

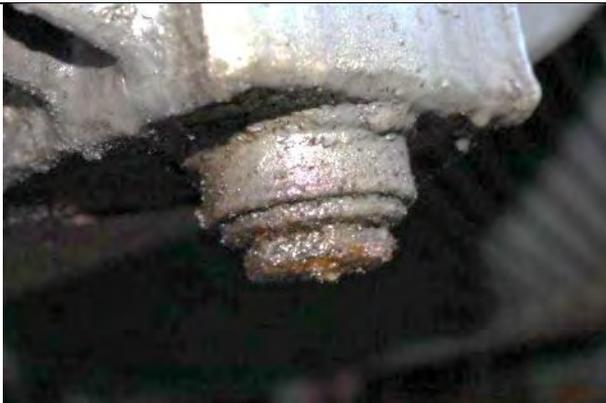
<p>Some small oil leakage or sweating was observed.</p>

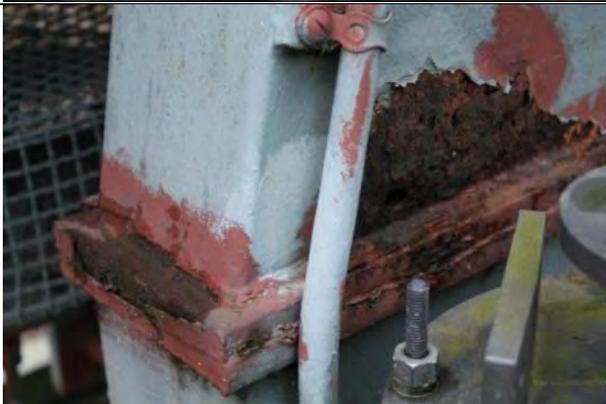
<p>Large spots with rust on the supporting construction of the radiators.</p>

- define and implement actions to correct/mitigate the observed rust.
 - St. Andrews T2:
 - define and implement actions to correct/mitigate the observed rust;
 - define and implement actions to correct the observed hot-spot on a 33 kV-terminal.
 - Cupar T1, Cupar T2:
 - define and implement actions to correct/mitigate the observed rust.
 - Whitchurch:
 - define and implement actions to correct the observed hot-spots on 33 kV-disconnectors.
 - Yockings Gate T1:
 - define and implement actions to correct the observed mass-leakage from the 33 kV-cable box.
- 3) In addition to the normal maintenance regime, perform the following long-term actions (24-60 months):
- Cupar T1, Cupar T2 and Yockings Gate T1:
 - define and implement actions to correct/mitigate the observed sweating.

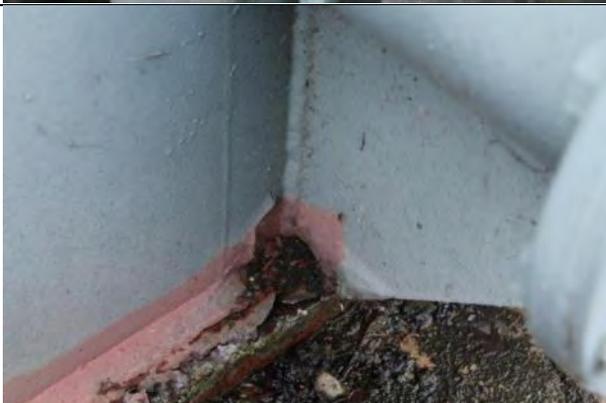
<p>Rust formation along the bottom plate of the transformer.</p>

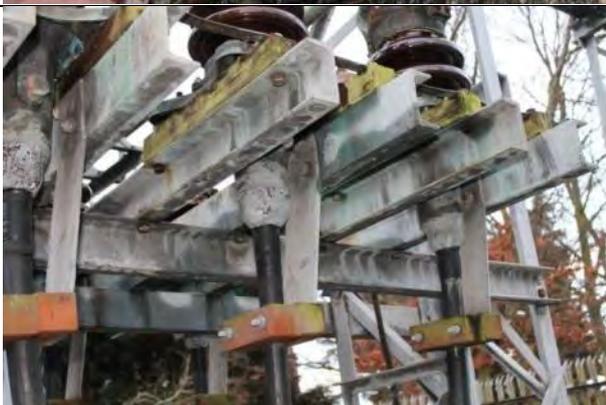
<p>11 kV cables have been replaced in 1988. Some wear on the terminations, but no signs of deterioration.</p>

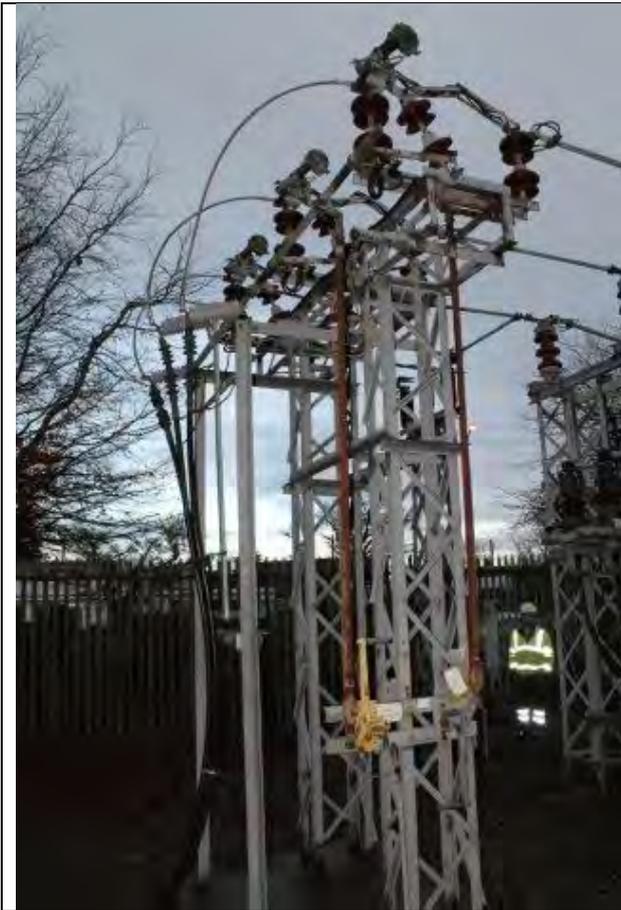
33 kV incoming cables and disconnecting switches. Cables have been replaced in 2010. No severe signs of damage and deterioration on other components.

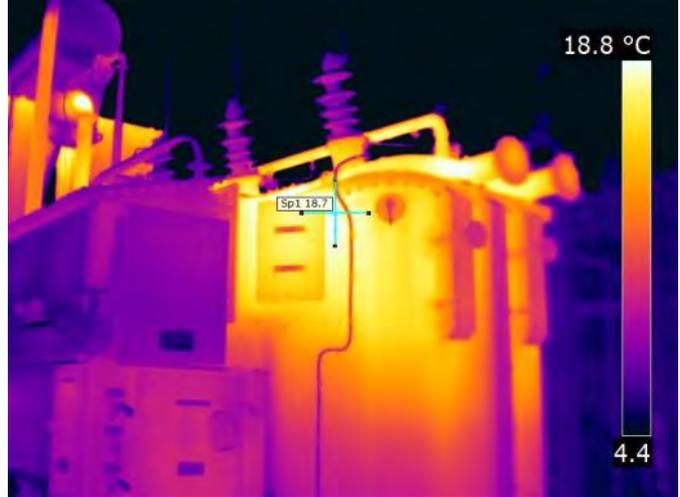
<p>18.8 °C Sp1 18.7 4.4</p>	<p>No indication of thermal issues.</p>

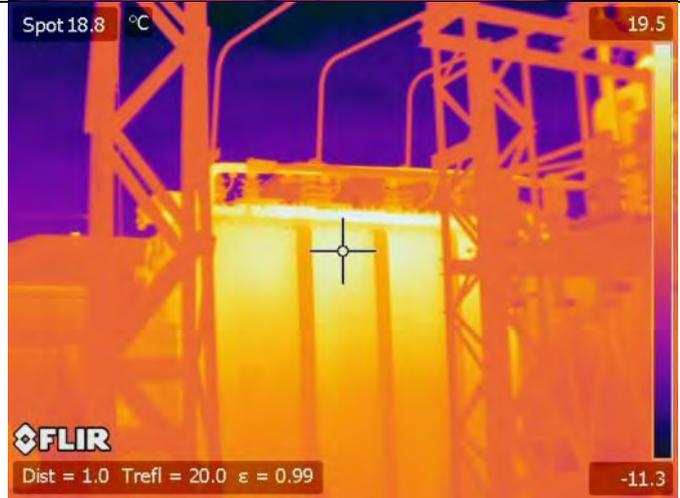
<p>Spot 18.8 °C 19.5 -11.3 FLIR Dist = 1.0 Trefl = 20.0 ε = 0.99</p>	<p>No indication of thermal issues.</p>

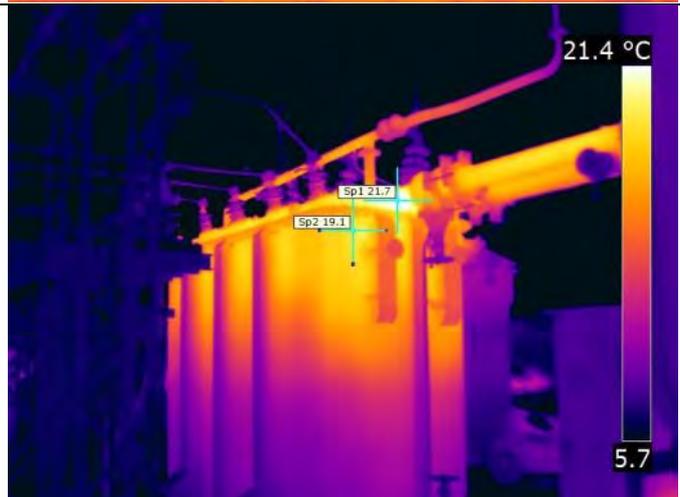
<p>21.4 °C Sp1 21.7 Sp2 19.1 5.7</p>	<p>No indication of thermal issues.</p>

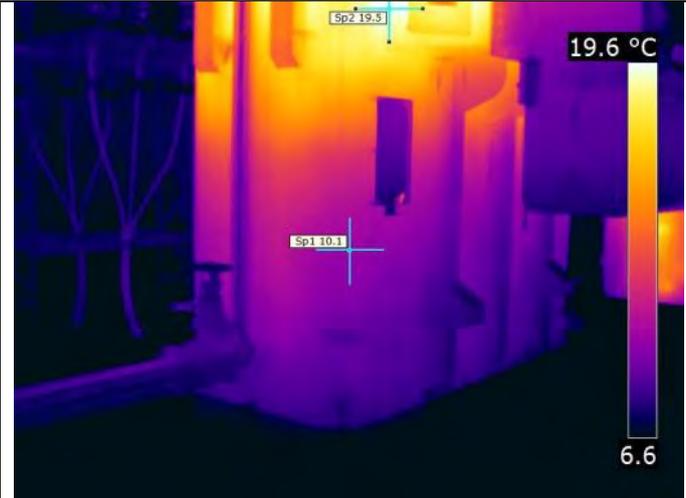
No indication of thermal issues.

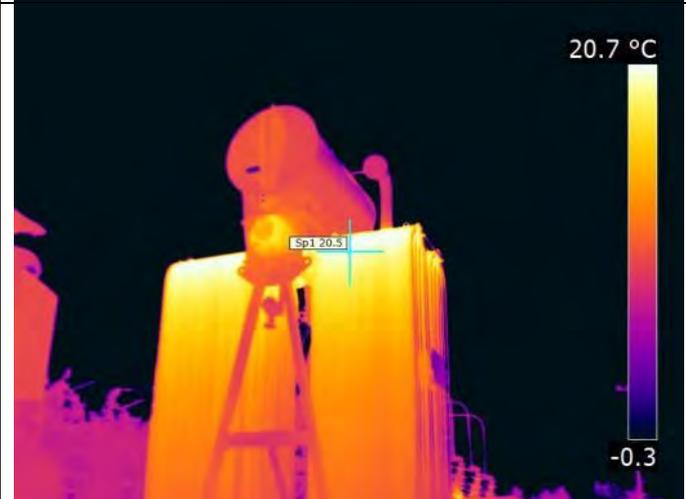
No indication of thermal issues.

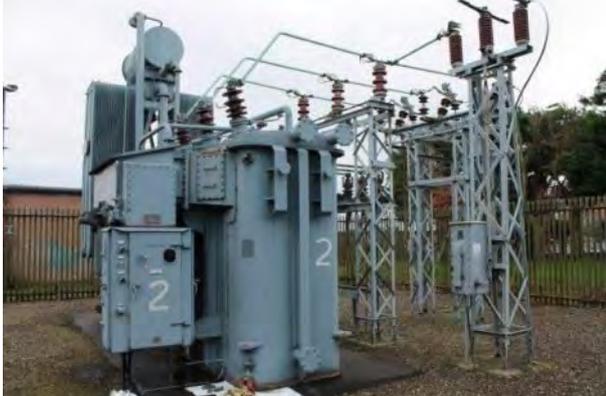
<p>Overview pictures of transformer T2 at substation St. Andrews.</p> <p>No severe signs of damage, deterioration and leakage.</p>

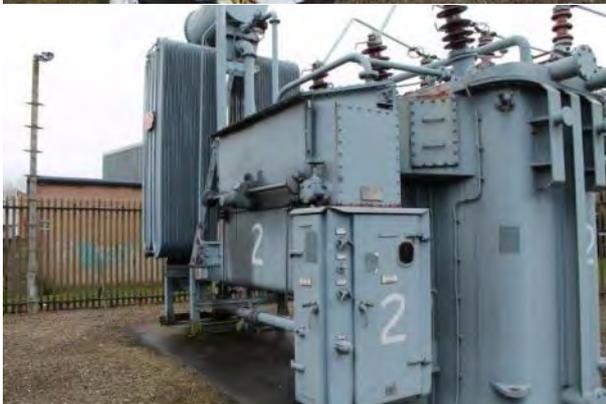
<p>Picture of the tap-changer compartment.</p> <p>No severe signs of damage and deterioration.</p> <p>Some indications for oil sweating.</p>

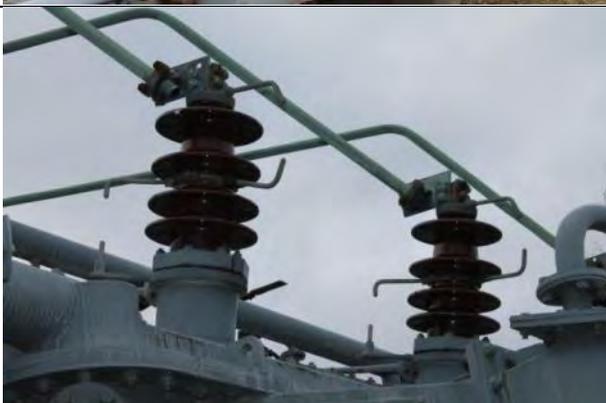
<p>Picture of two 33 kV bushings.</p> <p>No signs of damage or deterioration on the 33 kV and 11 kV bushings.</p>

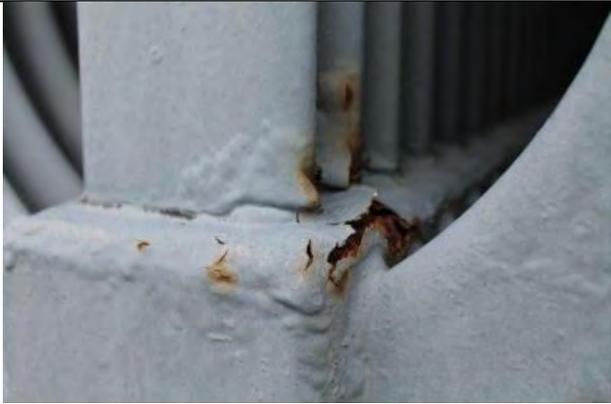
<p>Rust was found on several locations on the radiators.</p>

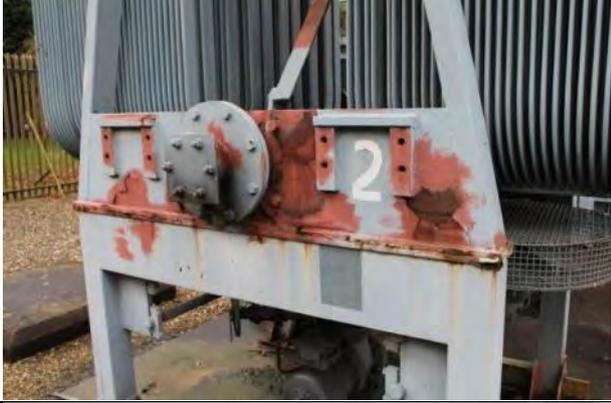
<p>Large spots with rust on the supporting construction of the radiators.</p>

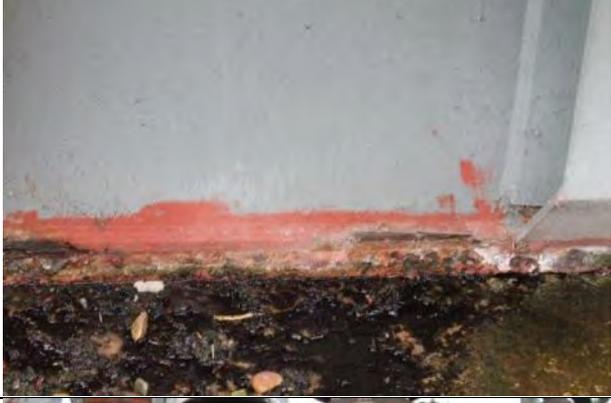
<p>Rust formation along the bottom plate of the transformer.</p>

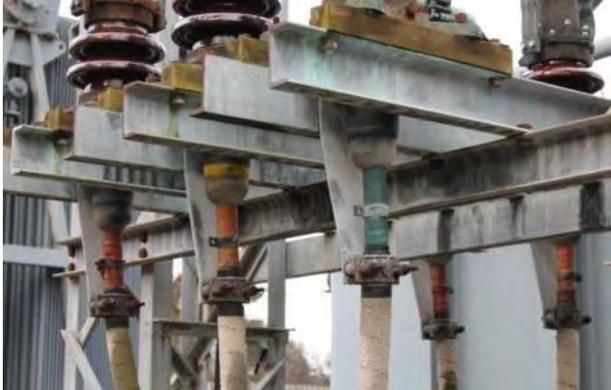
<p>Original 11 kV cables are still in operation. Some wear on the terminations, but no signs of deterioration.</p>

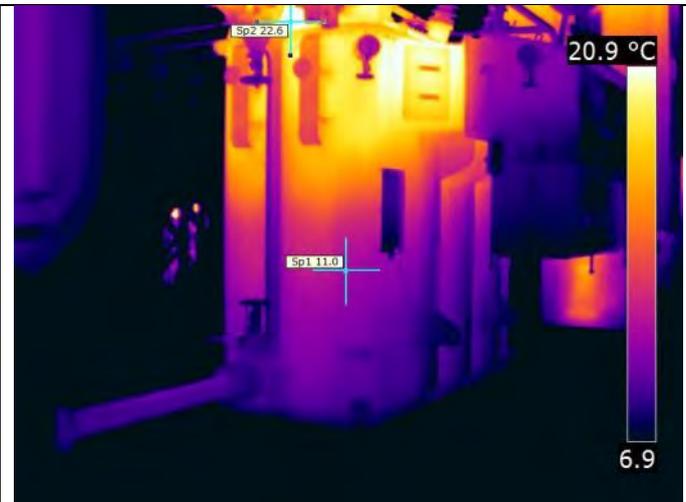
No indication of thermal issues.

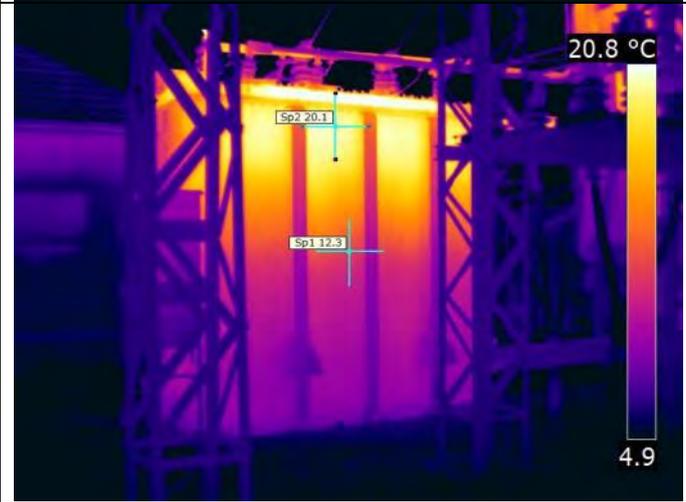
No indication of thermal issues.

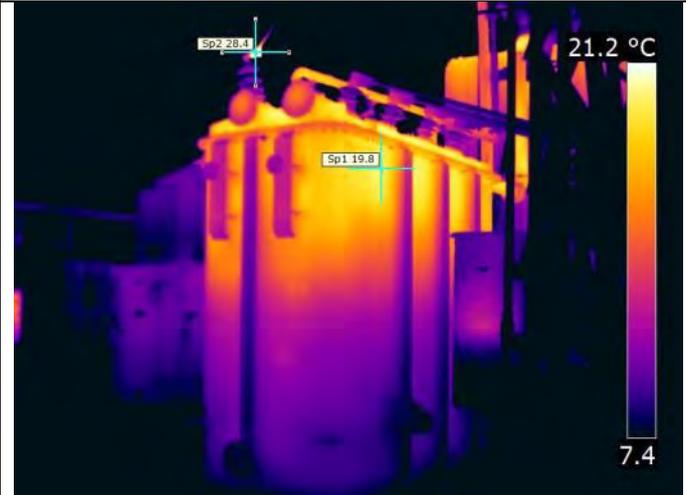
Hot spot on terminal of 33 kV-transformer bushing (left)

A minor hot spot was found on the terminal a 33 kV- transformer bushing. It is recommended to address this hot spot during the next scheduled maintenance/outage.

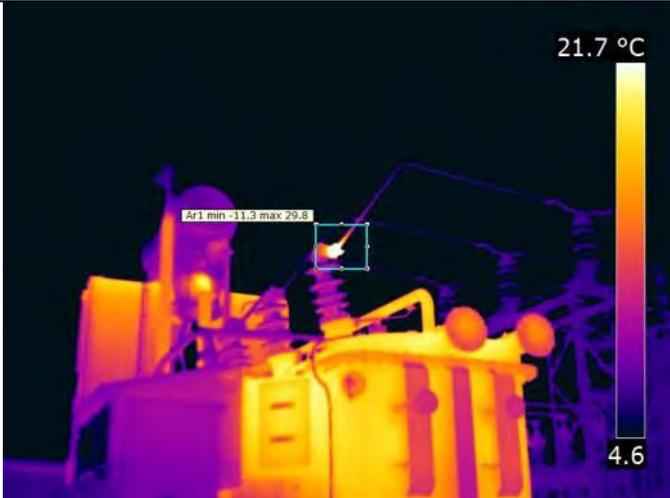
Hot spot on terminal of 33 kV-transformer bushing

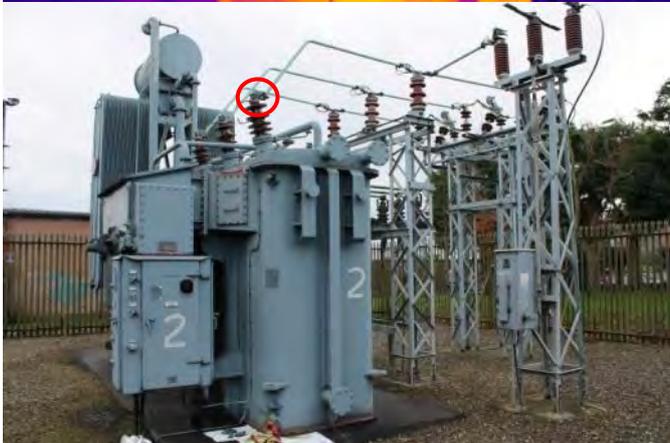
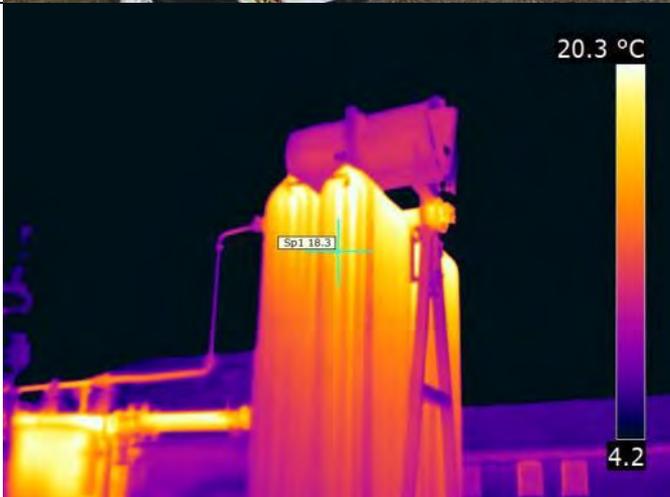
No indication of thermal issues.

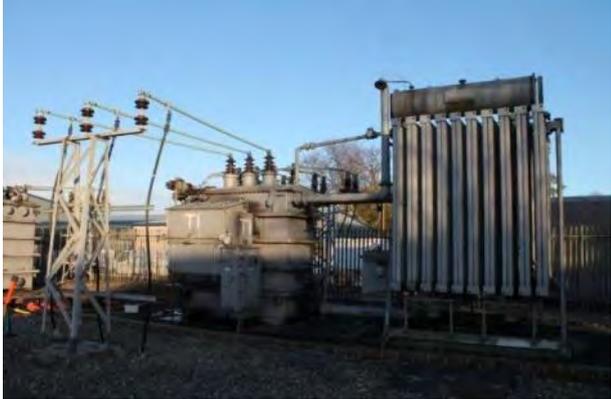
<p>Overview pictures of transformer T1 at substation Cupar.</p> <p>No severe signs of damage and deterioration. Oil leakage is observed at different spots.</p>

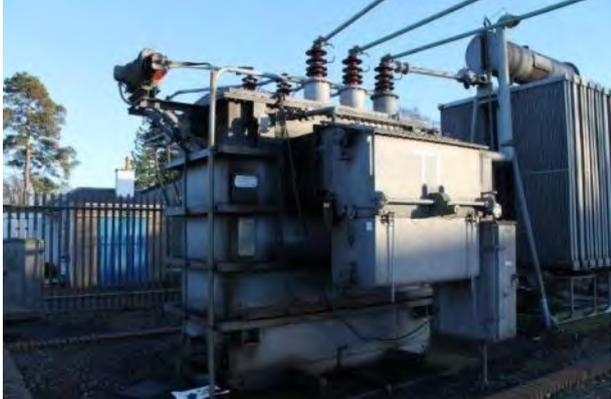
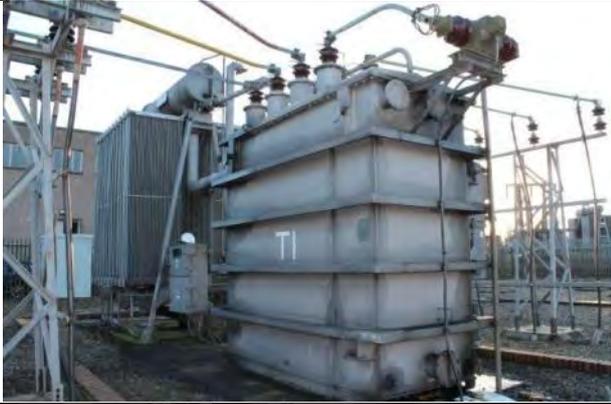
<p>Picture of hatch cover on the tap-changer compartment. No severe signs of damage and deterioration. Significant indications for oil sweating.</p>

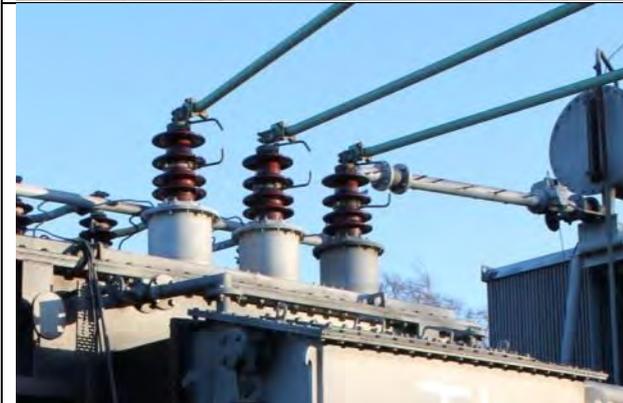
Picture of the 33 kV bushings.
No signs of damage or deterioration on the 33 kV and 11 kV bushings.

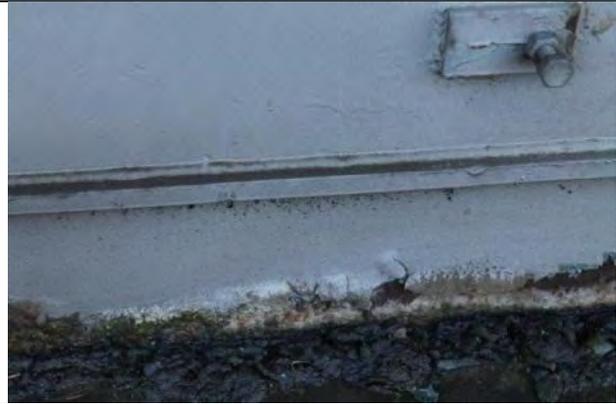
<p>Rust formation along the bottom plate of the transformer.</p>

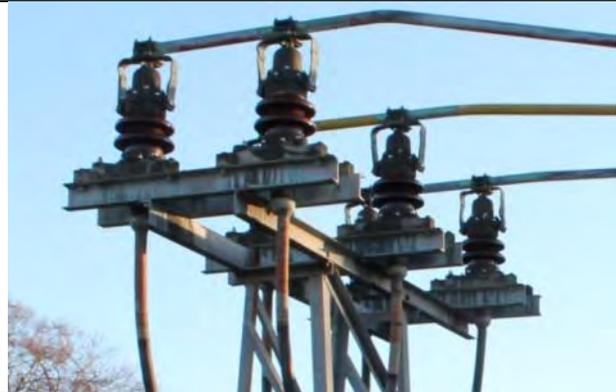
<p>Original 11 kV cables are still in operation. Some wear on the terminations, but no signs of deterioration. New 11 kV cables have been jointed to enter the new substation.</p>

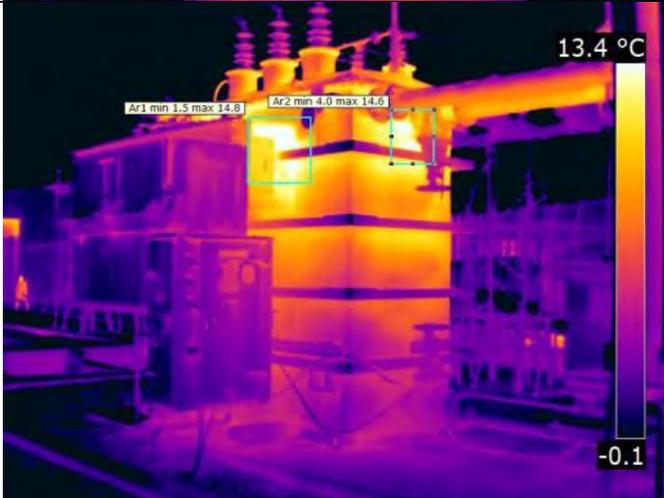
<p>13.4 °C</p> <p>Ar1 min 1.5 max 14.8</p> <p>Ar2 min 4.0 max 14.6</p> <p>-0.1</p>	<p>No indication of thermal issues.</p>

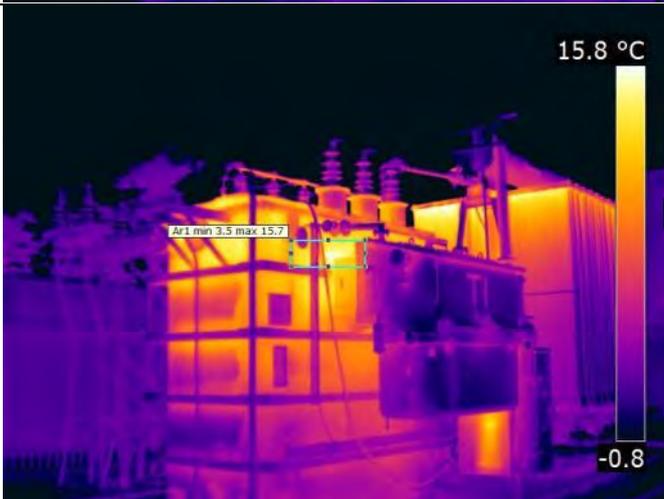
<p>15.8 °C</p> <p>Ar1 min 3.5 max 15.7</p> <p>-0.8</p>	<p>No indication of thermal issues.</p>

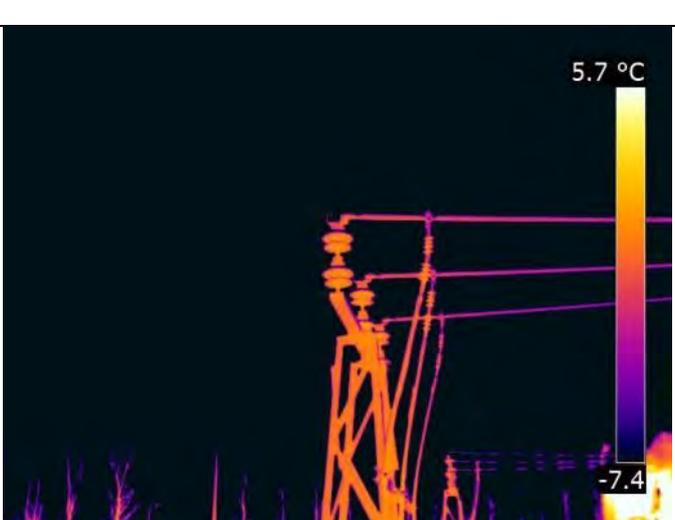
<p>No thermal issues were found in 33 kV-cable terminations.</p>

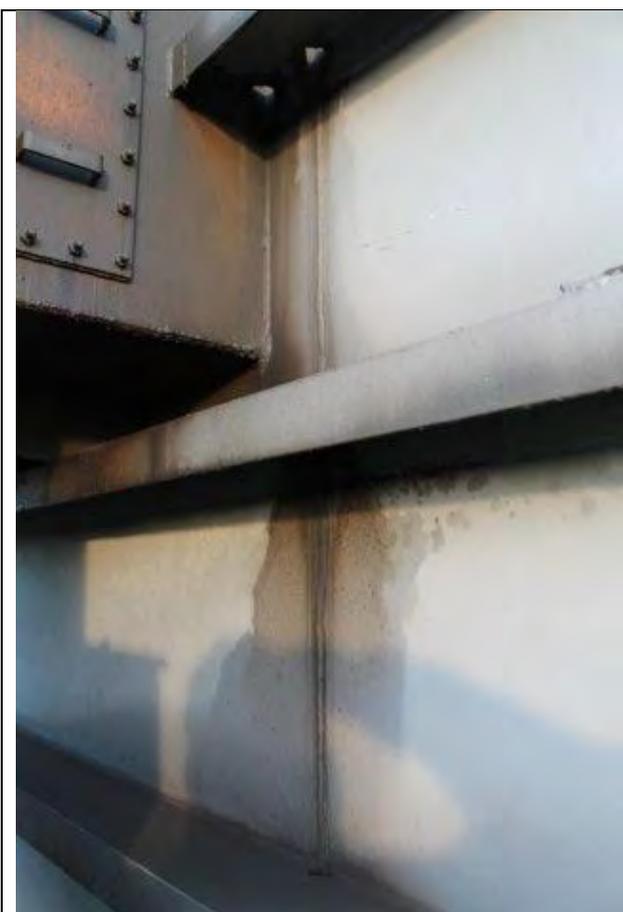
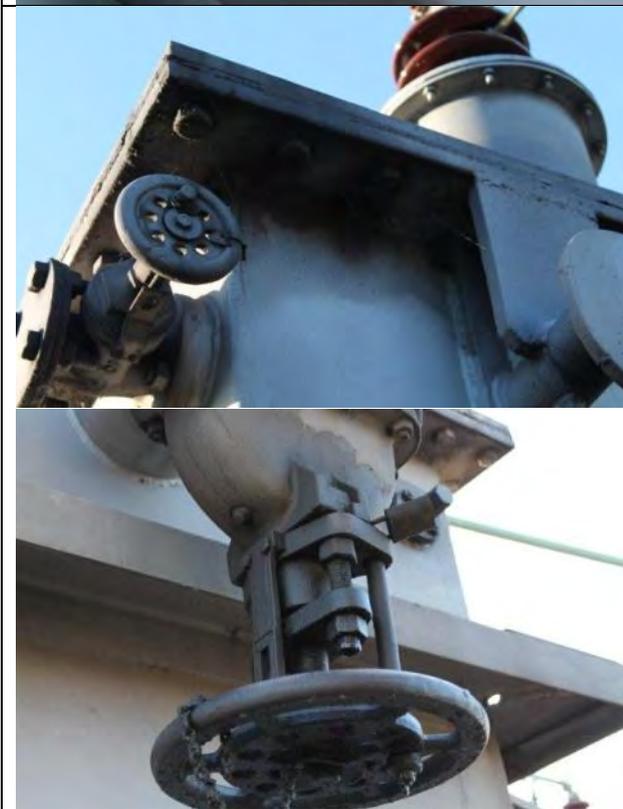
Picture of hatch cover on the tap-changer compartment. No severe signs of damage and deterioration. Significant indications for oil sweating.

Oil sweating at one of the corner tops of the transformer housing and around one of the valves.

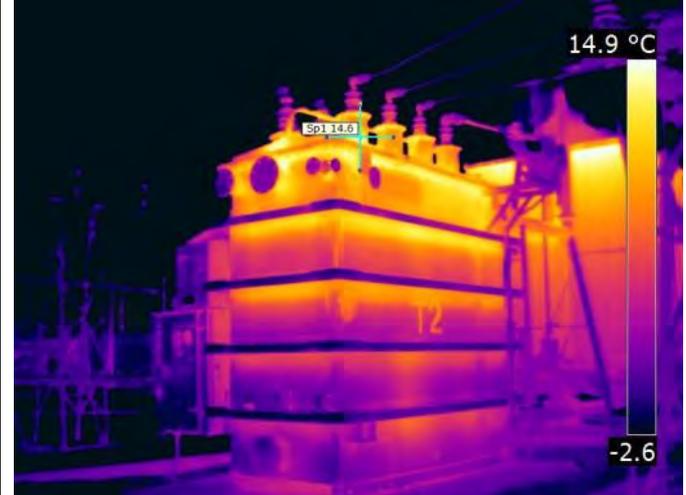
<p>14.9 °C Sp1 14.6 -2.6</p>	<p>No indication of thermal issues.</p>

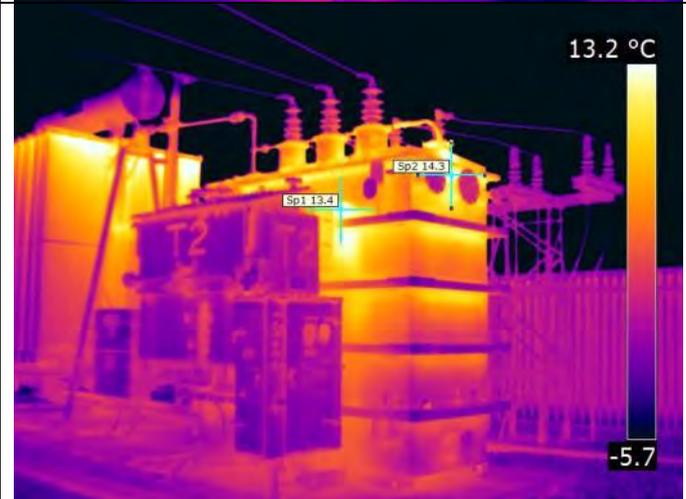
<p>13.2 °C Sp1 13.4 Sp2 14.3 -5.7</p>	<p>No indication of thermal issues.</p>

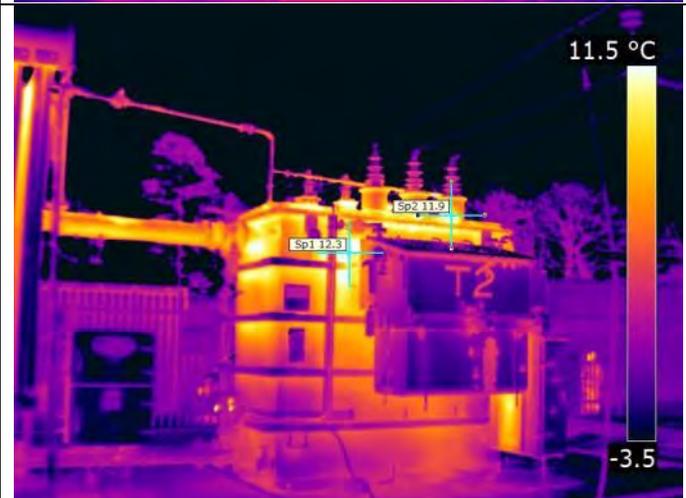
<p>11.5 °C Sp1 12.3 Sp2 11.9 -3.5</p>	<p>No indication of thermal issues.</p>

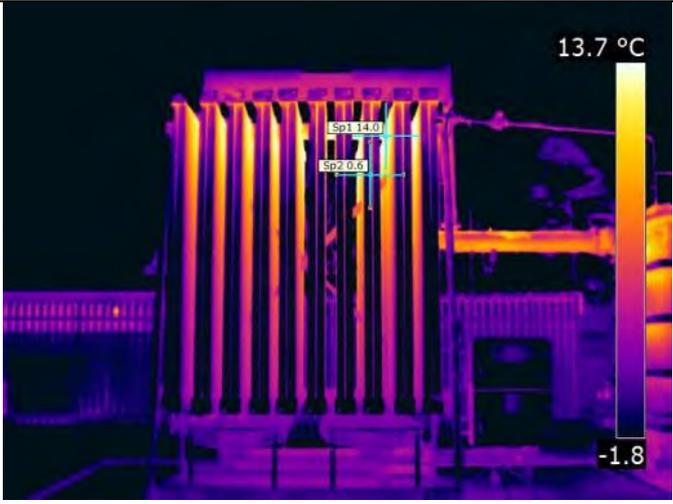
<p>No indication of thermal issues.</p>

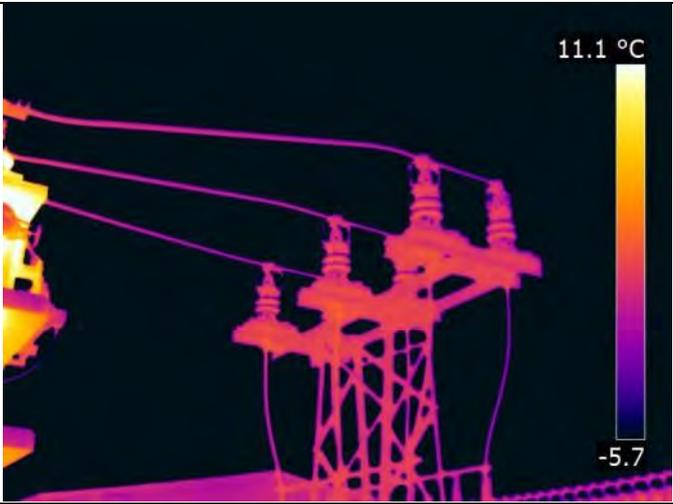
<p>No thermal issues were found in 11 kV-cable terminations.</p>

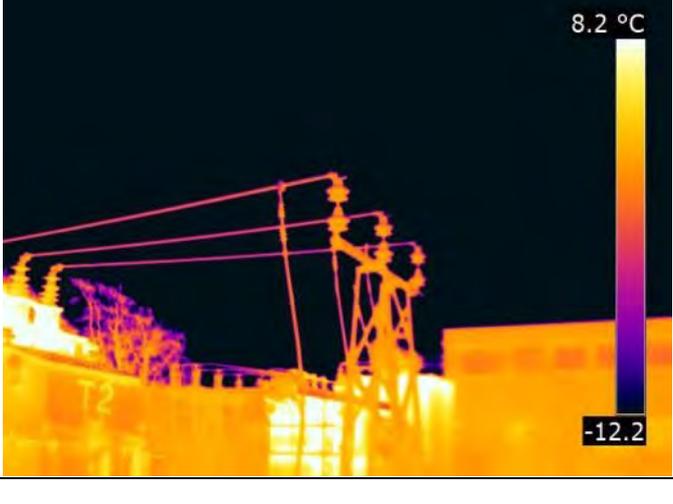
<p>No thermal issues were found in 33 kV-cable terminations.</p>
